Near collision involving a de Havilland DHC-2, VH-AWD and a Gippsland Aeronautics GA-8, VH-NOQ

16 km NNE of Hamilton Island Airport Queensland on 31 October 2014

ATSB Transport Safety Report
Aviation Occurrence Investigation
AO-2014-175
Final – 27 January 2015

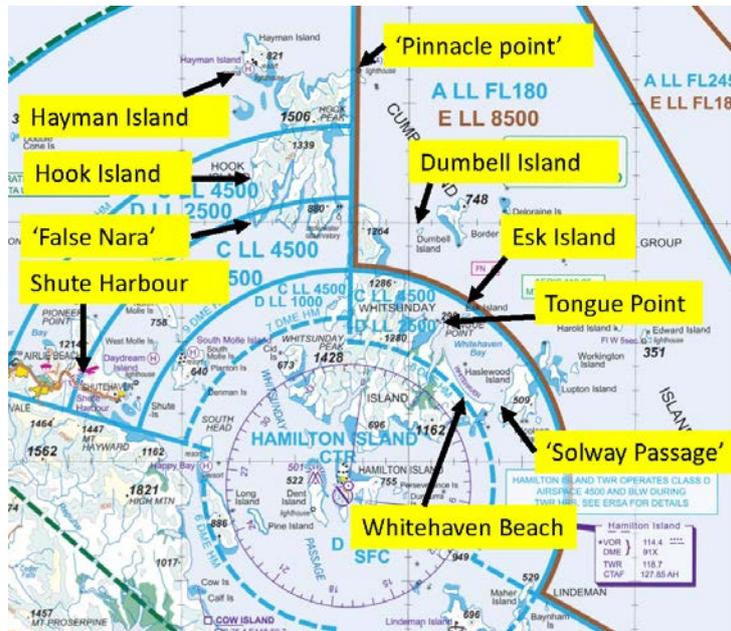
Figure 1: Hamilton Island visual terminal chart with reference locations

On 31 October 2014, the pilot of a de Havilland DHC-2 aircraft, registered VH-AWD (AWD), was conducting a scenic charter flight from Hayman Island Water Landing Area, Queensland, with five passengers on board. The aircraft tracked to the north of Hook Island (Figure 1), and climbed towards Pinnacle Point. The pilot of AWD broadcast on the common traffic advisory frequency (CTAF)¹ when passing Pinnacle Point.

The broadcast from AWD was heard by the pilot of a Gippsland Aeronautics GA-8 aircraft, registered VH-NOQ (NOQ), which had departed from Shute Harbour Airport at about 1325 Eastern Standard Time (EST) for a 30 minute scenic charter flight, with four passengers on board. Although he heard the broadcast, the pilot of NOQ did not know where Pinnacle Point was as it was not labelled on the Hamilton Island visual terminal chart (VTC).

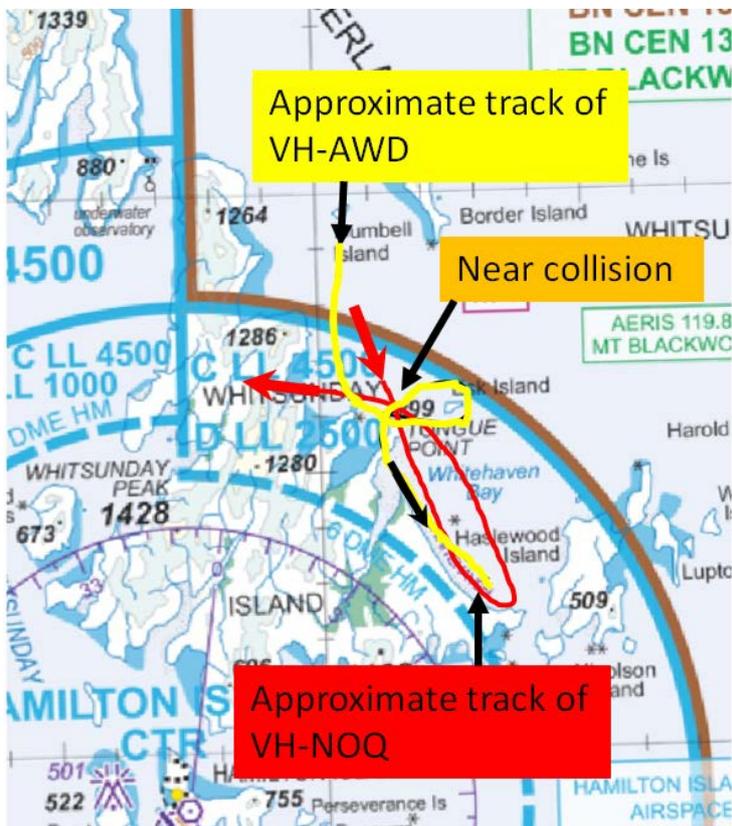
Figure 2: Aircraft tracks overlaid on Hamilton Island visual terminal chart

At about 1354, and at a height of 1,300 ft, as AWD approached Tongue Point from Dumbell Island (Figure 2), the pilot of AWD commenced a left turn to head towards Esk Island. While providing commentary to the passengers, and glancing out at the beach to ensure the aircraft was positioned correctly, the pilot sighted NOQ on a reciprocal track and estimated the aircraft passed on his right about 50 m away and about 50 ft above AWD. Both aircraft were turning left at the time.
