Flight crew incapacitation involving a Reims Aviation F406, VH-EYQ

near Emerald, Queensland, 1 August 2014

ATSB Transport Safety Report
Aviation Occurrence Investigation
AO-2014-134
Final – 26 February 2015

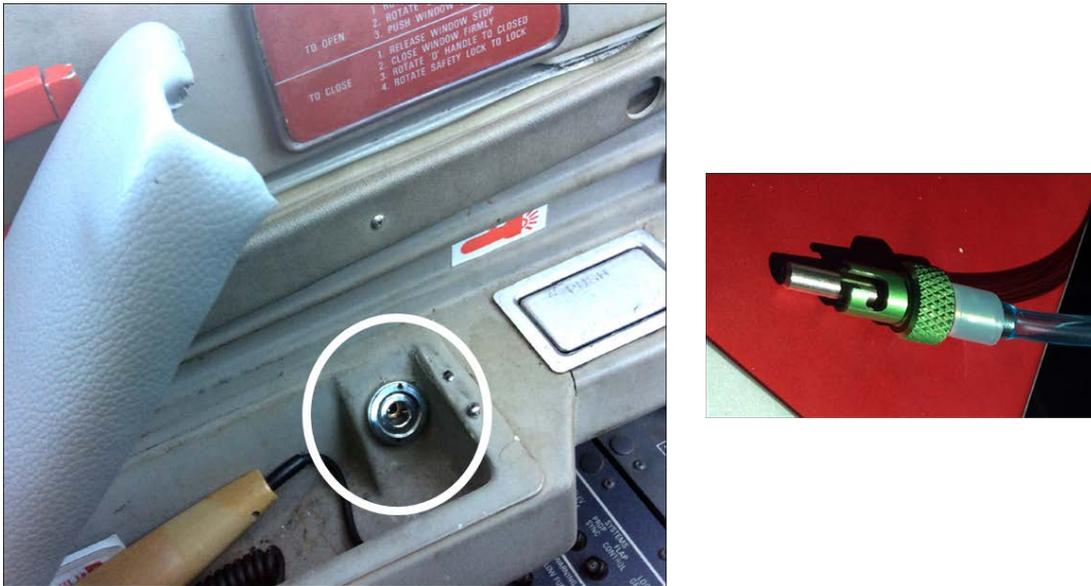
- Despite his apparently hypoxic condition, the pilot was ultimately able to identify that an oxygen supply system fitting had become disconnected. The fitting was located beneath the pilot's armrest, and was the same fitting that the pilot had earlier connected during the climb (Figure 1). When he reconnected the fitting, he took a number of deep breaths and sensed almost immediate relief.

Figure 1: Oxygen port beneath pilot's armrest and associated oxygen fitting

Consistent with the pilot's recollection of the event, the operator's investigation dealing with the incident found that the pilot's oxygen supply was interrupted when the fitting in the supply system beneath the pilot's armrest became disconnected. The investigation found that the bayonet fitting may not have been fully locked when connected by the pilot, noting that the connection could be in place but not necessarily properly locked. The investigation report added that the position of the port is such that some concentration and manipulation is required to ensure that the connection is seated correctly. The investigation also found that the supply tube may not have been correctly routed through an armrest cut-out, and that movement of the armrest may have dislodged the improperly secured bayonet fitting.

As a result of this occurrence, the aircraft operator has taken steps in relation to pre-flight oxygen system checks, and crew cross-checks on the performance of each other's oxygen system during flight above 10,000 ft.
