Collision with terrain involving an Air Tractor AT-502B, VH-PTF

45 km W of Moree Airport, New South Wales, on 18 December 2014

ATSB Transport Safety Report
Aviation Occurrence Investigation
AO-2014-191
Final – 26 February 2015

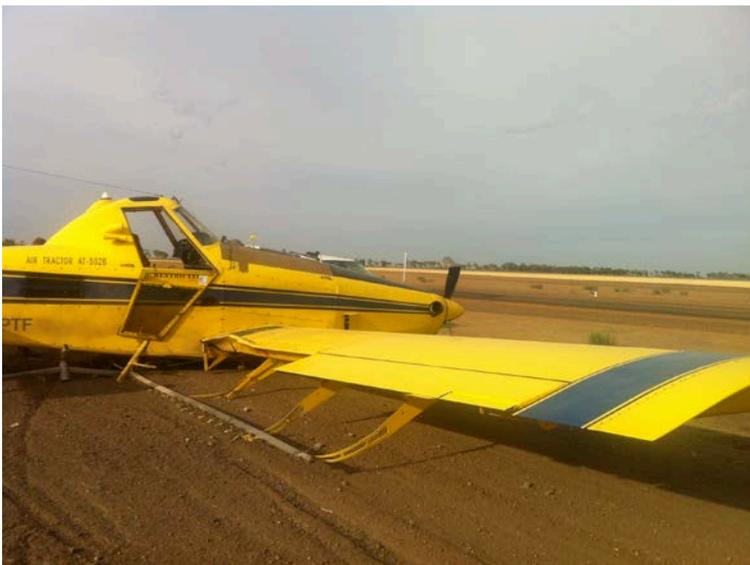
Figure 2: Damage to VH-PTF

At about 0704, PTF landed on a dirt road parallel to the airstrip. Both landing gear struts had been detached, which had then broken off the right flap, damaged the left flap and ruptured both fuel tanks. During the landing the propeller was damaged (Figure 2). The pilot was not injured.
