# Collision with terrain involving a Cessna 172, VH-ZZD

near Putty, New South Wales, 27 October 2014

**ATSB Transport Safety Report**  
Aviation Occurrence Investigation  
AO-2014-173  
Final – 26 February 2015

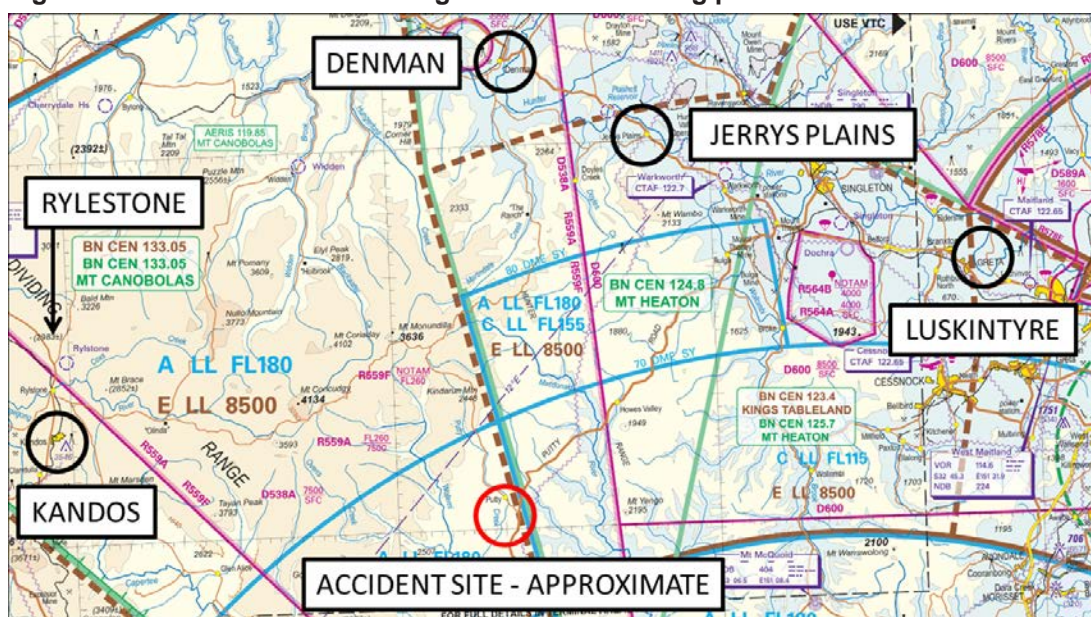
Figure 1: Extract from Visual Navigation Chart showing planned route and accident site

After departing Temora, the pilot planned to overfly Rylestone, Denman and Jerrys Plains, en route to Luskintyre. The flight proceeded as planned to about Kandos (just south of Rylestone), where the pilot visually fixed his position. At that point, rather than continuing as planned overhead Rylestone then on to Denman, the pilot elected to track directly to Luskintyre (Figure 1).

The direct track between Kandos and Luskintyre was over heavily treed and undulating terrain, leaving the pilot unable to positively visually fix his position. As he continued in an easterly direction, the pilot grew increasingly concerned about the possibility of infringing controlled airspace further to the east. Conditions at the time were windy and although the pilot recalled that the visibility was good, there may have been some bushfire smoke in the area.

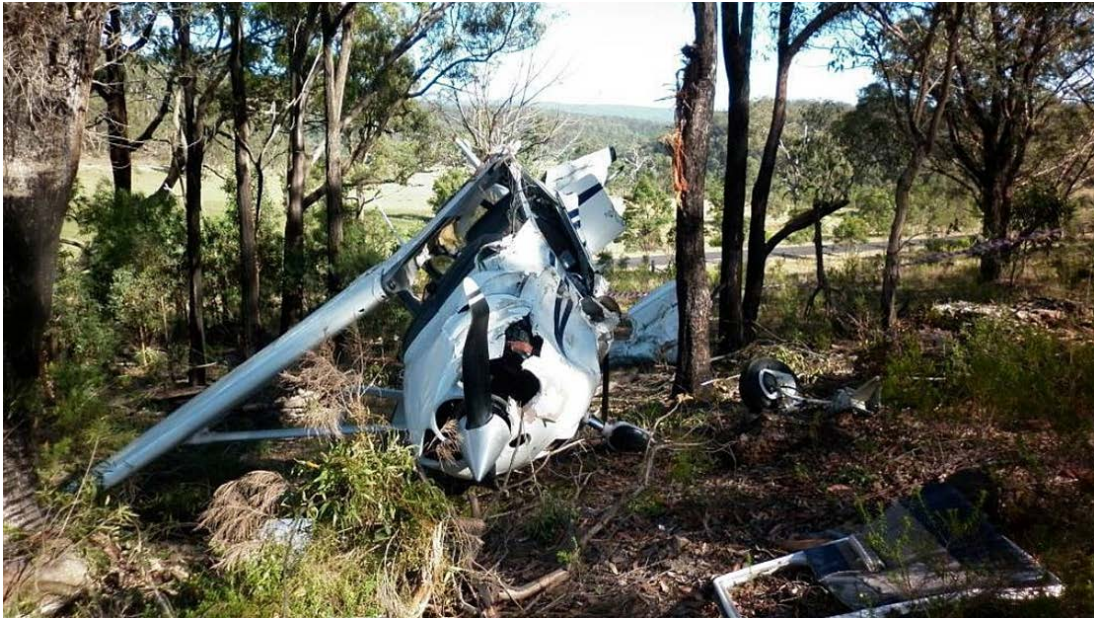
**Figure 2: Aircraft wreckage**

During his approach to land on the selected paddock, with full flap selected, the pilot found himself overshooting the selected aim point. He endeavoured to recover the profile, but had increasing difficulty maintaining the preferred aim point. Concerned that he would not be able to land safely, the pilot elected to discontinue the approach and commenced a go-around. As the go-around proceeded however, the pilot found that he was unable to climb over trees ahead of the aircraft on rising terrain beyond the far end of the selected paddock. He was able to manoeuvre around a small number of individual trees, but collided with a line of trees, slightly further on. The aircraft was substantially damaged in the collision (Figure 2) and the pilot received serious injuries.

With respect to precautionary landings, pilots are encouraged to initiate an early go-around as soon as there is any doubt regarding the prospects of a safe landing. The potential for a safe go-around may diminish as an aircraft continues an approach, particularly where there is rising terrain or obstacles beyond the selected precautionary landing area. With the assistance of a suitably qualified instructor, pilots are encouraged to regularly practise the skills required to make a safe precautionary landing.
