# Aircraft proximity event involving two Robinson R22s, VH-HQJ and VH-IAY, and an unknown aircraft

near Broome, Western Australia, 16 September 2014

**ATSB Transport Safety Report**  
Aviation Occurrence Investigation  
AO-2014-152  
Final – 26 February 2015

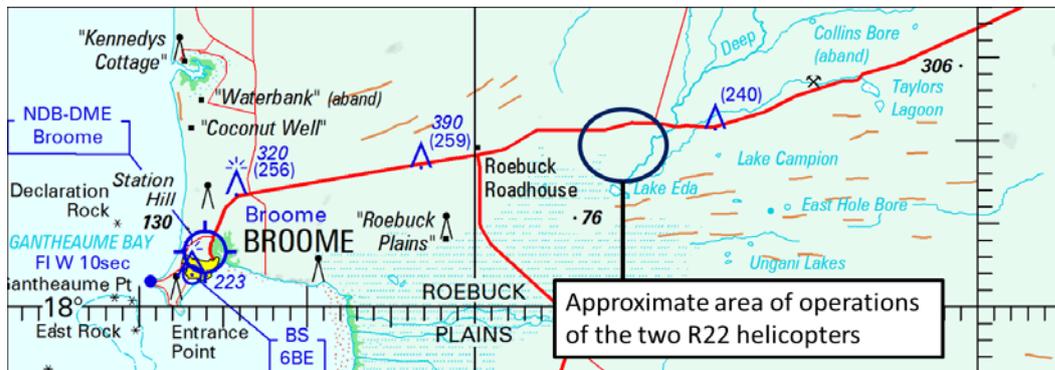
**Figure 1: Approximate area of operations of the two R22 helicopters**

On 16 September 2014, two Robinson R22 helicopters, registered VH-HQJ and VH-IAY, were conducting aerial mustering operations about 26 NM east-north-east of Broome, Western Australia (Figure 1). The two R22 pilots were working together, and had planned mutual separation using relevant ground features in the area of operations. The two R22 pilots were also in radio contact on a company radio, and monitoring the multicom frequency 126.7 MHz.<sup>1</sup> There was lifting fog in the area at the time, with some clear patches emerging. The fog in a westerly direction towards Broome was relatively thick, but it appeared to be clearing further east.
