Forced landing and ground fire involving a Robinson R44, VH-YY5

56 km east of Archer River, Queensland on 23 November 2014

ATSB Transport Safety Report
Aviation Occurrence Investigation
AO-2014-184
Final – 26 February 2015

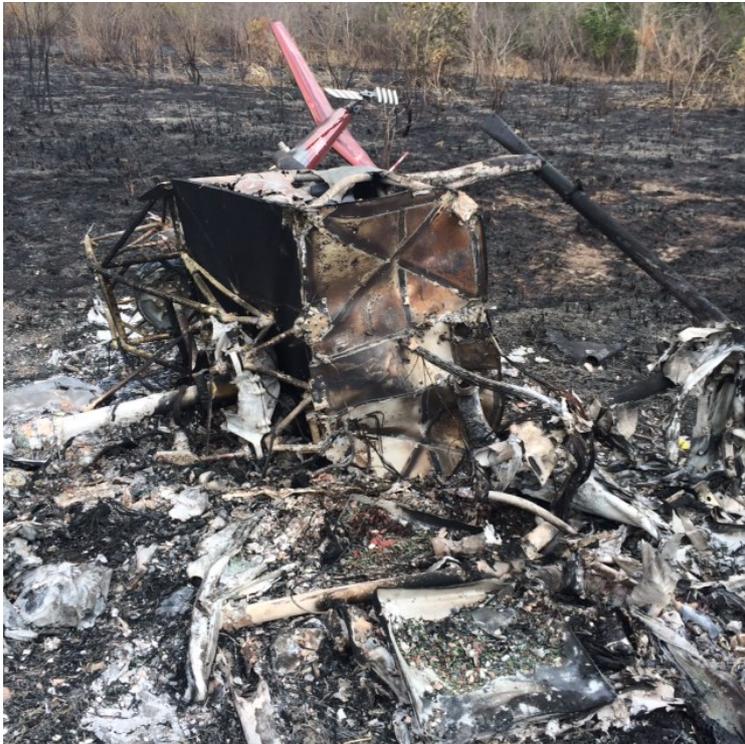
Figure 2: Accident site

As the helicopter neared the ground, the pilot saw that they were landing into tall guinea grass. As soon as the helicopter landed, the pilot locked the cyclic off, retrieved the emergency beacon and he and the passenger quickly exited the helicopter. The pilot observed smoke billowing from the rear of the helicopter, where heat from the helicopter's exhaust ignited a grass fire. They ran away from the helicopter and grassed area towards trees and within seconds the helicopter was engulfed by fire. The helicopter was subsequently destroyed and the pilot and passenger were uninjured (Figure 2). The helicopter had been fitted with bladder fuel tanks.

A review of the post-accident photographs found presence of the stainless steel brackets and clamps indicating that these shields had been fitted; however the actual aluminium shields were not observed and may have melted in the ensuing fire.

The pilot conducted a successful autorotation, but the helicopter was destroyed by the subsequent fire. When conducting a forced or precautionary landing, pilots may have limited choices for a suitable landing site. When time permits, the dangers of landing on grass, especially in areas of high temperatures and low humidity should be included when planning and assessing suitable landing sites.
