# Wheels-up landing involving a Cessna 210, VH-MCE

Gove Airport, Northern Territory, on 11 November 2014

**ATSB Transport Safety Report**  
Aviation Occurrence Investigation  
AO-2014-177  
Final – 22 April 2015

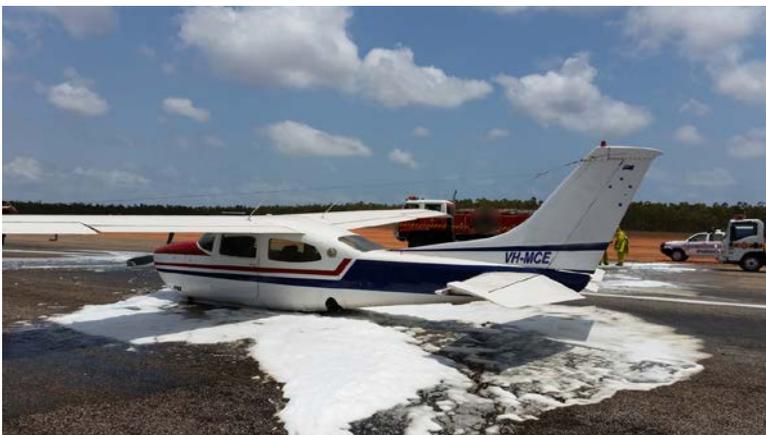
**Figure 1: Wheels-up landing**

The aircraft landed just beyond the threshold and on the centreline of runway 31 with the wheels retracted. When the pilot realised the wheels were retracted, he immediately selected the fuel to OFF. The aircraft sustained substantial damage and the pilot and passengers were uninjured (Figure 1).

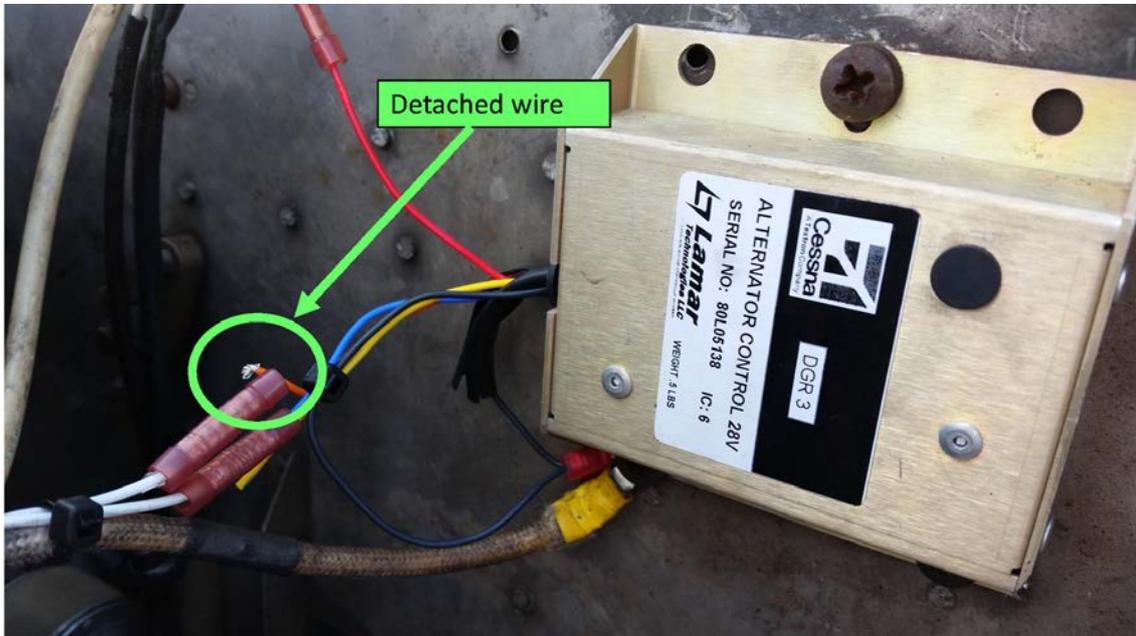
Figure 2: Detached alternator wire

A detached electrical cable was found to have caused the alternator to stop charging the battery (Figure 2). The engine had not been inspected before the completion of the ATSB report and the cause of the engine issues were unknown.
