Wheels up landing involving a Cessna 310, VH-TBE

Jabiru Airport, Northern Territory, 12 December, 2014

ATSB Transport Safety Report
Aviation Occurrence Investigation
AO-2014-188
Final– 22 April 2015

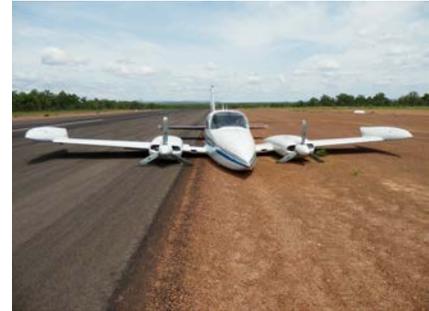
VH-TBE on side of runway

The pilot flared the aircraft in preparation for landing. He became aware that the undercarriage remained retracted when TBE touched down on the runway centreline and he heard the propellers contacting the ground.

Mindful there was an aircraft in the circuit behind him, he used the remaining rudder effectiveness to move the aircraft slightly to the left of the runway. When the aircraft came to a stop, he checked on the welfare of his passengers and opened the door for them to exit, directing them to assemble in a safe area. After completing shutting down, he also exited the aircraft. There were no injuries to either the pilot or passengers; however, the aircraft was substantially damaged.
