Wheels-up approach and go-around involving a Piper PA-31-350, VH-TXK

Townsville Airport, Queensland, 9 January 2015

ATSB Transport Safety Report
Aviation Occurrence Investigation
AO-2015-008
Final – 22 April 2015

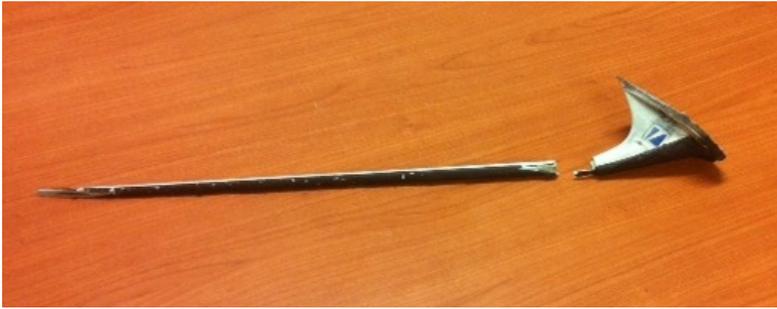
The VHF antenna was found on the runway, having broken off from the underside of the aircraft after striking the runway (Figures 1 and 2). Two aerodynamic fins also sustained minor scrapes from the runway. The pilots and passengers were uninjured in the occurrence and a subsequent engineering inspection found that the landing gear warning horn was serviceable.

Figure 1: Broken antenna

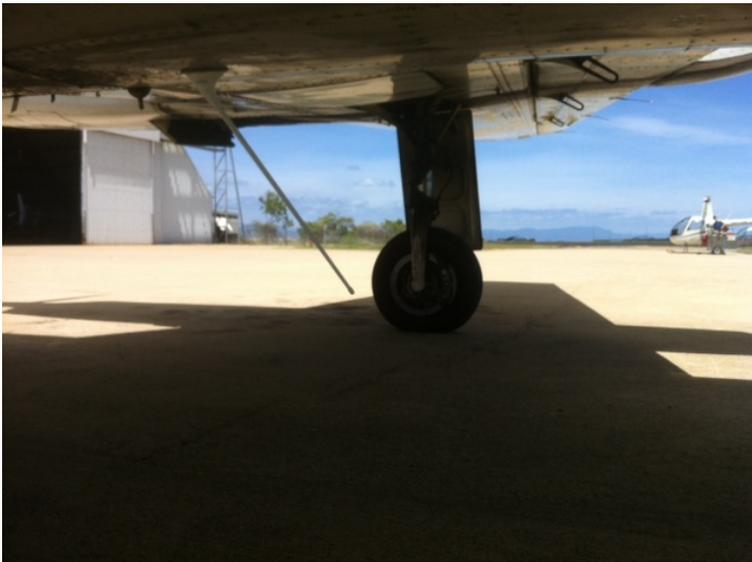
Figure 2: Photo of new antenna fitted to VH-TXK
