Collision with terrain involving a Robinson R22, VH-SSD

23 km NE of Roma, Queensland, 16 January 2015

ATSB Transport Safety Report
Aviation Occurrence Investigation
AO-2015-009
Final – 22 April 2015

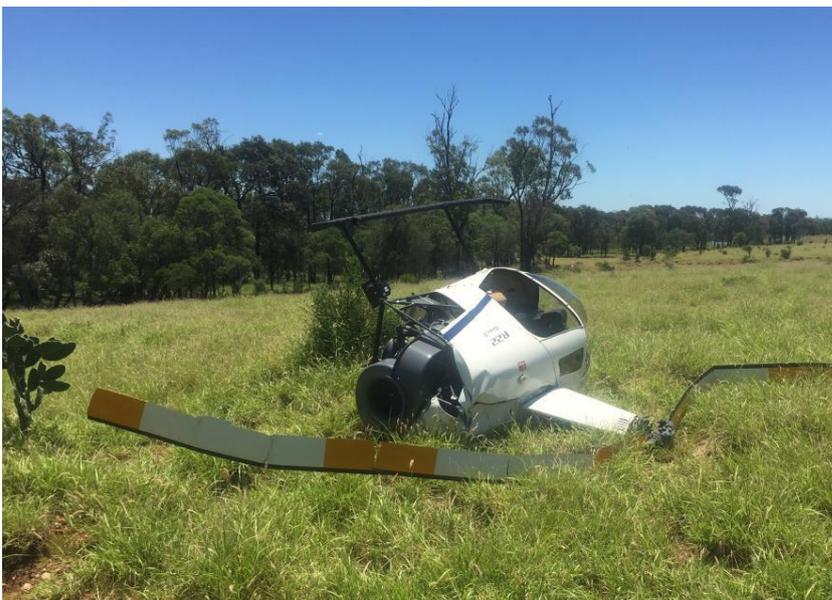
The pilot then ensured the skids were level and the helicopter collided with the ground. Due to the rough surface, the helicopter bounced into the air. The pilot pulled back on the cyclic² control, which resulted in the tail of the helicopter being chopped off by the main rotor. The helicopter then spun around and came to rest on its side (Figure 1). The helicopter was substantially damaged and the pilot was uninjured.

Figure 1: Damage to VH-SSD

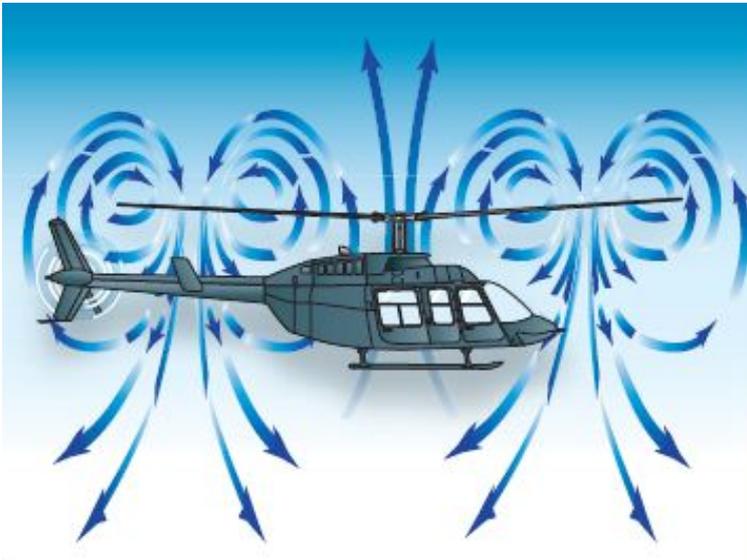
A fully developed vortex ring state is characterized by an unstable condition in which the helicopter has uncommanded pitch and roll oscillations, little or no collective authority, and a descent rate that may approach 6,000 fpm, if allowed to develop (Figure 2).

Figure 2: Vortex ring state
