Collision with terrain involving a Robinson R22, VH-ZBH

Herbertvale Cattleyard (ALA), Queensland, 23 January 2015

ATSB Transport Safety Report
Aviation Occurrence Investigation
AO-2015-010
Final – 22 April 2015

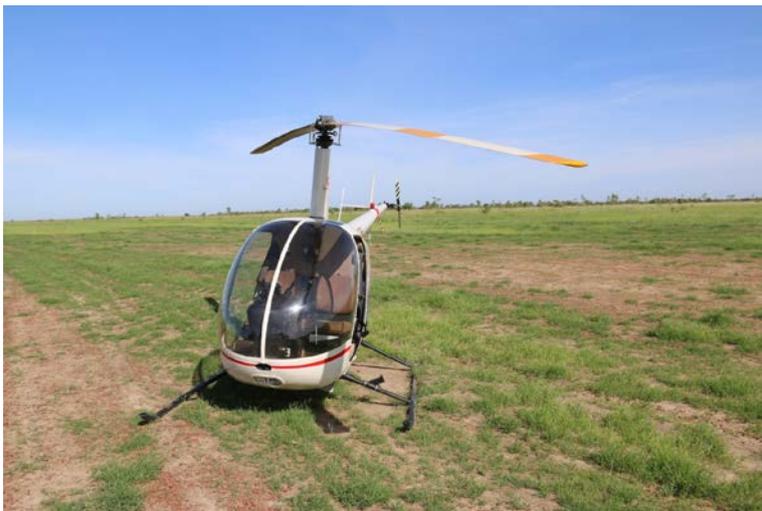
Figure 1: Damage to VH-ZBH

The pilot immediately wound on throttle and lowered the collective¹ in an attempt to increase the rotor rpm and to ensure the helicopter cleared a fence. He then prepared for an emergency landing. The rear of the skids touched down first and the helicopter skidded forwards. As the helicopter still had forward momentum, the pilot then pulled back on the cyclic² to prevent the helicopter rolling over forwards, and it became airborne, moved forwards and yawed right, and bounced again before coming to rest upright (Figure 1).

The helicopter was substantially damaged due to the impact on the skids, and the pilot and passenger were uninjured.

A post-accident engineering inspection did not reveal any cause of the engine loss of power.
