Wheels up landing involving a Beech BE58, VH-AKG

Darwin Airport, Northern Territory, 28 April 2014

ATSB Transport Safety Report
Aviation Occurrence Investigation
AO-2014-079
Final – 14 July 2014

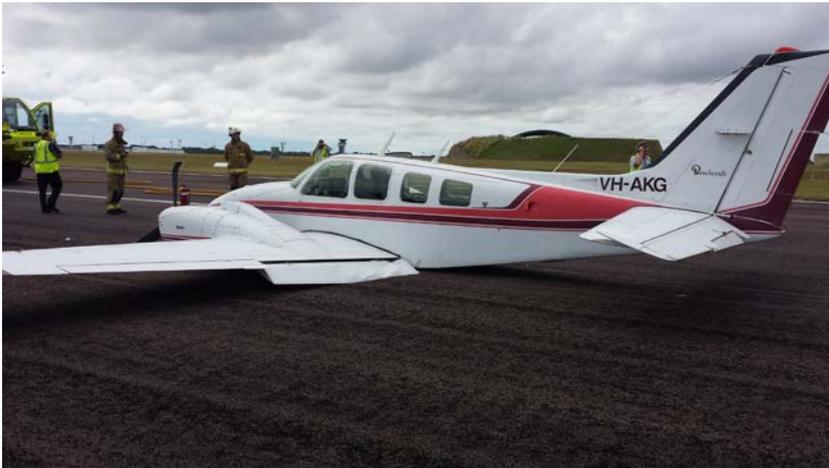
Figure 1: Damage to VH-AKG

The tower controller cleared AKG to land on runway 36, however the pilot requested holding at Lee Point to brief the passengers for a wheels-up landing and subsequent exit from the aircraft. He then fully extended the flaps, which took some time, with repeated resetting of the circuit breaker. At about 1145, the pilot was cleared to land on runway 36. He reported that the workload on the final approach was high, as the aircraft was more responsive without the landing gear extended. He kept some power on during the approach in case a go-around was required. When over the runway threshold, the pilot selected the mixture levers to idle cut-off. The rear step scraped on the runway, the flaps then contacted it, followed by the aircraft fuselage, and the left propeller, which caused the aircraft to yaw to the left. The pilot used right rudder to keep the aircraft straight and then the right propeller contacted the runway and the pilot again corrected the yaw. The aircraft came to rest about half way along the runway and the pilot switched all the electrics and fuel off. The pilot exited the aircraft and assisted the passengers to disembark. No injuries were sustained and the aircraft was substantially damaged (Figure 1).

An engineering inspection found that the up-lock assembly on the right main landing gear was binding and prevented extension of the right main landing gear. The up-lock mechanism pivots on a bolt, which was not listed in the lubrication chart for the aircraft. The binding of the assembly damaged the retract-extend rod and prevented any further movement of the retraction mechanism on the right main landing gear.

The damaged retract-extend rod placed load on the flap actuating cable, causing the flap circuit breaker to trip. This prevented the flaps from extending and retracting normally.
