Operational event involving a Boeing 737, VH-VUR

near Renmark, South Australia, 7 November 2014

ATSB Transport Safety Report
Aviation Occurrence Investigation
AO-2014-179
Final – 10 June 2015

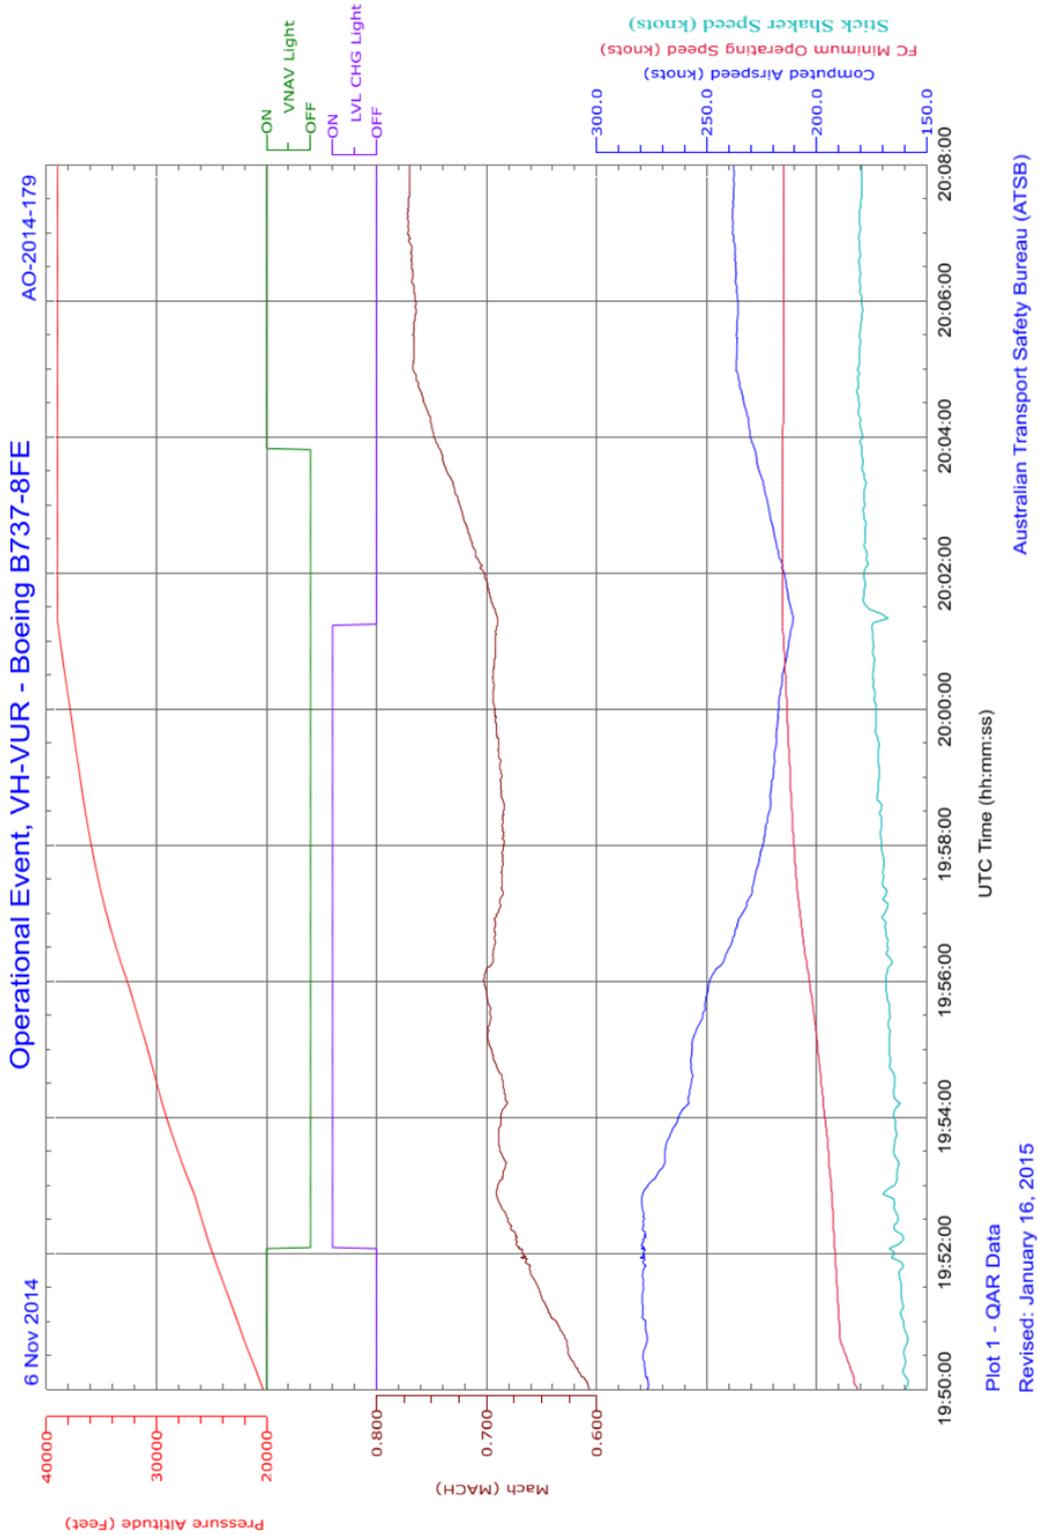
Figure 1: Selected flight parameters and auto-flight system modes.

The slowly reducing airspeed went unnoticed by the crew until the auto-flight system was levelling the aircraft at the planned cruise altitude of FL 390. At about that time, the captain noticed that the magenta airspeed bug⁵ on the primary flight display (PFD) airspeed indicator was at the top of the minimum manoeuvre airspeed amber bar. At that point, the top of the amber bar corresponded to an airspeed of about 216 kt. The crew also noticed a 'buffet alert' advisory message appear in the scratchpad of Control Display Unit (CDU).⁶

Figure 1 provides a graphical illustration of some relevant flight parameters and auto-flight system vertical modes from FL 200 until the aircraft had accelerated to Mach 0.77 in cruise flight at FL 390. Of particular note is the change from VNAV mode to LVL CHG mode soon after 1952 UTC.⁸ The figure also shows the near constant Mach number and gradually decreasing airspeed from about 1953 UTC, until the aircraft reached the planned cruise altitude soon after 2001 UTC. The airspeed dips beneath the minimum manoeuvre airspeed for a short time as the crew initiated acceleration, reaching a minimum recorded airspeed of about 211 kt. From that point, the aircraft accelerates to the planned cruise Mach number of Mach 0.77, with VNAV re-engaged just before 2004 UTC. Note that the minimum operating airspeed referred to in Figure 1 is the same as the minimum manoeuvre airspeed (see below). The computed airspeed referred to in Figure 1 is the same airspeed that would have been displayed on the captain's PFD.

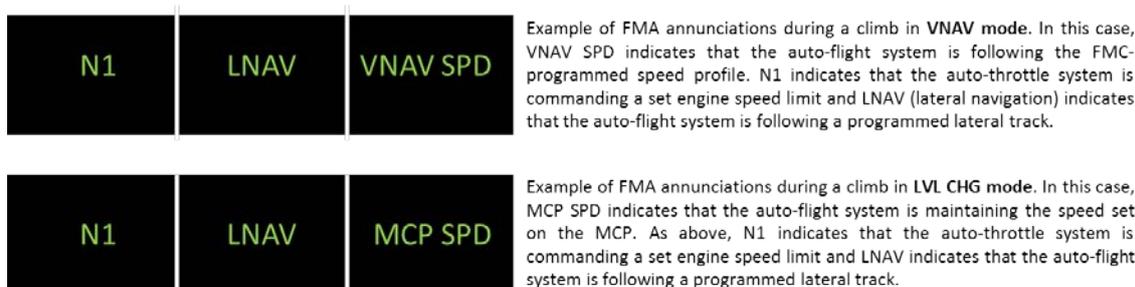
Figure 2: Relevant example FMA annunciations (VNAV upper example and LVL CHG lower example)

LVL CHG mode is selected by pressing the LVL CHG pushbutton on the MCP. Like the VNAV pushbutton, a green bar illuminates on the pushbutton when LVL CHG is selected. The speed control knob on the MCP is then used to select the required climb airspeed or Mach number, which is displayed in the corresponding IAS/MACH window. When LVL CHG mode is selected, the FMA indicates N1 as the auto-throttle mode and MCP SPD (speed) as the vertical auto-flight mode (Figure 2).
