Near collision involving a Diamond DA20, VH-YNB and a Mooney M20, VH-SJT

near Jandakot Airport, Western Australia, 20 February 2015

ATSB Transport Safety Report
Aviation Occurrence Investigation
AO-2015-022
Final – 10 June 2015

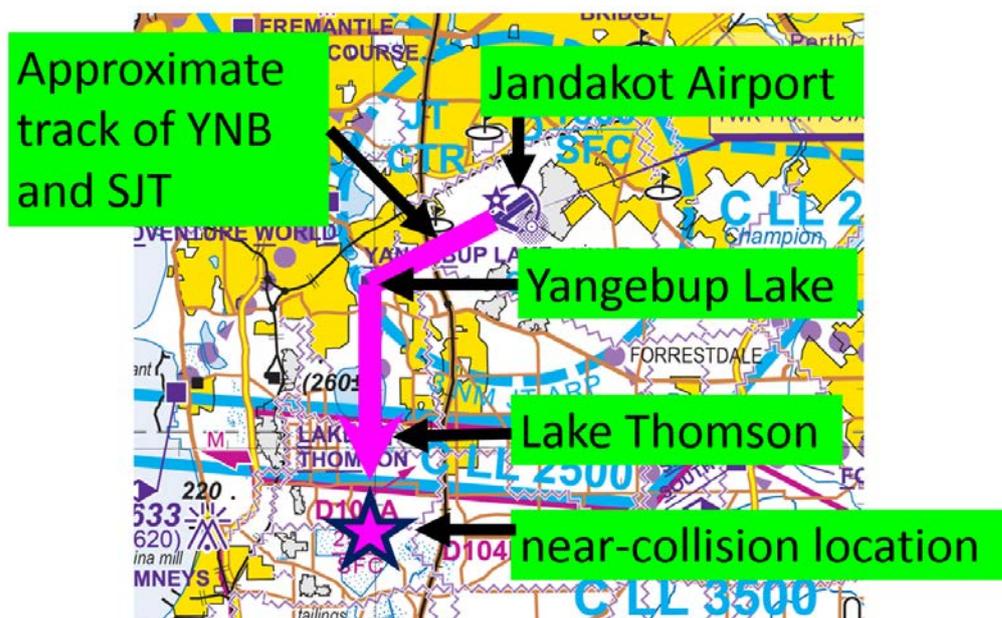
Figure 1: Perth Visual Terminal Chart with relevant points overlaid

At about 1136, the aerodrome controller (ADC) cleared YNB for take-off from runway 24 Right (24R) and advised the pilot of helicopter traffic ahead, which the trainee instructor reported in sight. About 16 seconds later, the pilot of SJT reported ready at the holding point for runway 24R. The ADC cleared SJT for take-off about 23 seconds later, at 1137, and did not advise of any traffic. The pilot of SJT then commenced the take-off run and directed the front seat passenger to close the door. The front seat passenger was unable to fully close the door, resulting in air flowing in on the passengers seated in the back seat and articles being blown around inside the cabin. The pilot continued with the take-off and asked the passengers to stay calm and silent, and the door was left partially open. Both aircraft departed Jandakot via Yangebup Lake at about 1,000 ft (Figure 1).
