# Engine failure involving a de Havilland Canada DHC-1, VH-RVY

near Luskintyre, New South Wales on 14 November 2014

**ATSB Transport Safety Report**  
Aviation Occurrence Investigation  
AO-2014-180  
Final – 27 August 2015

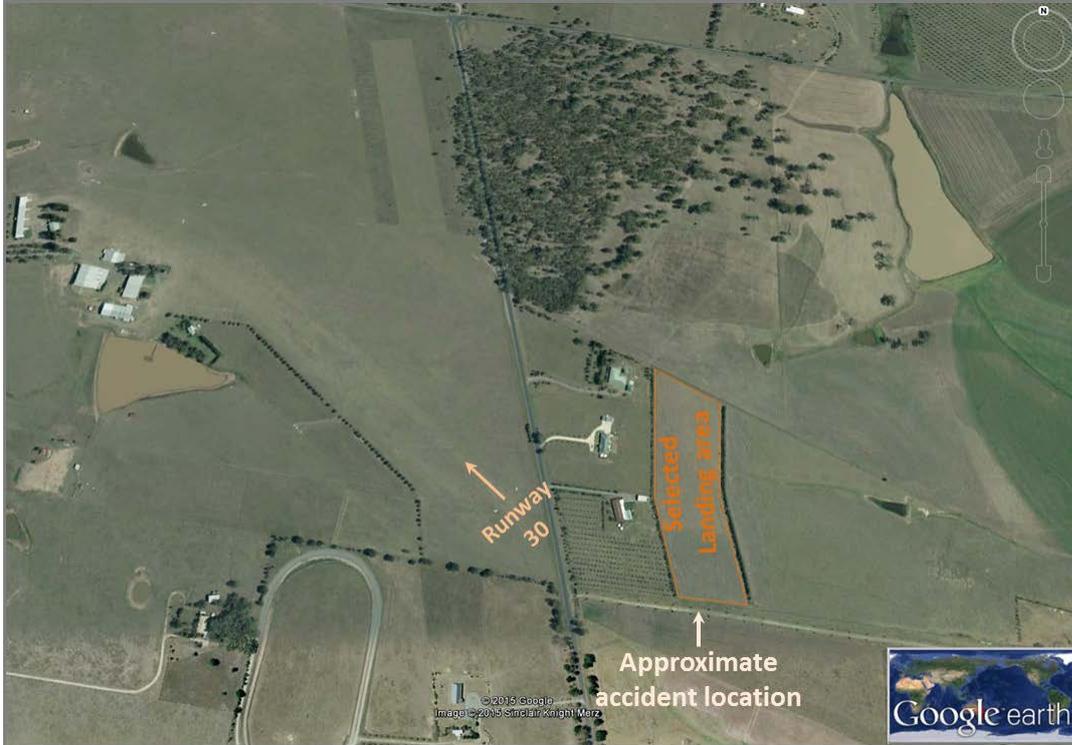
**Figure 1: Accident location**

At the time, RVY was about 1 km north of Luskintyre Airfield (Figure 1), heading east at about 3,000 ft above ground level (AGL). The westerly wind was reported to be gusting at around 20-30 kt. The pilot joined downwind for a landing on runway 30, noting the groundspeed was around 150-160 kt. While on downwind, the pilot advanced the throttle lever and noted that at about 1/3 lever movement the engine speed was at about 3,000 RPM (maximum continuous RPM at sea level pressure altitude is 2,700). Despite the engine speed, the aircraft was not able to maintain altitude. In an attempt to 'get back' to the airfield the pilot turned from a slightly extended downwind onto a 'base leg'. As the aircraft turned, the engine stopped producing power. The pilot unsuccessfully attempted to restart the engine.

When RVY turned onto a final approach, the aircraft was still descending. At about 500 ft AGL, the pilot determined that they would not make the runway, so he elected to land in a paddock about 500 m east of the airfield (Figure 1). During this manoeuvre, the right wing stalled and dropped slightly. To recover, the pilot lowered the nose of the aircraft to gain more airspeed. The pilot reported that due to the high outside air temperature and gusting wind, the conditions were quite turbulent near the ground. The pilot flared the aircraft in preparation for landing and noted airframe buffeting, with little to no response from the elevator. The aircraft landed heavily, travelling through an electric fence before the aircraft stopped on a drive way just short of the selected landing area (Figure 1).

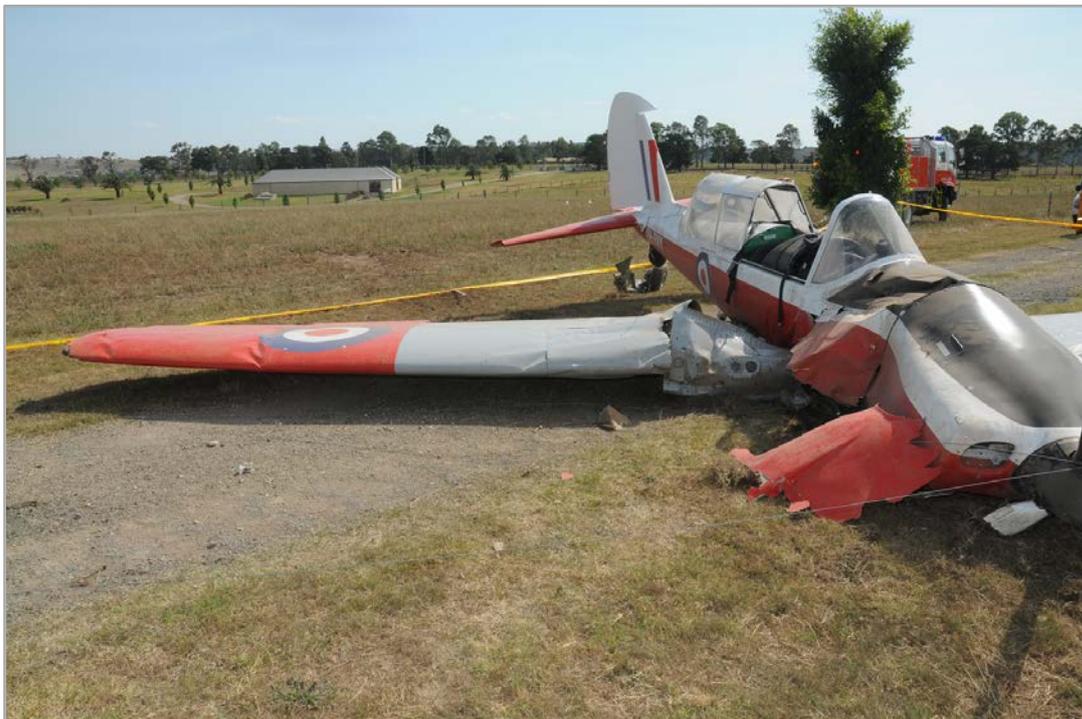
**Figure 2: VH-RVY**

he was unable to provide any physical assistance. After a short time, the passenger exited the aircraft. The pilot and passenger sustained serious injuries and the aircraft was substantially damaged (Figure 2).
