Tail rotor malfunction involving a Robinson R22, registration VH-HPH

La Belle Downs Station, Northern Territory on 18 November 2014

ATSB Transport Safety Report
Aviation Occurrence Investigation
AO-2014-181
Final – 27 August 2015

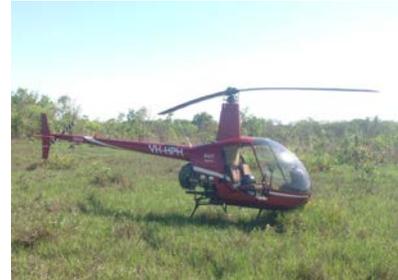
VH-HPH

About two minutes into the flight, on climb and at about 300 ft above ground level, the pilot felt a vibration through the tail rotor pedals. The pilot decided to return to La Belle Downs station, turned the helicopter to the right and started a descent. The pilot was unable to stop the turn and the helicopter continued to descend and turn to the right. The helicopter started to spin in a tight circle and completed between five and six rotations before landing hard, bouncing once and then coming to a stop. The pilot performed the shutdown procedure and the pilot and passenger exited the helicopter. The pilot and passenger were uninjured. The helicopter was substantially damaged, including damage to the tail boom and both skids.

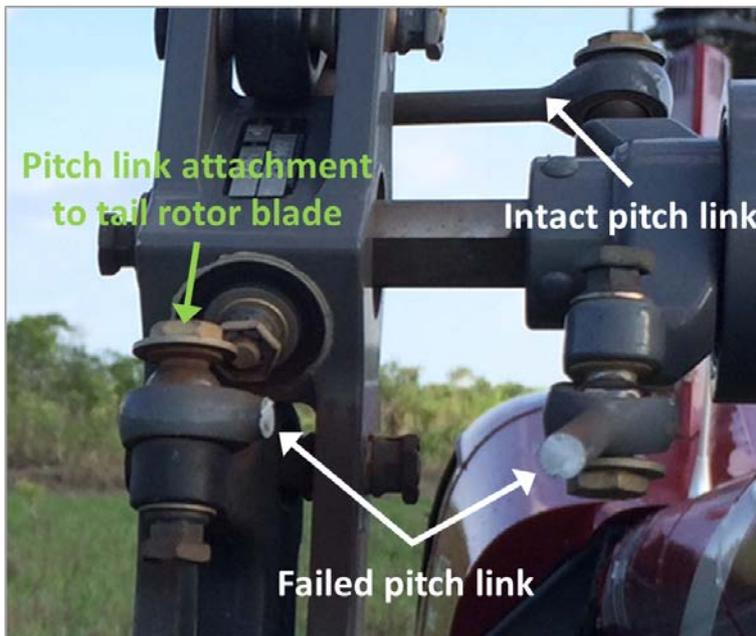
Figure 1: Failed tail rotor pitch link

After landing, the pilot observed that the tail rotor pitch link¹ had failed (Figure 1).

The helicopter manufacturer was only aware of one other similar failure that occurred about 10 years ago. The manufacturer believed that the failure was as a result of the axial wear (about five times more than permitted) allowed binding to occur, with resultant fatigue failure to the pitch link.

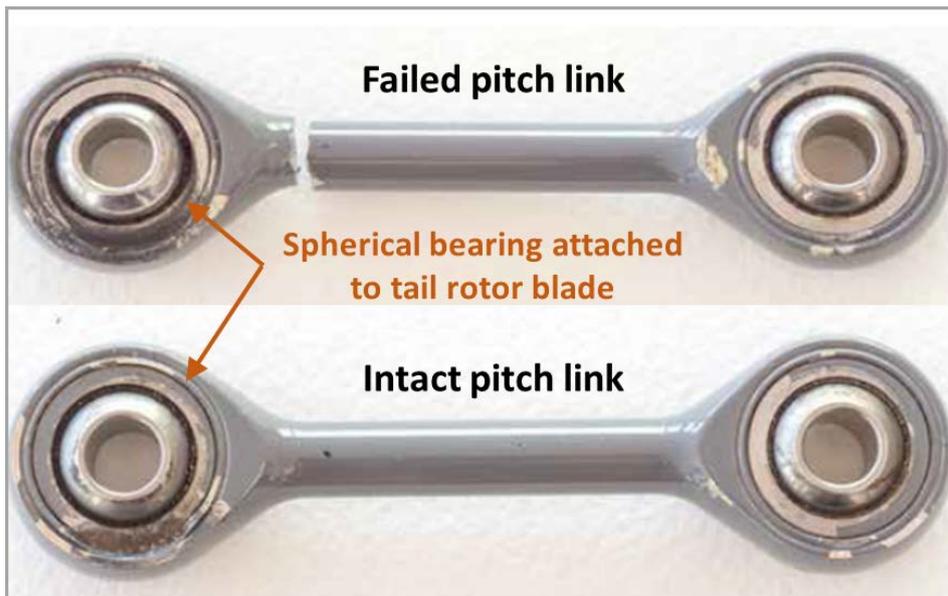
Figure 2: HPH tail rotor pitch links

An examination of the tail rotor pitch links was conducted on behalf of the helicopter operator by a consultant in engineered-system failure analysis and the following was found (Figure 2):

- Alternating stress in the failed pitch link resulted in the initiation and propagation of a fatigue crack.
- The alternating stress in the pitch link resulted from failure of the spherical bearing to provide a low friction connection between the end of the tail rotor blade and the pitch link.

- The failed pitch link spherical bearing attached to the tail rotor had extensive wear. Axial wear of the spherical bearing was measured to be about 0.108 inch (2.743 mm).

- The intact pitch link spherical bearing attached to the tail rotor also showed signs of extensive wear. Axial wear of the spherical bearing was measured to be about 0.041 inch (1.041 mm).

- No physical explanation was found as to why the specified inspection procedures (*R22 Maintenance Manual*, Chapter 2 Inspection, section 2.410) failed to detect bearing wear. Possible explanations beyond what could be ascertained by the examination were that the helicopter was operated in an exceptionally abrasive environment or the Teflon bearing lining was affected by some cleaning action.

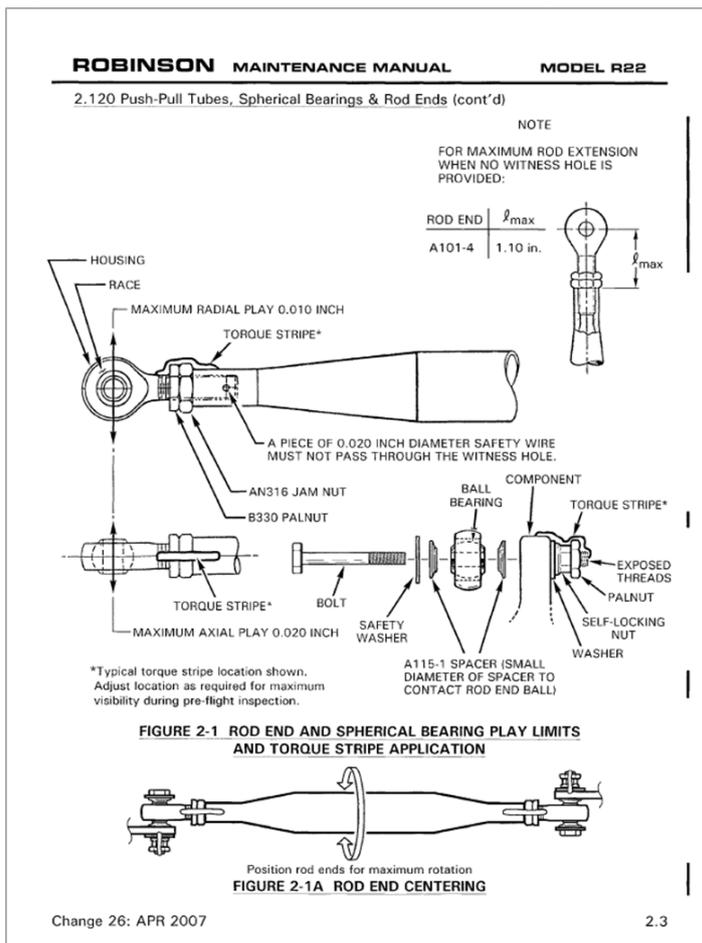
Figure 3: Robinson maintenance manual spherical bearing limits

The Robinson Maintenance Manual Model R22 contains inspection requirements to be conducted at the 100-hour or annual inspection. Section 2.410 Inspection procedures and checklist item 12. Rotor Hub Hinge Bolts, dated October 2014, required the condition of the pitch links and rod ends to be inspected. This inspection was to be in accordance with section 2.120 Push-Pull Tubes, Rod Ends, and Spherical Bearings (dated October 2014), with reference to Figure 2-1 (reproduced below in Figure 3). The inspection needed to meet the following conditions:

- the maximum allowed axial play of 0.020 inch (0.508 mm). The axial play of HPH's failed pitch link was about 0.108 inch (2.743 mm) and the intact pitch link was about 0.041 inch (1.041 mm)
- the maximum radial play of 0.010 inch (0.254 mm) for the rod end spherical bearings
- with no looseness between the bearing outer race and the rod end housing.
