# Engine failure and collision with terrain involving Stoddard-Hamilton Glasair III VH-USW

near Jandakot Airport, Western Australia | 9 December 2013

## **ATSB Transport Safety Report**

AO-2013-221

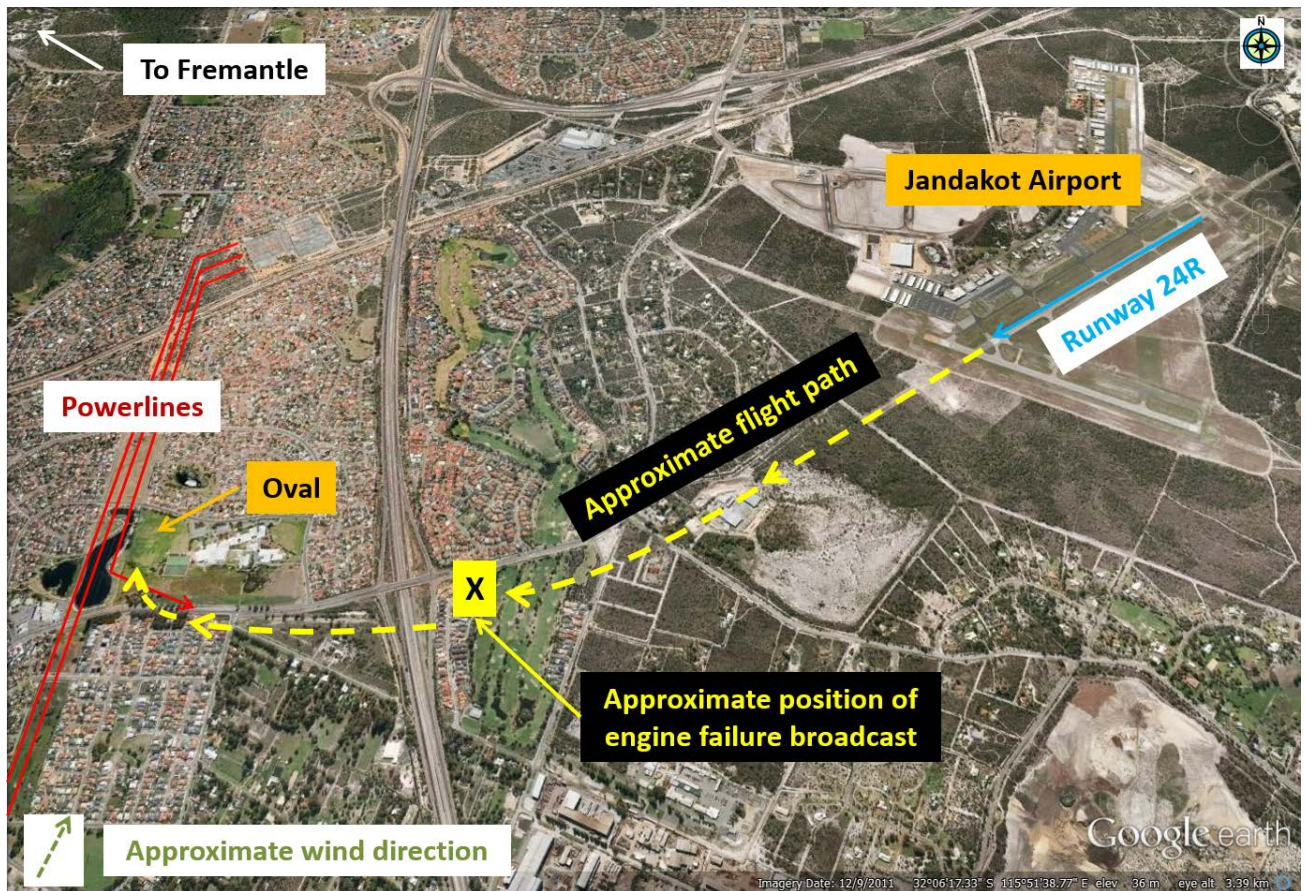
Figure 1: Approximate flight path and forced landing area

The pilot focused on flying the aircraft and looking for a suitable landing area. With very few options available, the pilot, who was aware of powerlines in the vicinity (Figure 1), manoeuvred the aircraft for a forced landing in a nearby grassed area (Lakelands Reserve Oval). It was reported that the propeller was windmilling during the descent.<sup>3</sup>

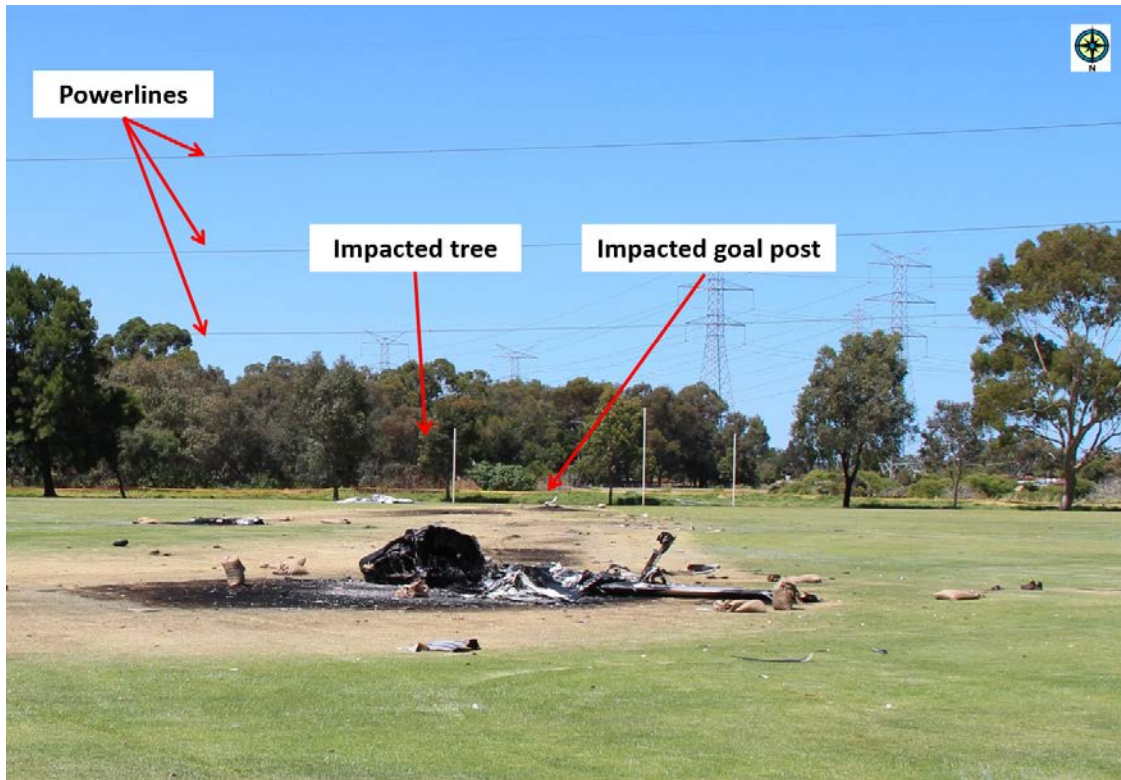
**Figure 2: Three-strand powerline on late approach to the landing area and the impacted tree and goal post (looking back along the direction of travel)**

Approaching the landing area, the pilot observed a powerline along the flight path and dived abruptly to pass beneath that line. At the same time, the pilot lowered the undercarriage and flaps to control the aircraft's airspeed and avoid overshooting the oval. The pilot elected not to turn the aircraft's electrical system off for the landing to ensure that the undercarriage lowered completely.

After flying under the powerline, the aircraft lightly clipped a tree bordering the oval before colliding with a metal goal post. The pilot reported not seeing the goal posts until it was too late to avoid the collision (Figure 2). The pilot recalled hearing the sound of the impact then next remembered lying on the ground and seeing the passenger nearby and the aircraft wreckage on fire. The pilot helped the passenger to move away from the wreckage and remove burning clothes items.

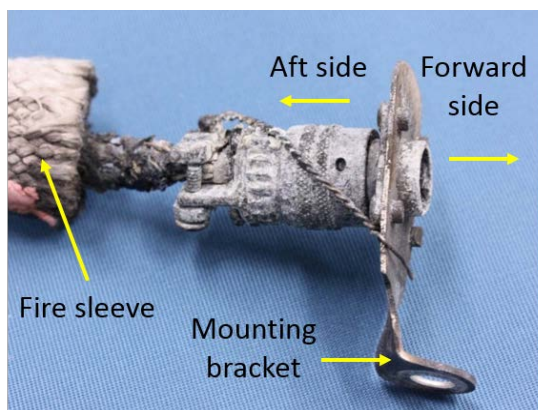
**Figure 3: Bracket-mounted connector plug and fire sleeve**

The aircraft’s ignition system was further modified by the aircraft builder to include a second CDI module and an auxiliary battery. The addition of an auxiliary battery was recommended by the manufacturer and independently powered the second system. The aircraft’s two CDI systems were intended by the builder to operate independently, providing redundancy in the event that one of the duplicated elements failed. To duplicate the wiring for the two CDI modules, the builder split the single wiring harness from the trigger plate into two using a MIL-SPEC connector plug.<sup>6</sup> This plug was designed to be attached to a metal box or a panel, such as a firewall. However, in USW, it was mounted onto a homemade, right-angled bracket that was fastened to the front of the engine crankcase (Figure 3). The connector plug and associated wiring were in an in-line arrangement.

each CDI module. On the forward side of the plug, the single set of wires from the trigger plate was inside two plastic sleeves and their ends inserted into brass sockets, which were crimped for security (Figure 4). The sockets were then pushed into the forward side of the connector plug through a rubber sealing grommet and held in place in the cylindrical, plastic insulator by plastic clips. There was no means on this type of connector for relieving any stresses placed on the wires.

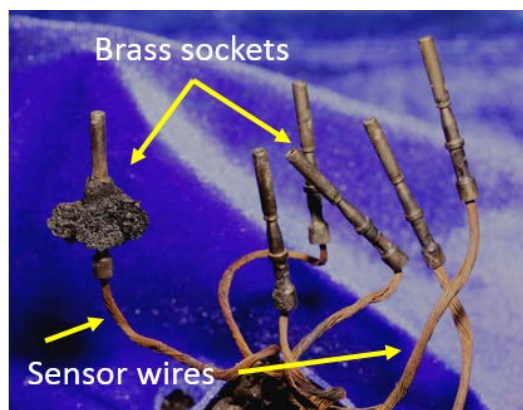
**Figure 4: Sensor wires and brass sockets**

Light Speed Engineering Plasma II and III ignition systems, such as the direct crank sensor installation, are now available as a dedicated dual system, with two independent wiring harnesses originating from the sensor plate and connecting directly to each CDI module. No intermediate plug, such as the connector plug used on USW, is required.

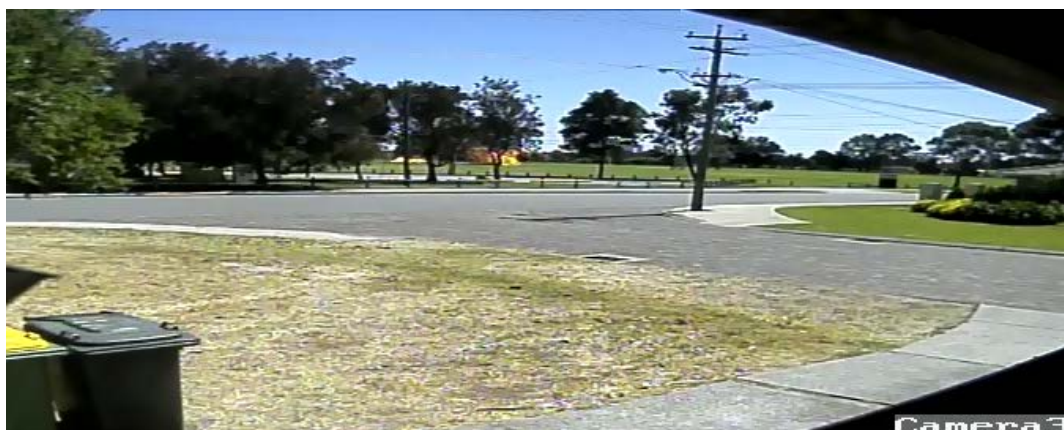
**Figure 5: Security camera image of the fire (looking south-south-east)**

An examination of the wreckage found that the aircraft's right wingtip clipped a tree on the southern boundary of the oval before the left wing was sheared off at the wing root by the collision with a tubular, metal goal post. This impact ruptured the left wing fuel tank and severed aircraft wiring from the fuselage into the left wing. Images from a nearby surveillance camera showed that the fuel ignited shortly after the collision with the goal post (Figure 5).

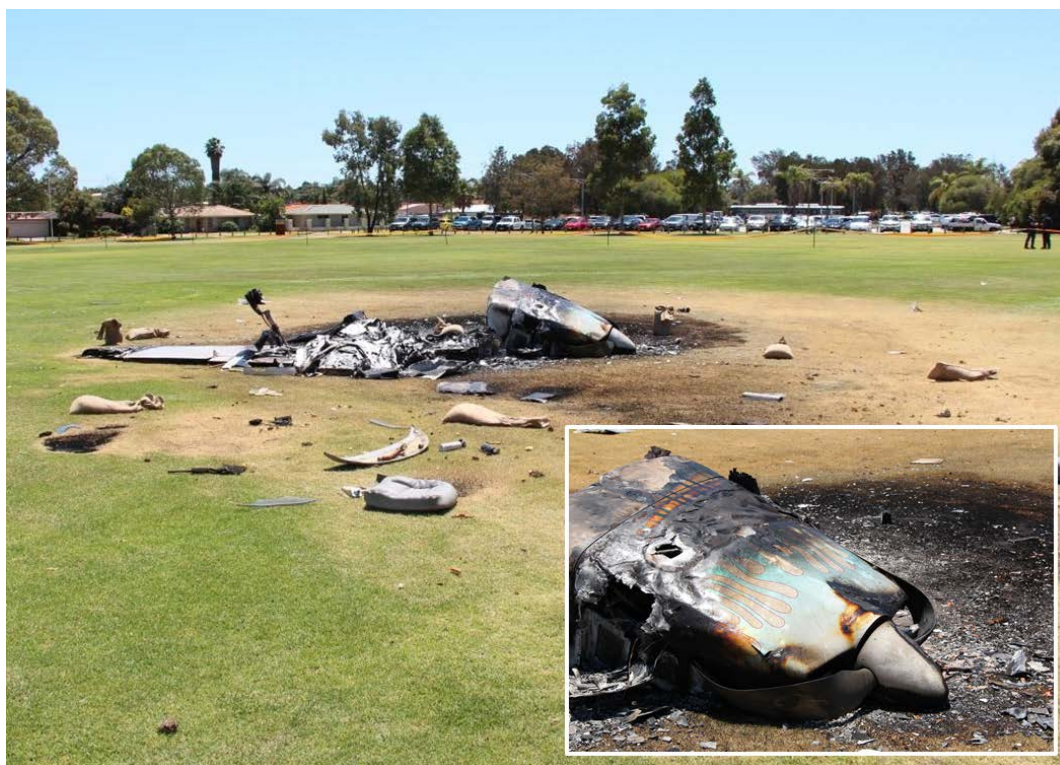
**Figure 6: Aircraft wreckage and propeller damage (see inset)**

Damage to the aircraft was consistent with witness descriptions and the surveillance images depicting the aircraft tumbling before coming to rest with the fuselage, attached right wing and tailplane inverted. The engine, upper engine cowling, engine mounts and header tank were orientated in an upright position. The upper engine cowling was in situ and intact, with the engine still attached to the firewall assembly via the support frame. The damage to the propeller blades and strike marks on the ground were consistent with the propeller rotating at impact but the engine producing no power (Figure 6 inset).

The impact and fuel-fed fire destroyed the cockpit and severely damaged the composite airframe. This included the destruction of components of the electronic ignition and fuel systems, limiting or preventing examination of these parts.

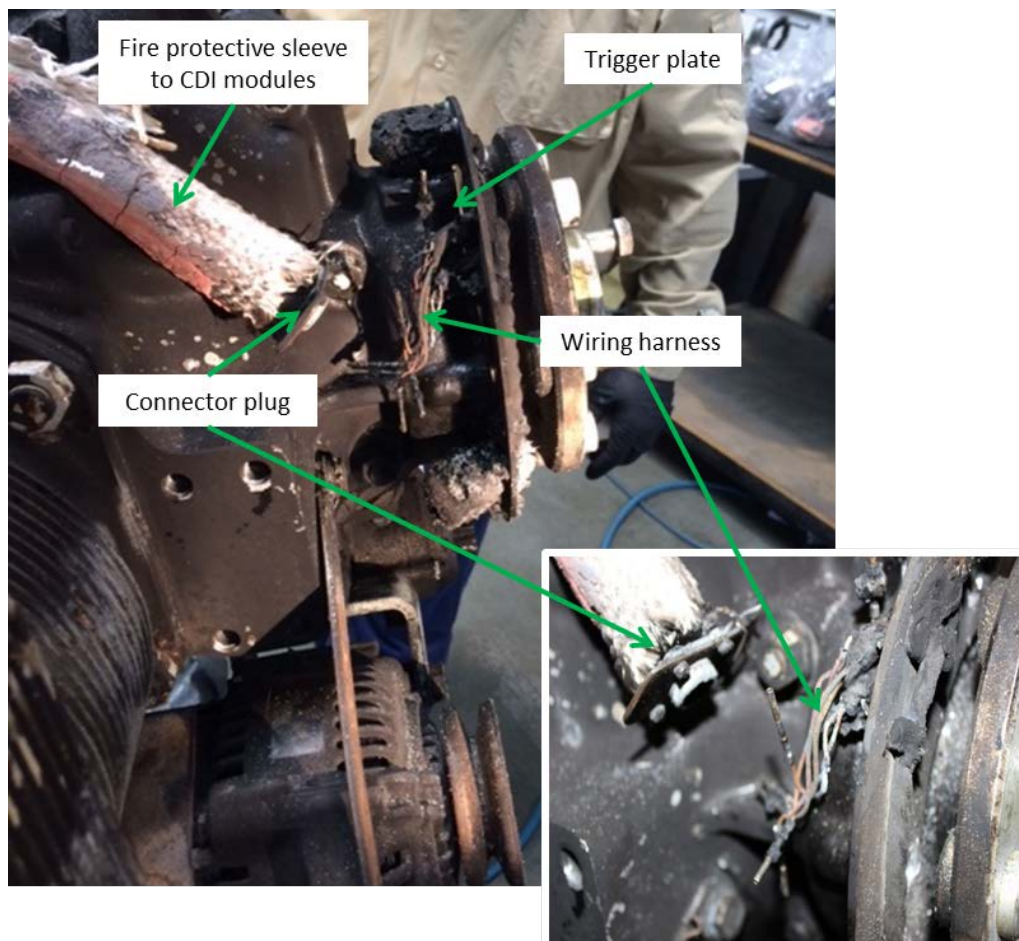
**Figure 7: Disconnected engine timing trigger plate wiring and connector plug (engine positioned upright)**

The wires from the engine timing trigger plate for the aircraft's electronic ignition system were found disconnected from the connector plug and displaced in the direction of engine rotation (Figure 7). In addition, there was no evidence of the alternator V-belt. Whether the belt failed or dislodged from the drive prior to or during the accident sequence, or was consumed in the post-impact fire could not be determined.

Examination of the pins and brass sockets on the forward side of the connector plug showed damage consistent with the wiring harness being forcefully and unevenly disconnected either in-flight or during the early stages of the impact sequence. However, no witness marks were identified on the two flywheel trigger bolts to indicate contact with another part of the engine or its accessories. This and the fire damage to the plastic insulation on the wiring harness meant that there was insufficient evidence to conclude that they had contacted a trigger bolt.

While the engine examination identified no internal mechanical failure or abnormality that would have precluded normal operation, the single wiring harness to the aircraft's electronic ignition system was found disconnected.

Cessation of the engine timing signal, such as from the disconnection of the single wiring harness, would result in the loss of timing signals to both ignition modules and failure of the ignition system. Without an ignition source, the engine would stop operating.

The alternator V-belt and the engine timing trigger bolts on the flywheel were the only two moving components within the vicinity of the single wiring harness and connector plug with the potential to disconnect the harness. The still-rotating propeller meant that, dependent on the presence of an operational alternator belt, these components may still have been rotating at impact. However, the unavailability of the alternator belt for examination prevented any conclusion on its pre-impact condition or contribution to the disconnection of the harness. Regardless, the continued use of the V-belt, which had been stored under tension for longer than the manufacturer's acceptable storage life, increased the risk of belt failure.
