# Collision with terrain involving a Robinson R44, VH-VOH

130 km E of Alice Springs, Northern Territory, on 14 July 2015

**ATSB Transport Safety Report**  
Aviation Occurrence Investigation  
AO-2015-077  
Final – 7 October 2015

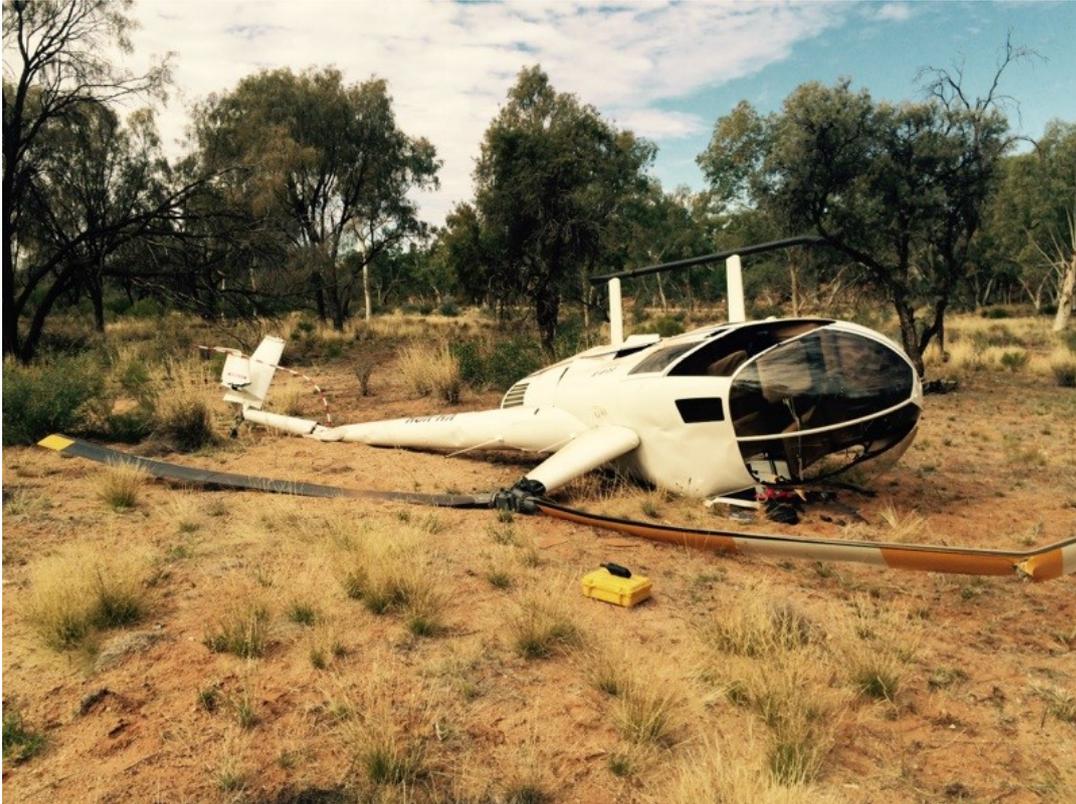
The pilot sustained minor injuries and the helicopter was substantially damaged (Figure 1).

**Figure 1: Accident site showing damage to VH-VOH**

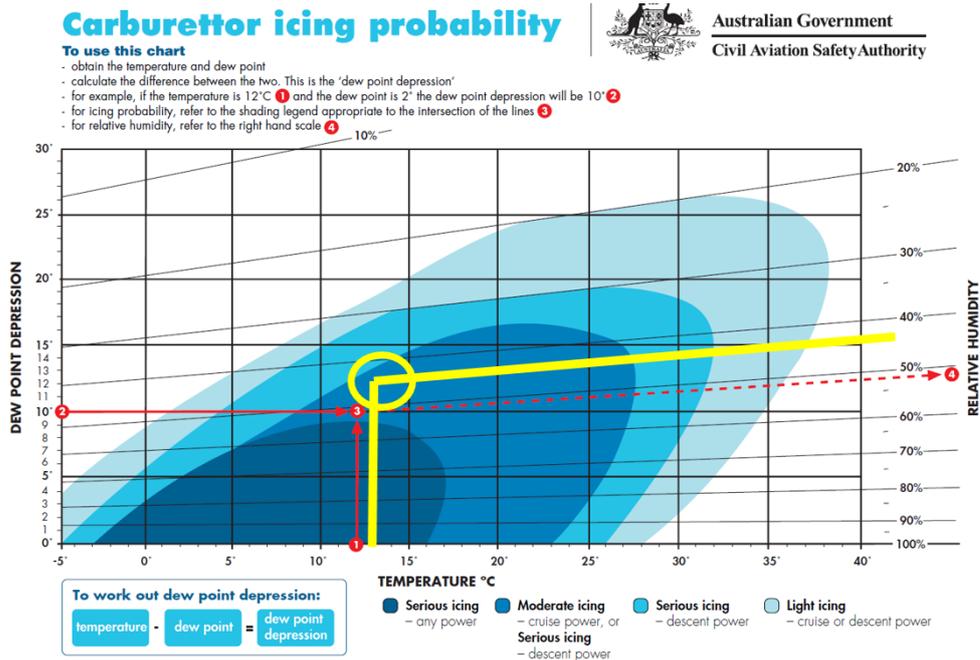
Weather observations from the Bureau of Meteorology's automatic weather station at Alice Springs indicated that at 1300, the temperature was 12.9°C, relative humidity 45%, and the dew point<sup>4</sup> was 1.2°C. The dew point depression, calculated by subtracting the dew point from the temperature, at that time was 11.7.

According to the Carburettor Icing Probability chart (Figure 2), the conditions indicated a high probability of serious carburettor icing at descent power.

Figure 2: Carburettor icing chart showing prevailing conditions in yellow

The ATSB advises all pilots of aircraft fitted with a carburettor to check the forecast conditions and know the risk of carburettor icing prior to each flight. The [carburettor icing probability chart](#) is available on the CASA website.
