Descent below minimum altitude involving a Boeing 777, A6-ECO

near Melbourne, Victoria, 18 July 2014

ATSB Transport Safety Report
Aviation Occurrence Investigation
AO-2014-128
Final – 7 October 2015

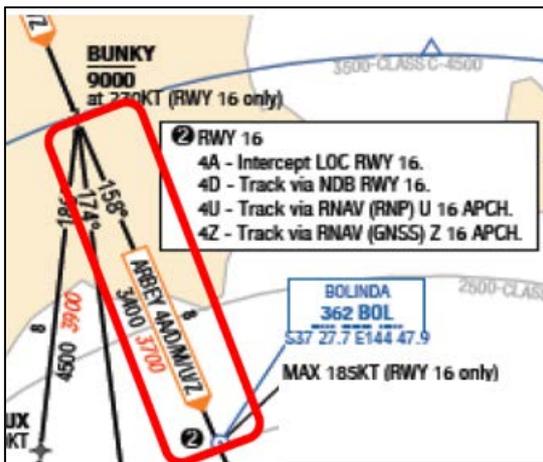
Figure 1: Excerpt from the ARBEY 4 STAR chart used by the operator depicting MEA (3400) and MTCA (3700)

The ARBEY 4U STAR required that the aircraft track from ARBEY to BUNKY, then to the Bolinda (BOL) non-directional (radio) beacon (NDB).² The arrival procedure included speed and altitude restrictions at BUNKY, and a speed restriction at BOL, but there was no altitude restriction at BOL depicted on the STAR chart. Even though there was no altitude restriction depicted at BOL, the STAR chart depicted a minimum en route altitude (MEA) of 3,400 ft and a minimum terrain clearance altitude (MTCA) of 3,700 ft, between BUNKY and BOL (Figure 1).³

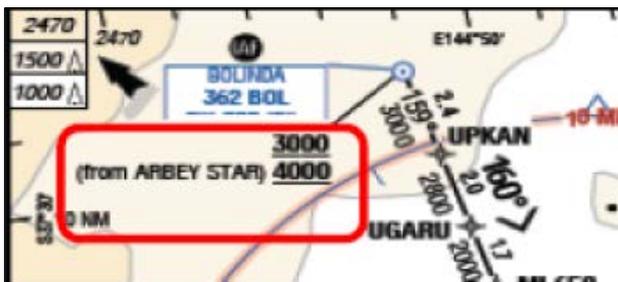
Figure 2: Excerpt from the RNAV-U (RNP) runway 16 approach chart used by the operator depicting two altitudes at BOL

The ARBEY 4U STAR linked to the RNAV-U (RNP) runway 16 approach at BOL, which was identified as the initial approach fix for the RNAV-U (RNP) runway 16 approach. While no altitude was specified at BOL on the STAR chart, the RNAV-U (RNP) runway 16 approach chart depicted two altitudes at BOL (Figure 2). These were:

- an 'at or above' 4,000 ft altitude restriction at BOL when joining the approach from the ARBEY STAR
- an 'at or above' 3,000 ft altitude restriction at BOL applicable when the approach was linked with STAR procedures other than the ARBEY STAR.

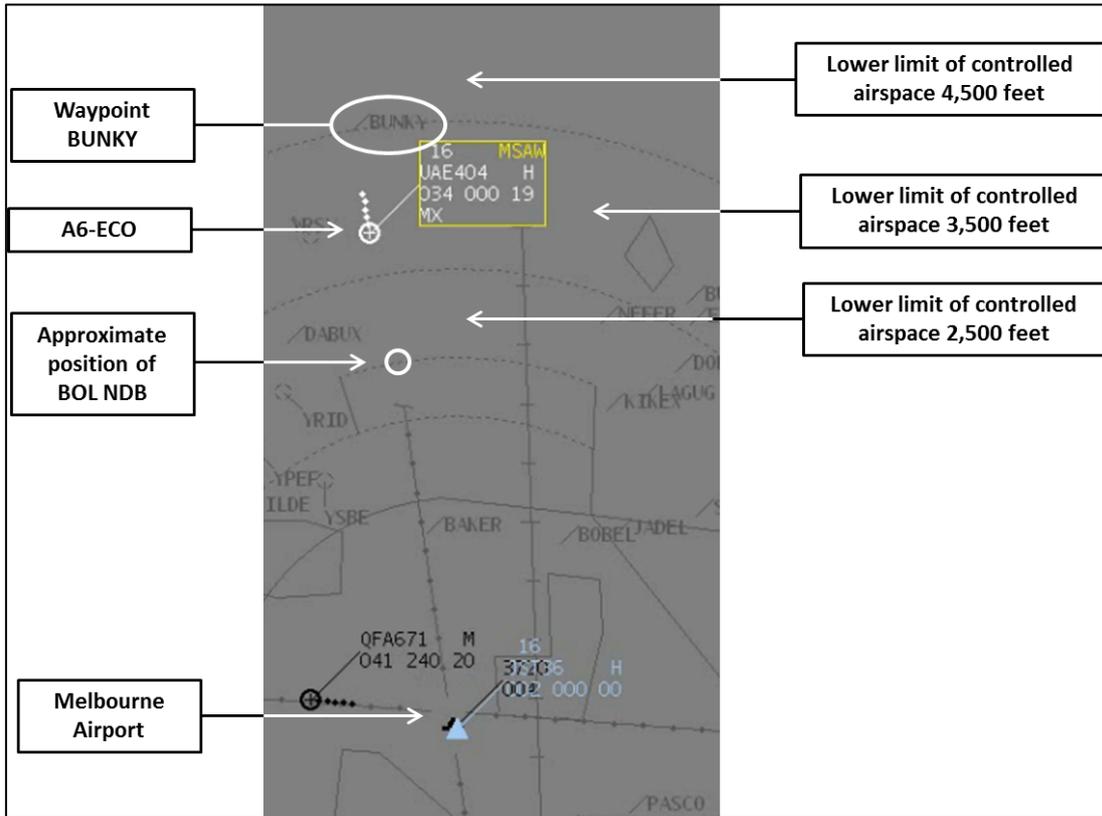
Figure 3: ATC radar image at the time the MSAW alert activated

Descent then continued, and ATC received a Minimum Safe Altitude Warning (MSAW)⁵ alert, as the aircraft descended through 3,400 ft about 4 NM prior to BOL (Figure 3). ATC questioned the crew about their altitude, and advised them that the relevant radar lowest safe altitude was 3,200 ft. Moments later, the aircraft passed over BOL at about 3,000 ft and maintained that altitude until intercepting the vertical profile of the RNAV-U (RNP) runway 16 approach. ATC then transferred the crew to the next frequency, and the crew confirmed they had the correct QNH setting.⁶ The approach continued for an uneventful landing.

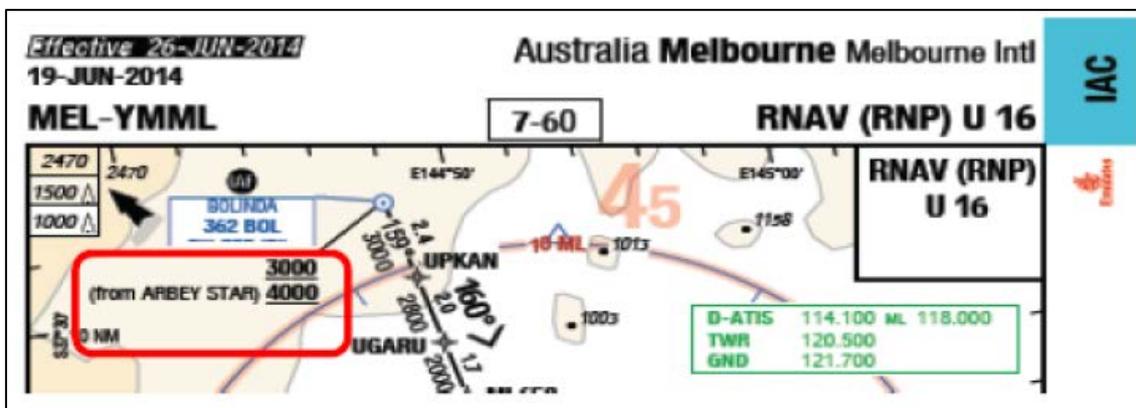
Figure 4a: RNAV (RNP) approach chart used by the crew

The operator reported that the absence of altitude restriction information on the STAR chart reduced the level of protection against deviation below the BOL minimum altitude restriction. The 4,000 ft altitude restriction at BOL when tracking from ARBEY STAR was physically depicted below the 3,000 ft altitude restriction applicable to other STAR procedures (see Figure 4a). This may also have influenced the crew’s interpretation of the FMC altitude.

The chart provider advised that on the RNAV (RNP) chart the higher value (4000) should have been depicted above the lower value (3000). They reiterated that the approach chart (Figure 4a) used in this incident is no longer valid.

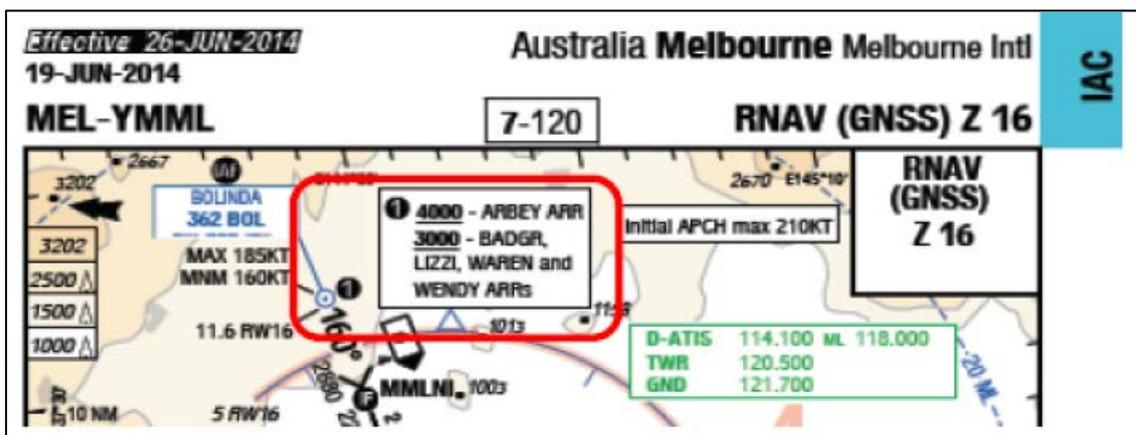
Figure 4b: RNAV (GNSS) Z approach chart

If the information can be charted clearly using a leader line, this is used (see Figure 4a). As soon as the information exceeds two lines, the preference is usually for the information framed together in a box with a ball note⁷ at the point in question (see Figure 4b).

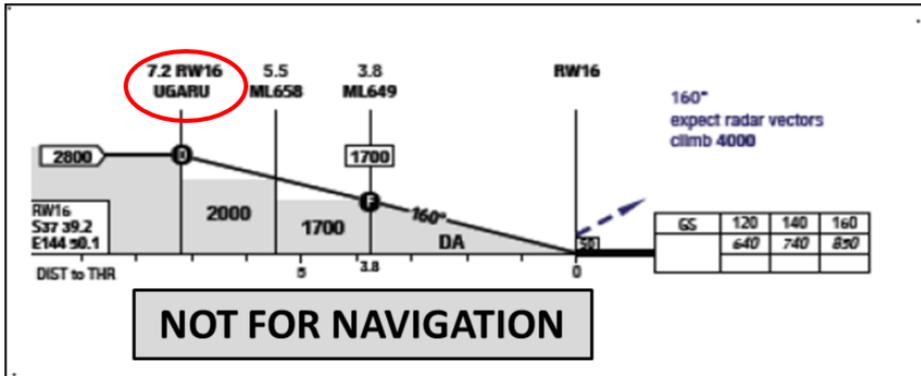
Figure 5a: Excerpt from the RNAV-U (RNP) runway 16 approach chart used by the operator showing vertical profile information

The approach chart provided a vertical profile view of the approach, but the view began immediately prior to intermediate fix (IF), waypoint UGARU, which is 4.4 NM beyond BOL (Figure 5a). As such, there was no profile view information on the approach chart for the approach from the initial approach fix (IAF) BOL, to UGARU. Had this information been present in a vertical profile, it may have alerted the crew to the different altitude requirements at BOL, associated with the different STAR procedures.

The operator suggested that the profile view of the Naverus charts should be amended to conform to that of the Airservices Australia charts.

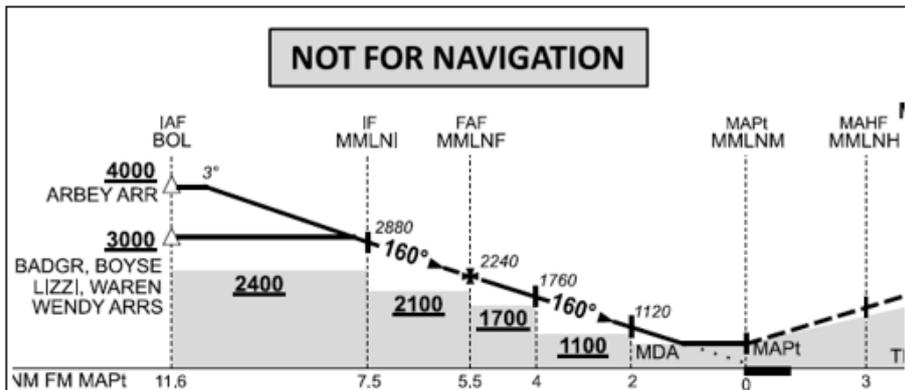
Figure 5b: Excerpt from the Airservices RNAV-Z (GNSS) runway 16 approach chart for comparison

The operator noted that the profile view of Naverus charts was inconsistent with similar Airservices Australia charts. For example, the RNAV-Z (GNSS) runway 16 approach chart, which was designed by Airservices Australia, provided the important hazard information of the different minimum crossing altitudes over BOL in the profile view (Figure 5b). However the RNAV-U (RNP) runway 16 approach chart, which was designed by Naverus, depicted these altitudes in the plan view only. The operator considered that extension of the profile view, as published on similar Airservices Australia charts, would assist flight crews to select the correct altitude for the IAF.
