Landing gear malfunction involving a Cessna 210, VH-SMP

Kununurra Airport, Western Australia, 1 February 2015

ATSB Transport Safety Report
Aviation Occurrence Investigation
AO-2015-013
Final – 4 November 2015

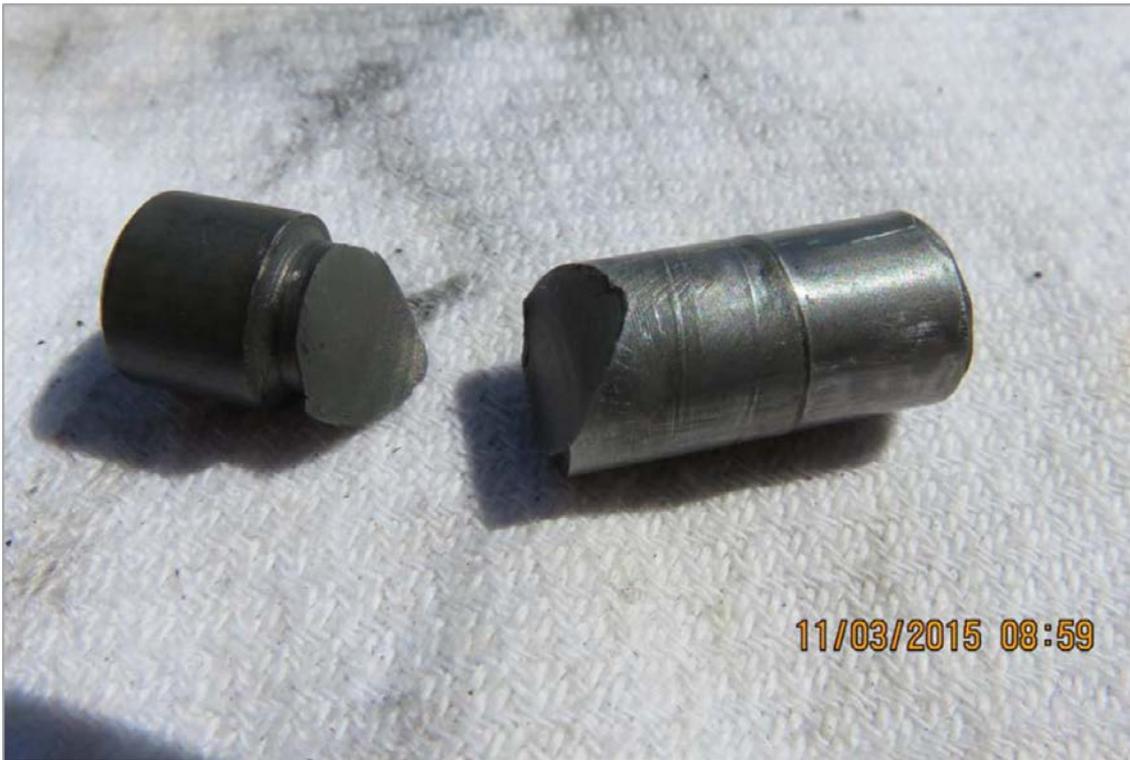
The owner of the aircraft conducted an investigation into the incident. As part of their investigation, they determined that one of the nose landing gear down lock pins had failed. The pin had failed in the area of the machined groove for the pin retention roll pin (Figure 1). The failed down lock pin migrated out and interfered with the nose landing gear actuator. This movement prevented the nose landing gear down lock mechanism from engaging in the down and locked position (Figure 2). The other down lock pin was serviceable.

Figure 1: Failed nose landing gear downlock pin

Cessna had introduced the service bulletin as they had received reports that the nose landing gear actuator downlock pins had cracked and failed. It was found that the pins had failed at a circumferential groove that was used to secure the pin in the actuator bearing end. The service bulletin indicated that non-compliance could result in failure of the nose landing gear to lock in the down position and possibly collapse.

The recommended inspection was to be carried out initially within the next 200 hours operation or 12 months, whichever occurred first. Subsequent inspections at each landing gear retraction check were not to exceed 200 hours of operation thereafter. After the installation of the downlock actuator pin replacement, the repetitive inspection was not required.

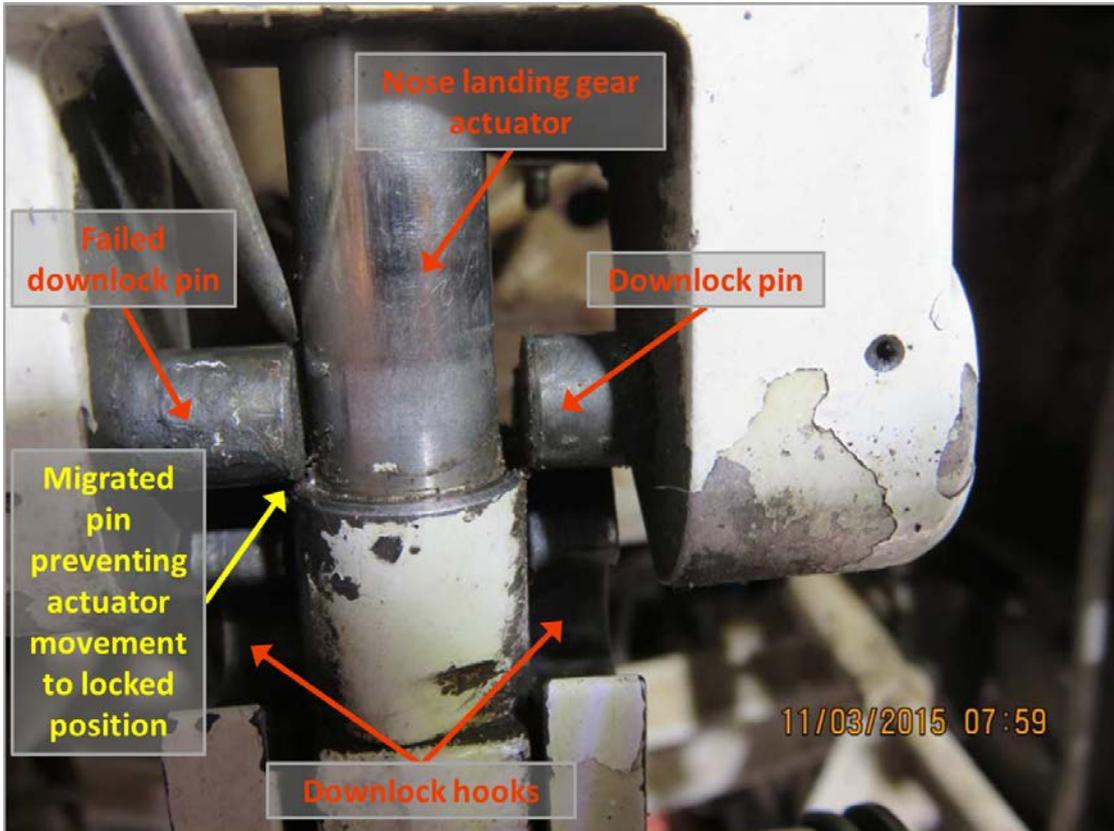
Figure 2: SMP nose landing gear downlock assembly, showing the failed downlock pin preventing actuator movement to the locked position
