Collision with terrain during landing, involving a PA32 aircraft, VH-BDG

Lakeside Airpark, Queensland, 26 July 2015

ATSB Transport Safety Report
Aviation Occurrence Investigation
AO-2015-086
Final – 4 November 2015

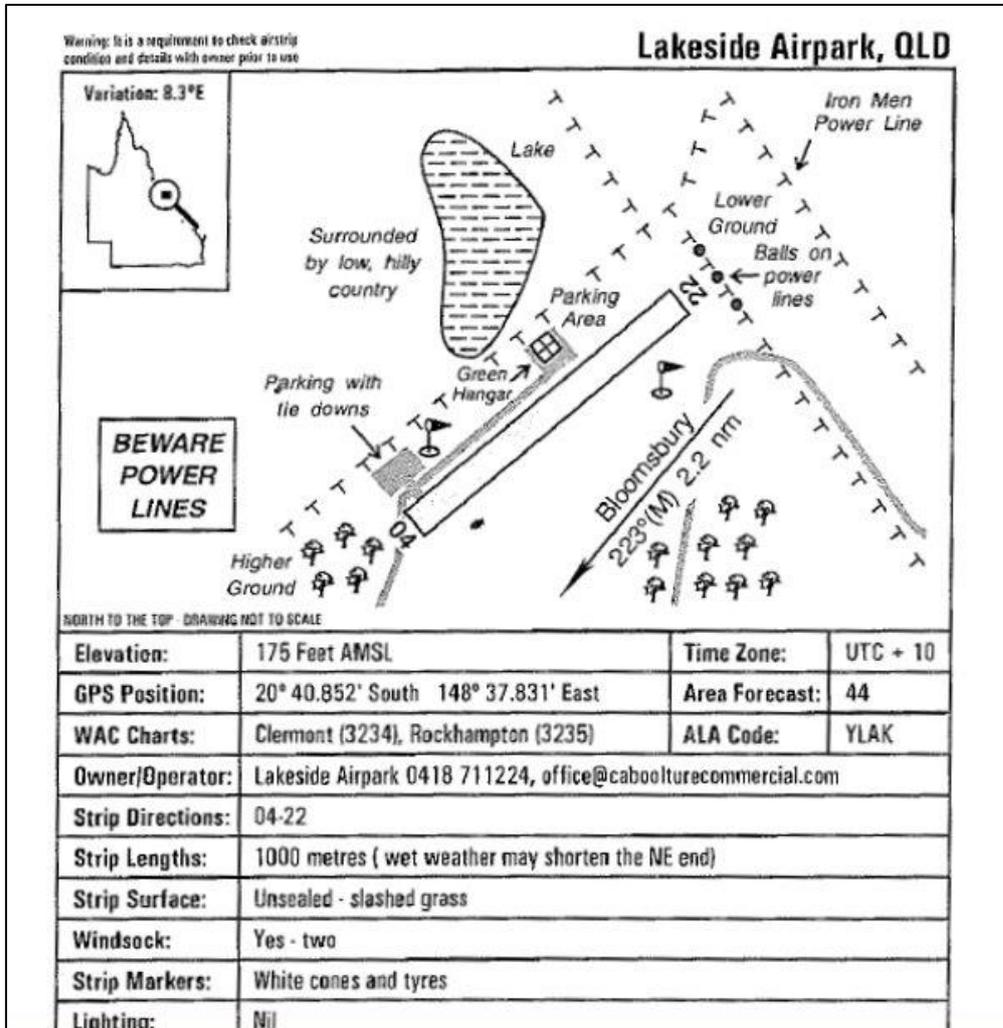
Figure 2: An extract from the Queensland Country Airstrip Guide. Diagrammatic representation of Lakeside Airpark and local hazards

As per the requirement for operations at this aerodrome, the pilot sought prior permission to operate there and a briefing on local hazards from the aerodrome operator. This onsite briefing by the aerodrome operator pointed out local hazards such as the power-lines in the vicinity and the preferred protocol of taking-off on runway 04, and landing uphill on runway 22, wind permitting. There was no hazard map available as mentioned in the ERSA.

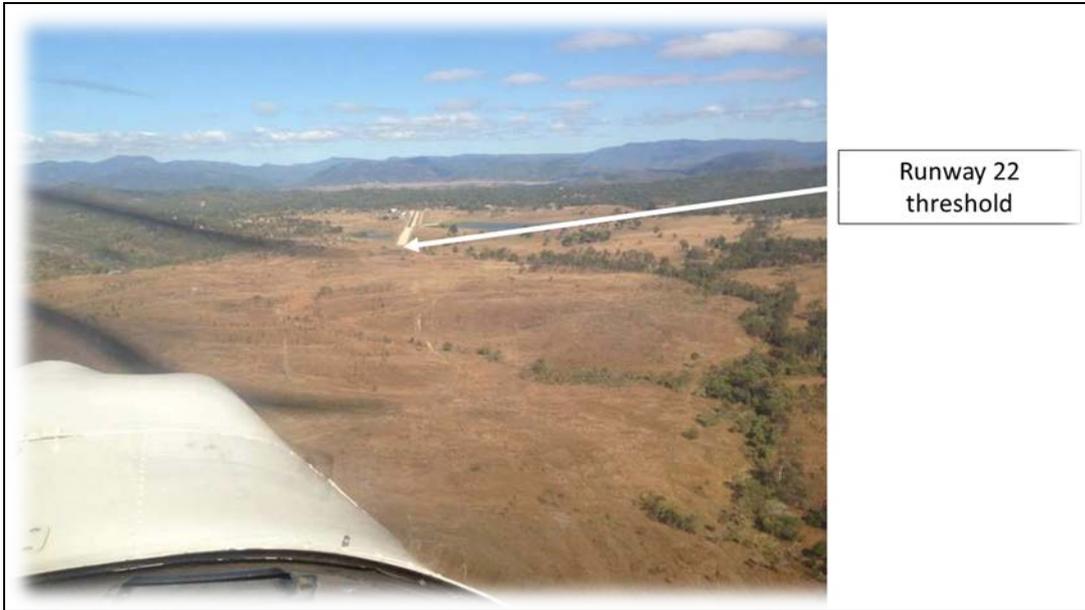
Figure 3: Approach to runway 22 at Lakeside Airpark. Note the unsealed and sealed portion of the runway. Also, note the difficulty in detecting the power lines on approach. Photo taken about a week prior to the accident

In order to maintain sufficient clearance over the two rows of power lines, and still land near the threshold, well before the sealed section of the runway, the pilot planned a steeper approach than normal. The flap was set to 40° (full flap) and the rate of descent increased to about 500-600 feet per minute.

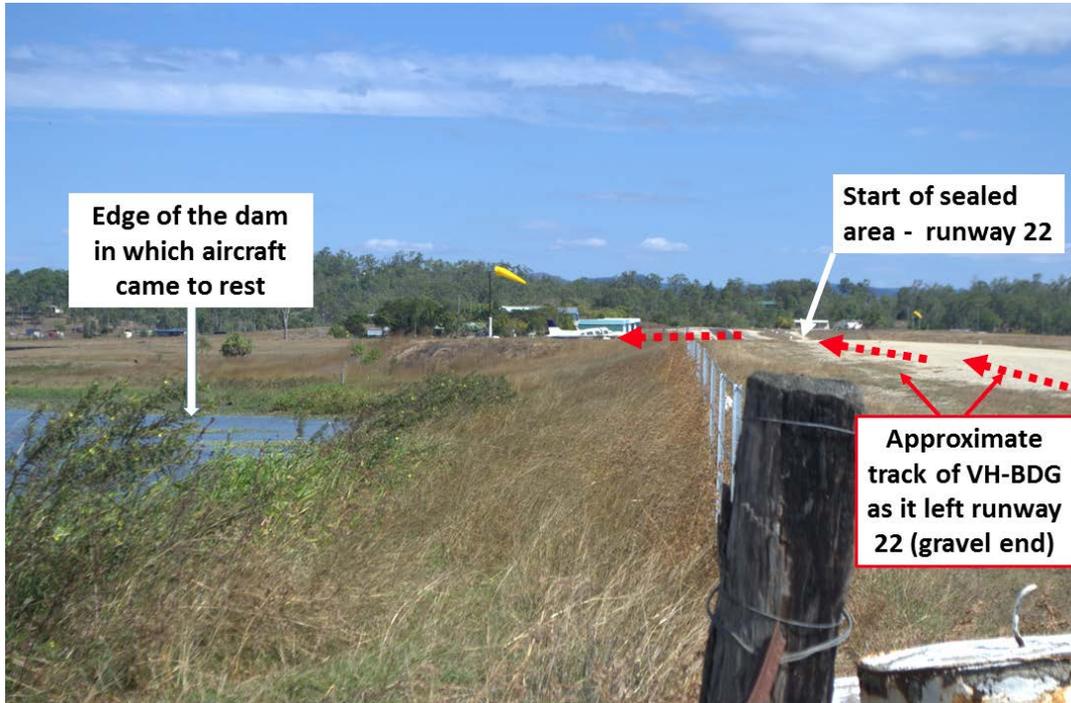
Once into the grassed area, and with the aircraft most probably airborne, it struck a wire fence (Figure 4) then the raised embankment of the dam, which ran perpendicular to the runway. The pilot reported that the left wing tip struck the water and the aircraft spun around and entered the water. At some point throughout this sequence, the main wheels detached from the aircraft. The pilot reported continuing to battle for control of the aircraft, up until it arrived in the water.

Figure 4: Looking along runway 22 taken a few days after the accident

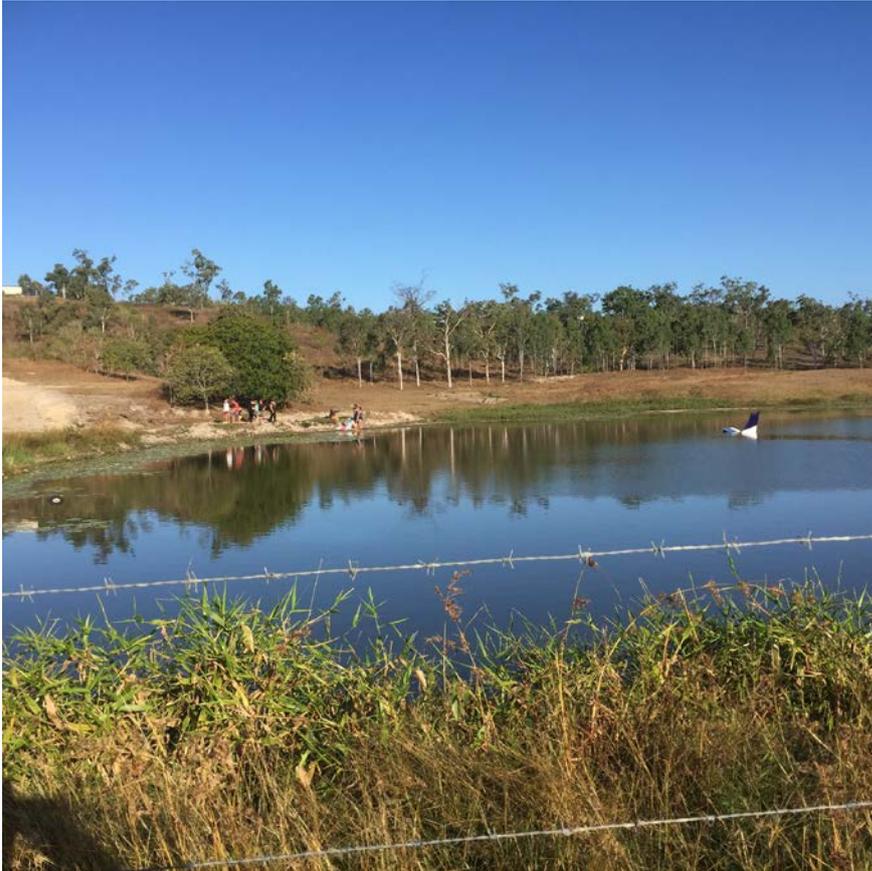
One of the passengers sustained serious injuries, and the pilot and another passenger, minor injuries. The aircraft was almost completely submerged resulting in substantial damage (Figures 5 and 6).

Figure 5: Post accident showing VH-BDG partially submerged in the dam.

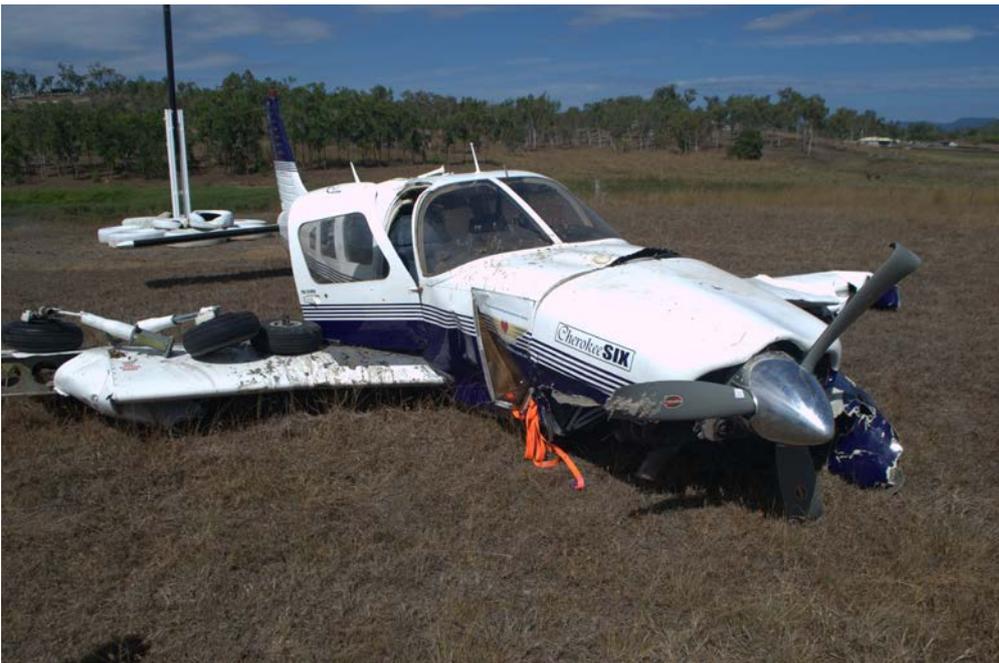
Figure 6: VH-BDG after retrieval from the lake. Passenger 2 (below) reported that the left wing crumpled during the ‘cartwheeling’ toward the lake. Note: Significant damage occurred during the retrieval process
