# Engine failure involving an Enstrom 280, VH-YHD

5 km north-west of Redcliffe Airport, Queensland, on 28 February 2015

**ATSB Transport Safety Report**  
Aviation Occurrence Investigation  
AO-2015-026  
Final – 4 November 2015

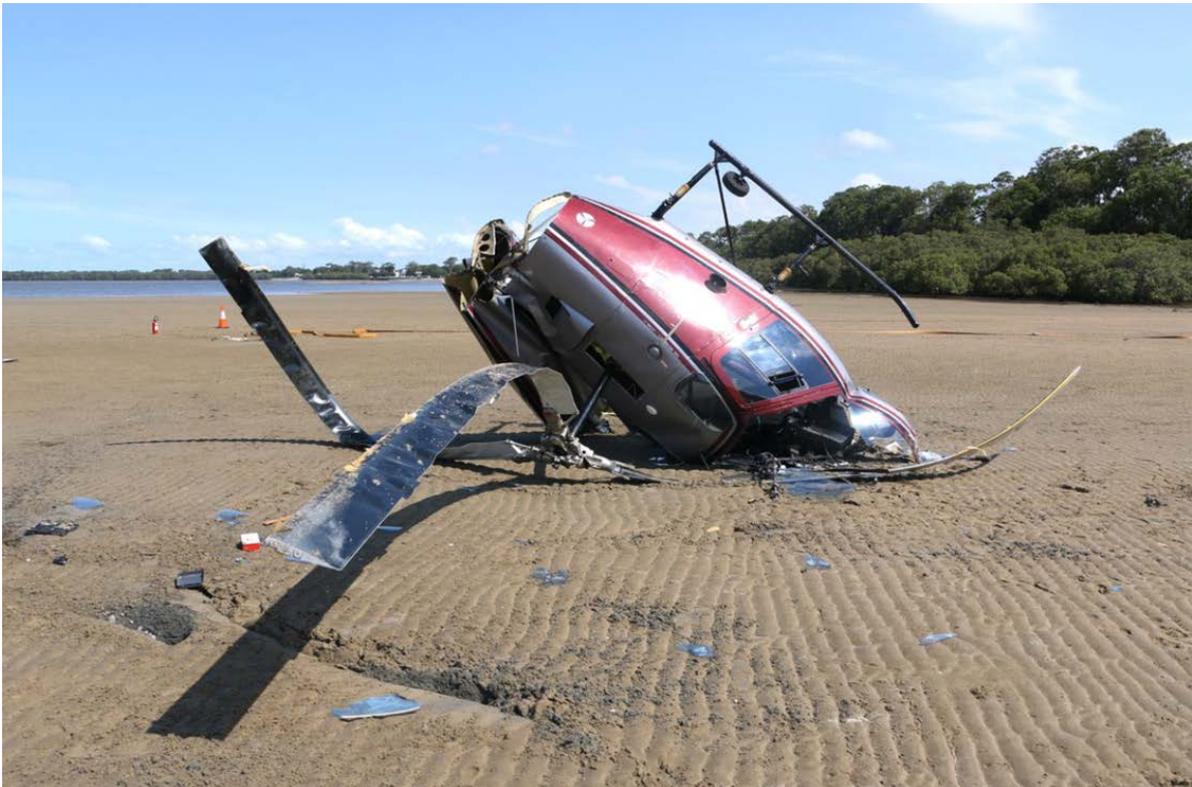
At about 1,000 ft AGL, the pilot heard a bang and the engine stopped. This caused the helicopter to yaw to the left violently. The pilot then attempted to restart the engine but was unsuccessful. At about 800 ft AGL, the helicopter entered autorotation<sup>1</sup> and the pilot prepared to land on the beach. The pilot observed people swimming in the sea and manoeuvred the helicopter to an area where there were no people. The pilot arrested the descent and the skids contacted the sand. The helicopter continued to move forward along the sand, and then a few seconds later the helicopter blades impacted the sand, and the helicopter rolled over. The pilot received minor injuries and the helicopter was destroyed (Figure 1).

**Figure 1: Accident site showing the damage to VH-YHD**

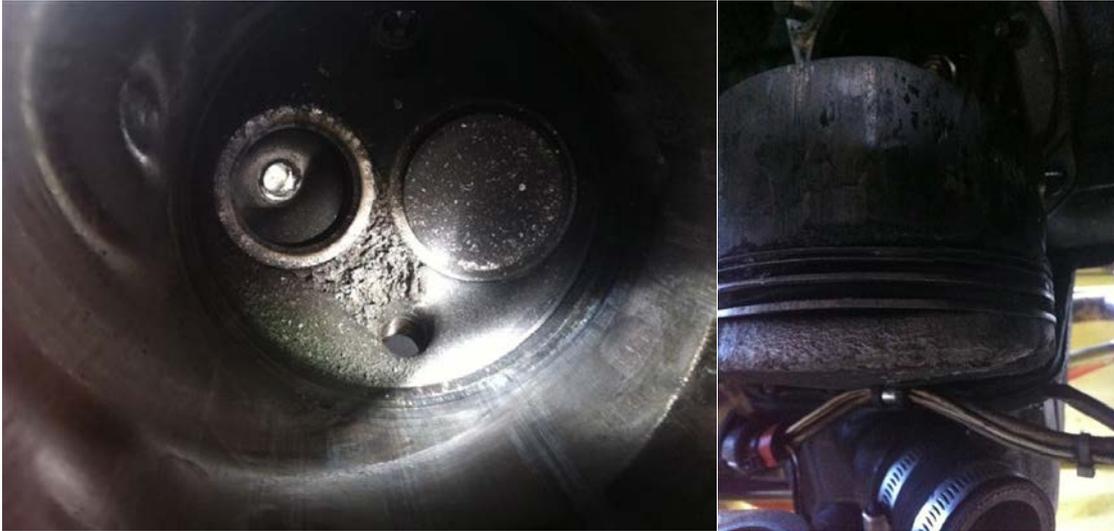
The maintenance organisation inspected the engine externally and removed the number three cylinder. They determined that the damage found to the number three cylinder and piston (Figure 2) was consistent with detonation. Extreme heat from uncontrolled burning of the combustion gases resulted in melting of the cylinder between the spark plug hole and the exhaust valve seat. This melting damaged the piston to an extent that the combustion gases would blow past the piston rings. The maintenance organisation did not remove the other cylinders.

The maintenance organisation also removed the engine magneto and fuel control unit. Both units were examined at a component overhaul facility. The examination of the magneto found no defects. The examination of the fuel control unit found that it was functioning normally and was set to a lean position, although this position could not be validated due to disruption during the accident.

**Figure 2: Damage to number three cylinder and piston**
