Safety summary

On 3 October 2013, immediately before *HC Rubina* sailed from Beira, Mozambique, the control system for its controllable pitch propeller failed. The ship subsequently made its voyage to Brisbane, Australia, with the propeller's pitch manually operated from the local control station.

On the afternoon of 29 October 2013, a pilot boarded *HC Rubina* for its passage in to Brisbane. While the ship was being manoeuvred off its berth, a flexible coupling for the shaft alternator that was providing power to the bow thruster, suddenly failed. The aft end of the engine room rapidly filled with smoke, forcing the engineer controlling the propeller pitch to leave the local station. Consequently, the ship's propulsion was no longer being controlled and the ship made contact with the wharf, sustaining minor damage.

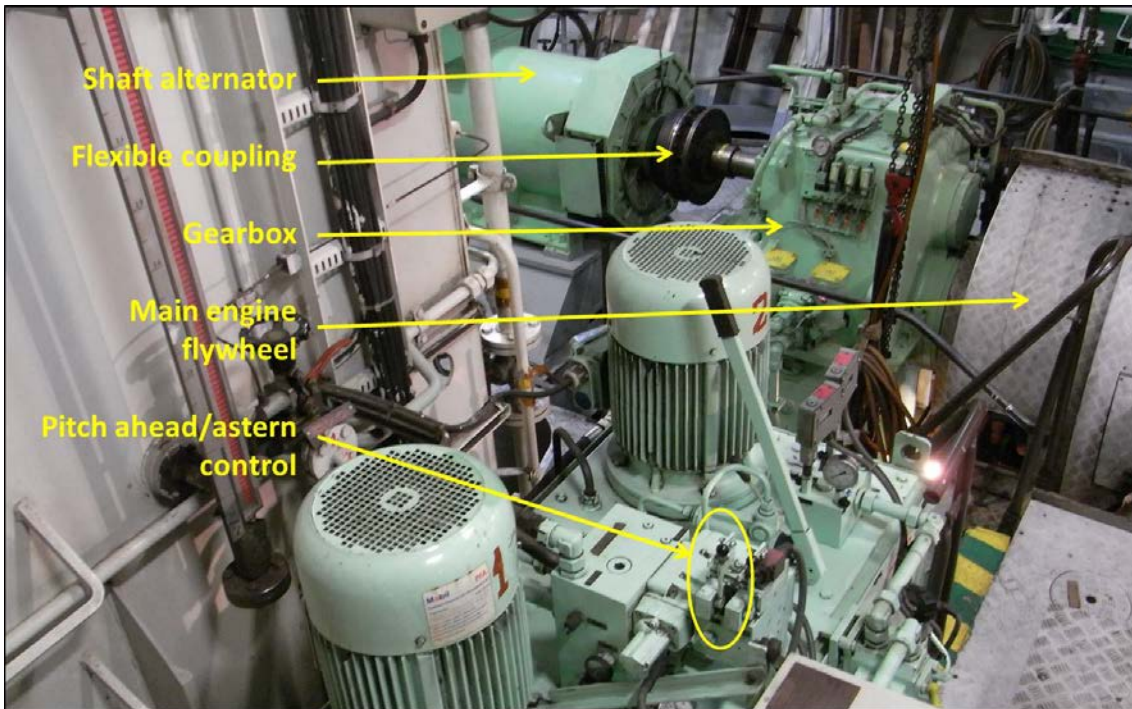
Figure 4: Photograph with the local control station and flexible coupling (guard removed)

At about 1958, the shaft alternator flexible coupling catastrophically failed. The aft end of the engine room quickly filled with smoke and power to the bow thruster was lost. The second engineer ran from the CPP local control station, which was about 3 m from the flexible coupling, to the forward end of the main engine to escape the smoke. The propeller pitch setting was left between 3 and 5 per cent ahead.

At the time of the incident, the pitch was being operated from the local control station (Figure 4) following a complete failure of the pitch control system. The pitch order was being relayed from the bridge via telephone to the second engineer, who was manually operating the ahead and astern pitch control hydraulic valves until the required pitch was achieved.

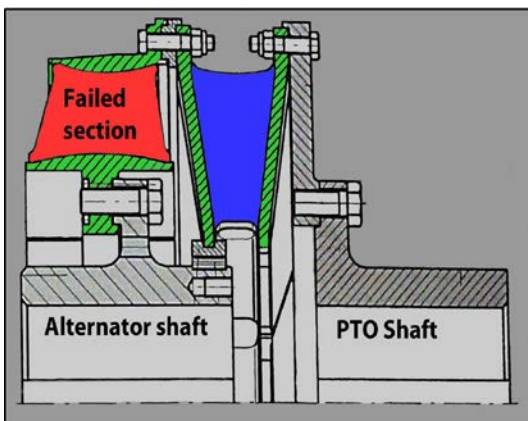
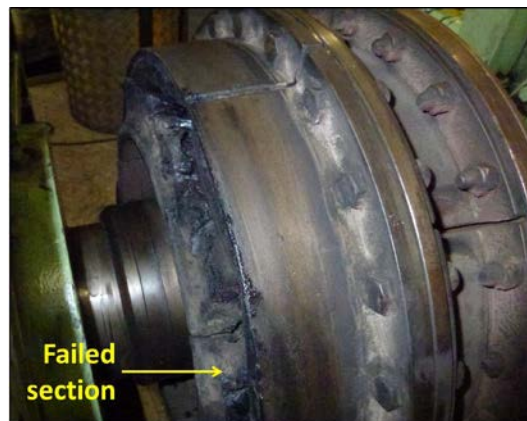
Figure 5: Shaft alternator flexible coupling

The coupling (Figure 5) transmitted the output power to the shaft alternator through an annulus rubber ring (red). The annulus ring was bonded to steel plates (green) and radial rubber segments (blue) which were also bonded to steel plates (green).

According to the manufacturer, the condition of the flexible coupling deteriorated as a result of loading and age. Therefore, they recommended it be replaced every 12 years.

At the time of this incident, *HC Rubina* was 14 years old and there were no available records to indicate that the coupling had ever been replaced. Further, no electronic job histories could be found for this task, or any task, prior to the middle of 2008. No other records were available relating to the maintenance of the coupling. Therefore, the ATSB concluded that the coupling was probably the original installed item and had exceeded its prescribed service life, being 14 years old.

While the nature of the damage sustained prevented the ATSB from specifically identifying the coupling failure mechanism, it was likely that the failure arose because it had deteriorated through age, to a point where it was no longer capable of carrying its rated load.

HC Rubina's electronic planned maintenance system (PMS) did not contain any instructions relating to the shaft alternator flexible coupling. Therefore, the PMS could not produce a notification to ensure the shaft alternator flexible coupling was replaced at 12-year intervals in accordance with the manufacturer's instructions.

The Australian Transport Safety Bureau recommends that IMM Shipping takes action to address the lack of instructions in the planned maintenance systems of its managed ships, to ensure that ship equipment is maintained in accordance with manufacturers' requirements.
