# Data entry error and tailstrike involving Boeing 737-838, VH-VZR

Sydney Airport, New South Wales | 1 August 2014

**ATSB Transport Safety Report**  
Aviation Occurrence Investigation  
AO-2014-162  
Final – 16 November 2015

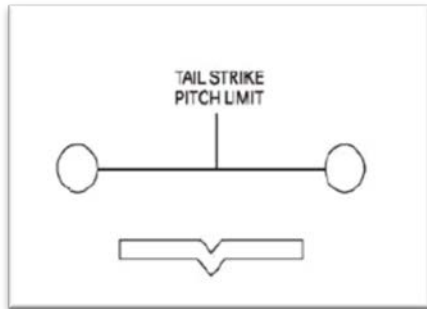
During rotation, the aircraft tail strike pitch limit symbol will appear when the aircraft is approaching the tail strike angle. As well as the tail strike pitch limit indication, the aircraft reference symbol is also displayed and if the two symbols come in contact, a tailstrike has probably occurred (Figure 1).

**Figure 1: Tail strike pitch limit symbol (dumb bell) and aircraft reference symbol as displayed on the HGS**

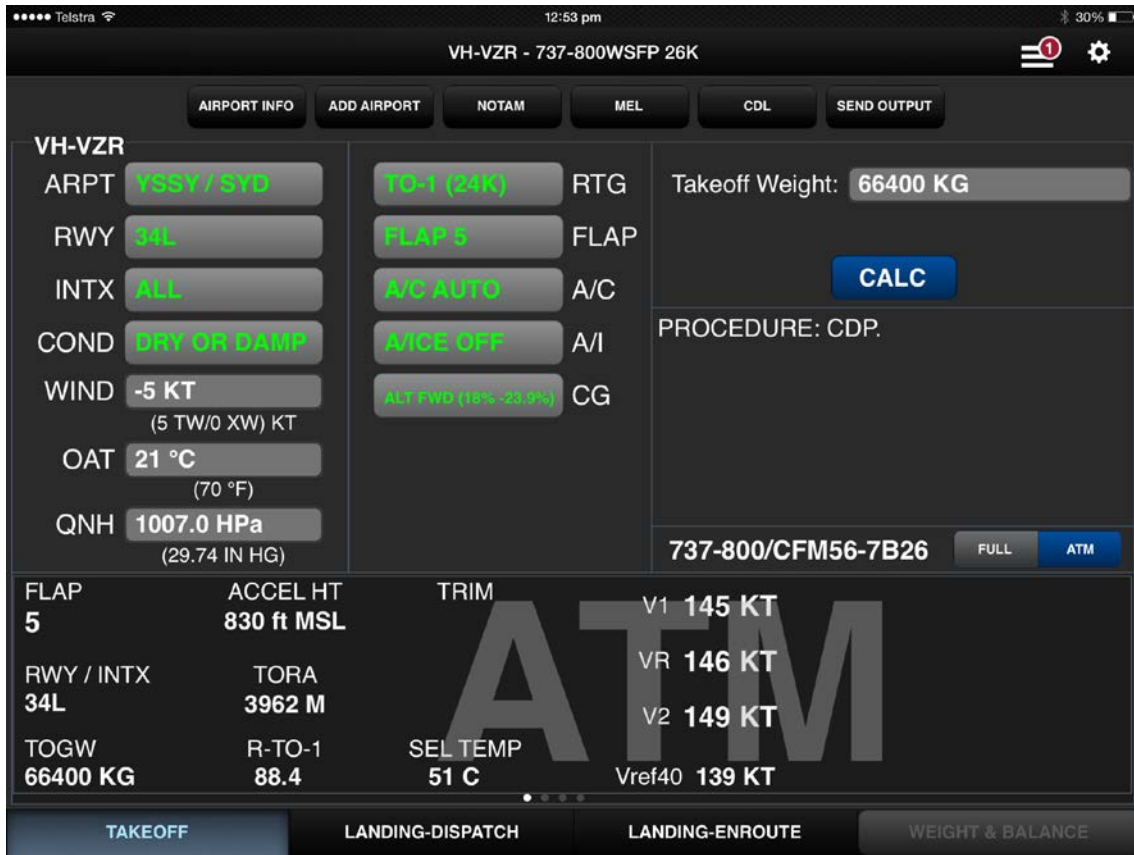
Figure 2: Take-off data entry screen in the on-board performance calculation tool for VH-VZR showing the erroneous take-off weight (66,400 kg)

The OPT also gives a temperature (51 °C in Figure 2, above) to be entered in the FMC to reduce the take-off thrust from the engines. This allows the aircraft to use a lower engine setting (N1) for take-off, which improves engine reliability. The OPT takes into account the runway length and weight in determining this value to ensure the aircraft can take off within the runway distance available and maintain the required obstacle clearance during the subsequent climb.

The second error occurred when the first officer entered the take-off weight into their OPT. While the first officer reported correctly adding the ZFW and fuel figure to get a TOW of 76,400 kg, the weight entered into the OPT was 66,400 kg. This was likely the result of a transposition error when entering the figure into the OPT. A transposition error occurs when an individual inadvertently swaps two adjacent numbers or letters while speaking or writing down a value or word. In this case, it is likely the intended '7' was entered as '6'. As the two derived TOW figures of 66,400 kg matched when the crew compared them, the error was not detected.

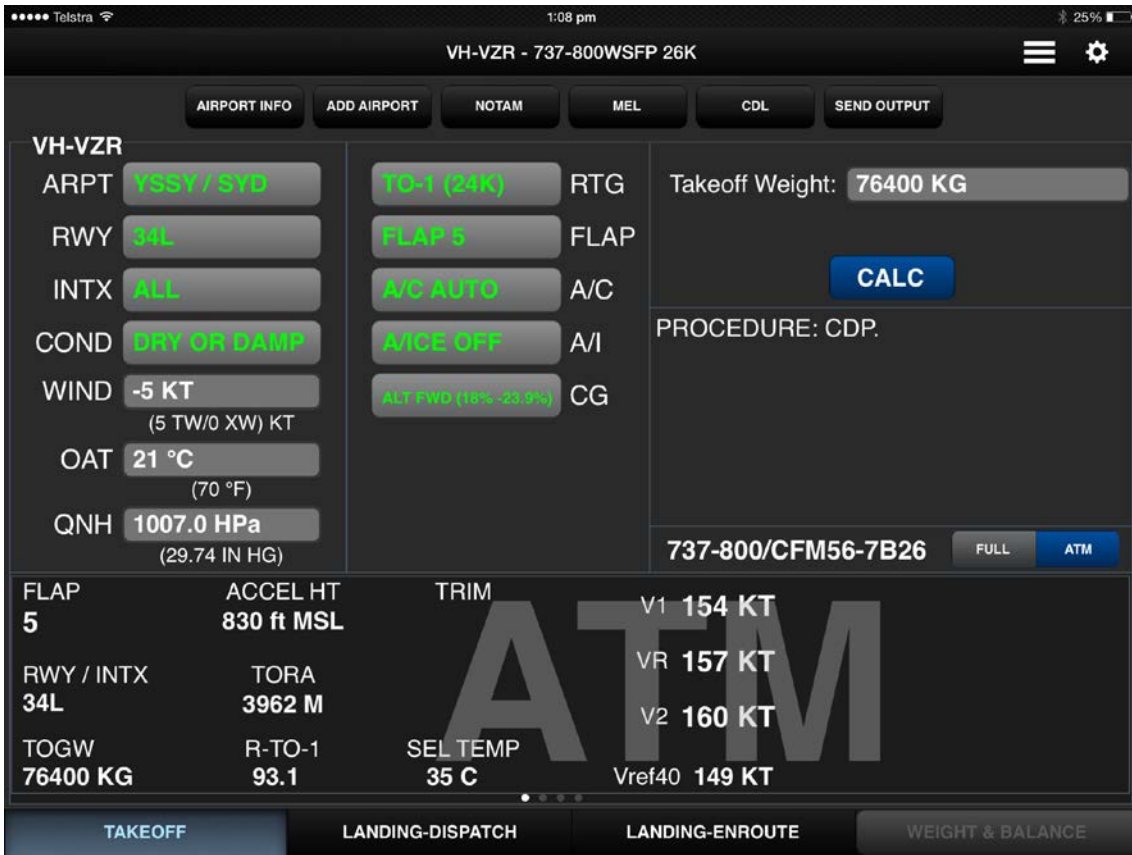
Figure 3 shows the OPT data for the correct take-off weight of 76,400 kg. Of note is the difference in the take-off speeds, but also the temperature (51°C v 35°C). The lower temperature for the higher weight is indicative of the need for greater engine thrust for the take-off. This, in part, is due to the runway length and obstacle clearance requirements as noted above.

Figure 3: Take-off data entry screen in the on-board performance calculation tool for VH-VZR showing the correct take-off weight (76,400 kg)

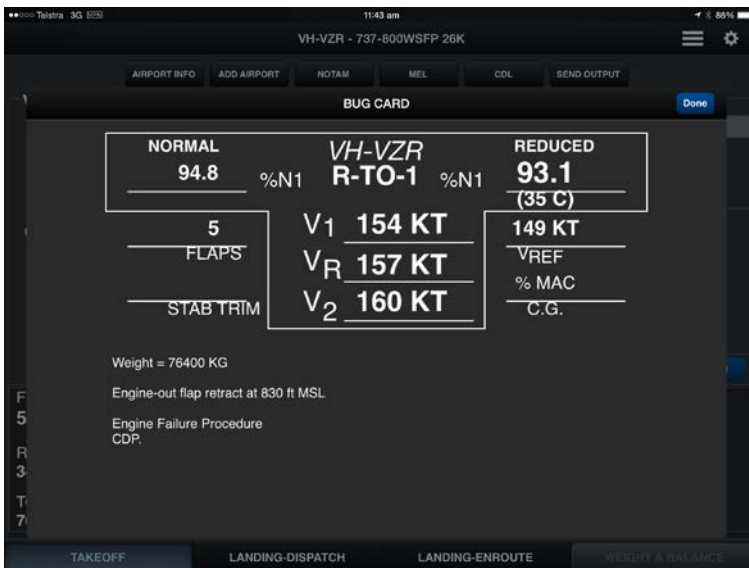
The OPT has numerous outputs that allow crew to send or view the take-off speeds and relevant information. One of these is the ‘bug card’, which displays the weight entered, the take-off speeds, flap setting and engine %N<sub>1</sub> value (Figure 4). This feature presents this information in a similar format to the informal systems used by flight crew prior to the introduction of electronic flight bags. It also allows the crew to easily view all relevant information for take-off.

Figure 4: Bug card showing the correct take-off weight (76,400 kg) and speeds
