# Data entry error and tailstrike involving Boeing 737-838, VH-VZR

Sydney Airport, New South Wales | 1 August 2014

**ATSB Transport Safety Report**  
Aviation Occurrence Investigation  
AO-2014-162  
Final – 16 November 2015

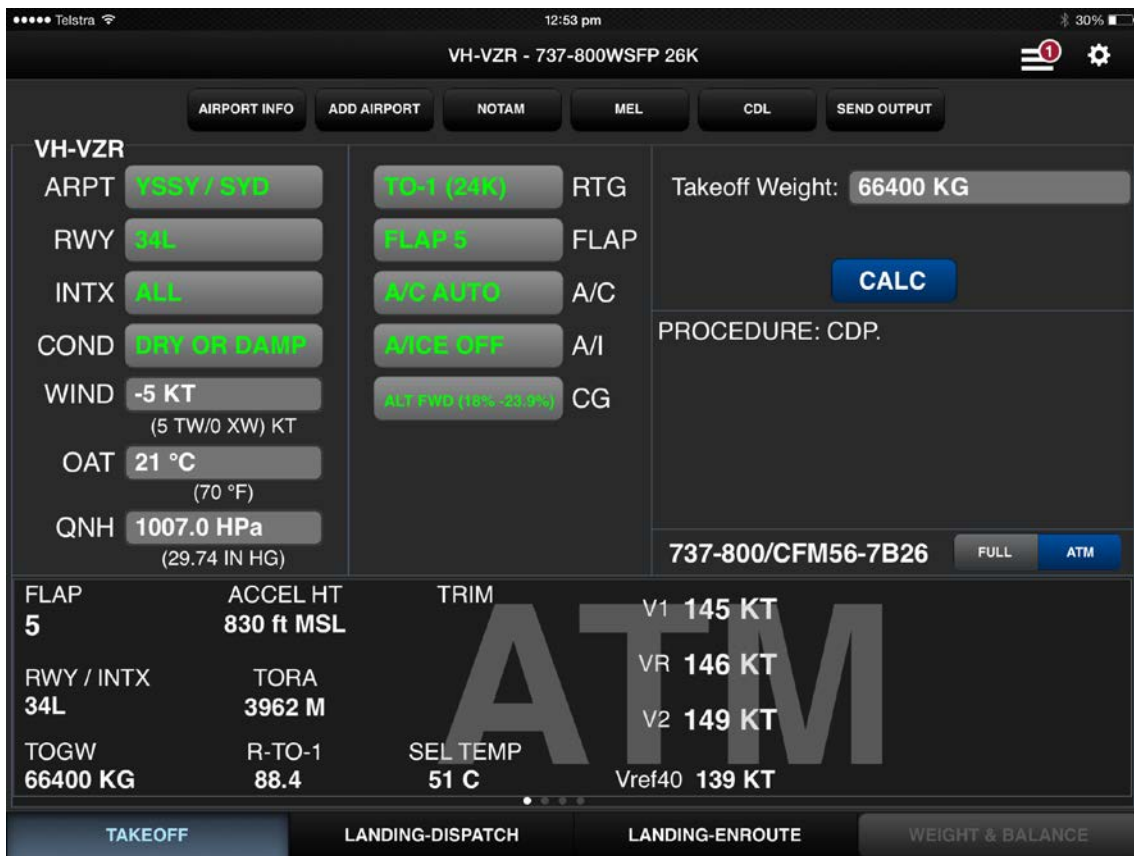
Figure 2: Take-off data entry screen in the on-board performance calculation tool for VH-VZR showing the erroneous take-off weight (66,400 kg)

The OPT also gives a temperature (51 °C in Figure 2, above) to be entered in the FMC to reduce the take-off thrust from the engines. This allows the aircraft to use a lower engine setting (N1) for take-off, which improves engine reliability. The OPT takes into account the runway length and weight in determining this value to ensure the aircraft can take off within the runway distance available and maintain the required obstacle clearance during the subsequent climb.

The second error occurred when the first officer entered the take-off weight into their OPT. While the first officer reported correctly adding the ZFW and fuel figure to get a TOW of 76,400 kg, the weight entered into the OPT was 66,400 kg. This was likely the result of a transposition error when entering the figure into the OPT. A transposition error occurs when an individual inadvertently swaps two adjacent numbers or letters while speaking or writing down a value or word. In this case, it is likely the intended '7' was entered as '6'. As the two derived TOW figures of 66,400 kg matched when the crew compared them, the error was not detected.

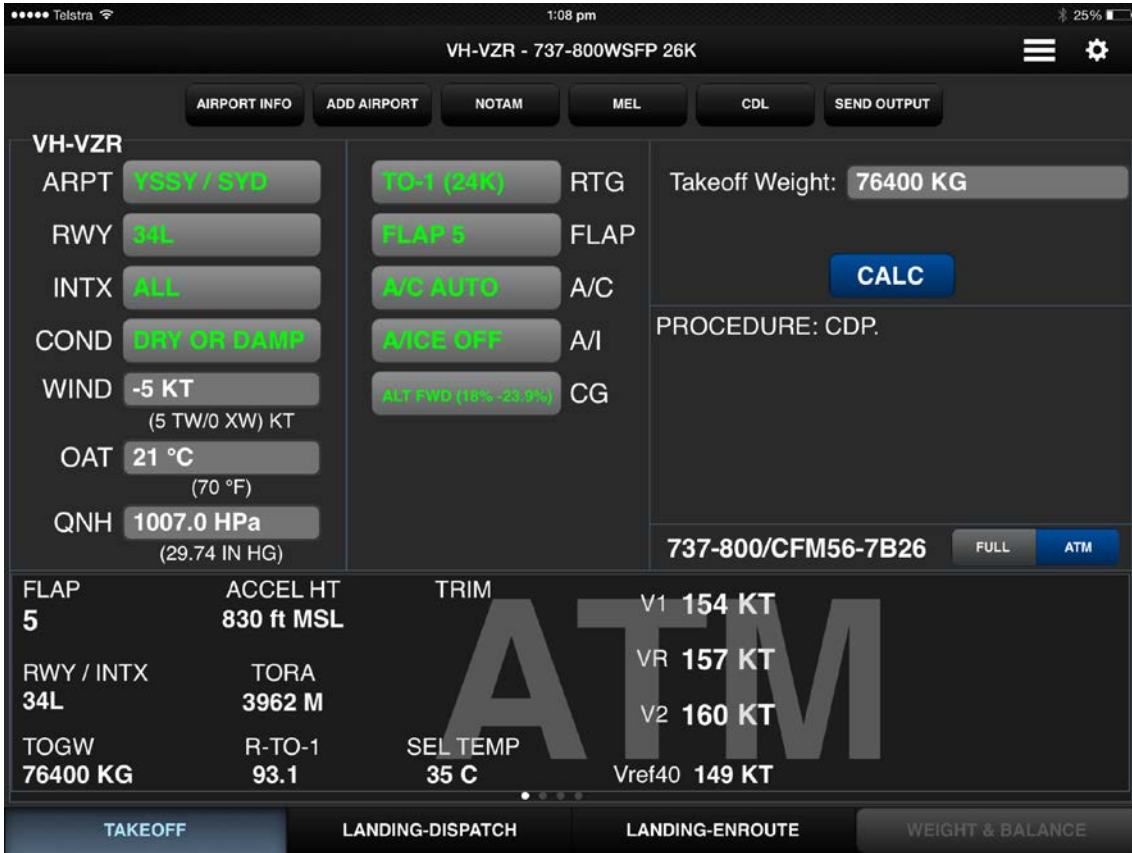
Figure 3 shows the OPT data for the correct take-off weight of 76,400 kg. Of note is the difference in the take-off speeds, but also the temperature (51°C v 35°C). The lower temperature for the higher weight is indicative of the need for greater engine thrust for the take-off. This, in part, is due to the runway length and obstacle clearance requirements as noted above.

Figure 3: Take-off data entry screen in the on-board performance calculation tool for VH-VZR showing the correct take-off weight (76,400 kg)

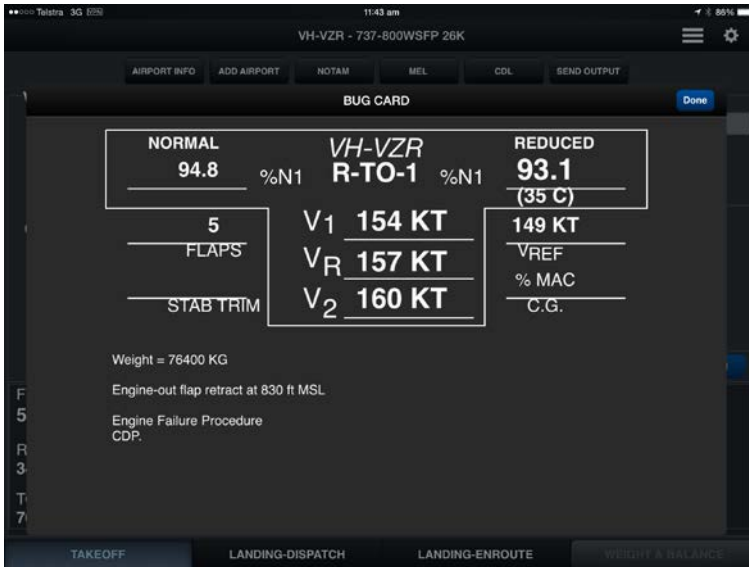
The OPT has numerous outputs that allow crew to send or view the take-off speeds and relevant information. One of these is the ‘bug card’, which displays the weight entered, the take-off speeds, flap setting and engine %N<sub>1</sub> value (Figure 4). This feature presents this information in a similar format to the informal systems used by flight crew prior to the introduction of electronic flight bags. It also allows the crew to easily view all relevant information for take-off.

Figure 4: Bug card showing the correct take-off weight (76,400 kg) and speeds
