## Uncontained failure of air turbine starter led to loss of engine oil

### **ATSB Transport Safety Report** Aviation Occurrence Investigation

AO-2013-172

Final – 10 December 2015

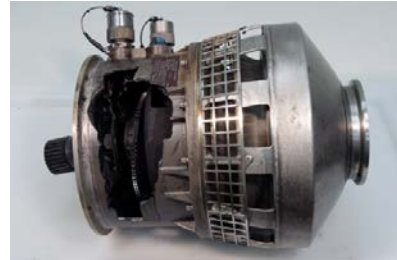
## Air turbine starter

The model ATS200-61 air turbine starter from the number one engine sustained an uncontained failure. Released debris from the starter severed an adjacent oil sump scavenge pipe, resulting in the loss of oil from the engine and necessitating the in-flight shutdown.

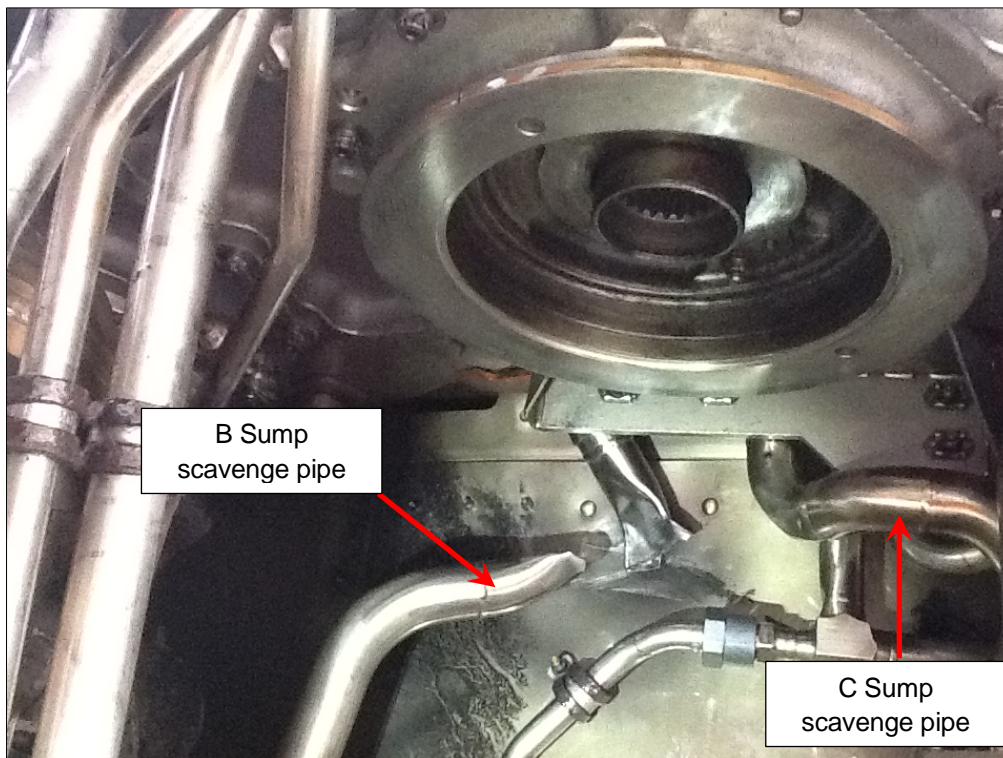
Preliminary examination of the No. 1 engine by maintenance personnel at Cairns found that the air turbine starter had sustained an uncontained failure. Debris released from the starter had severed the adjacent B-sump engine oil scavenge pipe and damaged (without rupturing) the C-sump oil scavenge pipe (Figure 1). This resulted in the complete loss of oil from the No. 1 engine, necessitating the engine shut down.

**Figure 1: Damage to oil pipes visible after removal of the starter**

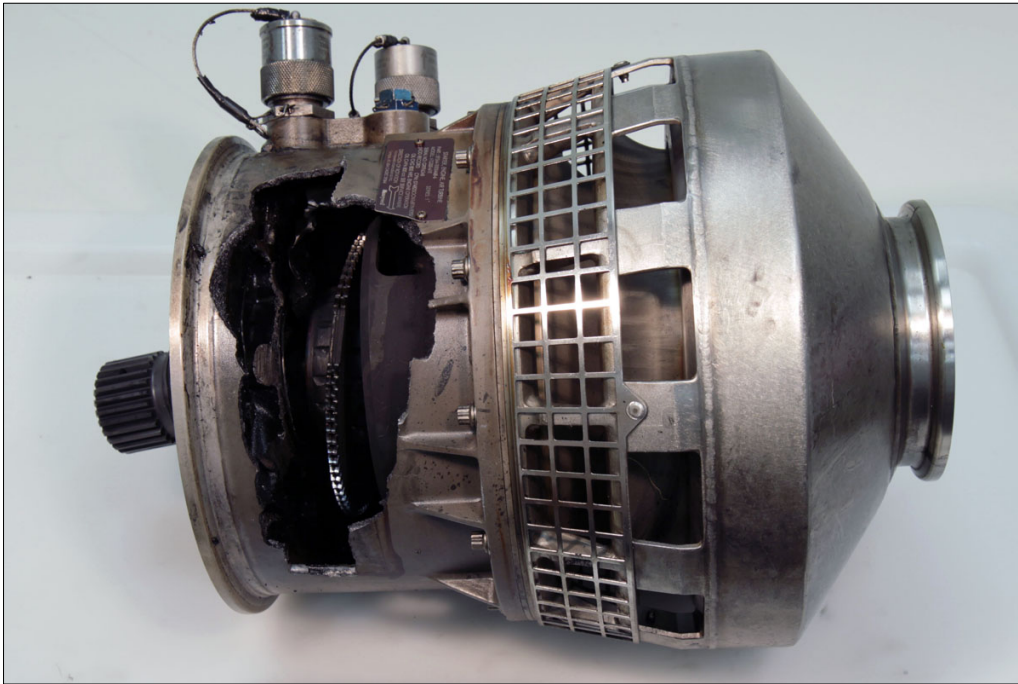
The starter (Figure 2) and associated starter air valve were initially sent to the ATSB for visual examination before being forwarded to the starter manufacturer for detailed disassembly and inspection.

**Figure 2: The air turbine starter removed from B-18358, as-recovered**

Disassembly and examination of the starter was conducted by the starter manufacturer at their investigation facility and a detailed report was provided to the ATSB. The report concluded that the failure sequence was initiated by failure of the output shaft support bearing. This allowed contact between the rotating pawl carrier and ratchet, which subsequently failed, along with the hub gear. Failure of these components resulted in the fracture of the starter casing and release of debris with enough energy to sever the adjacent B-sump scavenge pipe on the engine.

Recovered output shaft bearing components were limited to fragments of the bearing cage, one fractured ball and one ball with significantly reduced diameter. The inner and outer bearing races were extensively damaged, but intact. It was likely that the output shaft continued to run for some time after the loss of oil, which caused additional damage to the bearing. It was therefore difficult to accurately assess the bearing failure mechanism. Nevertheless, the report indicated that based on analysis of the starter components, the most probable factor contributing to failure of the output shaft bearing was damage caused by a prior crash-engagement<sup>3</sup> of the clutch.

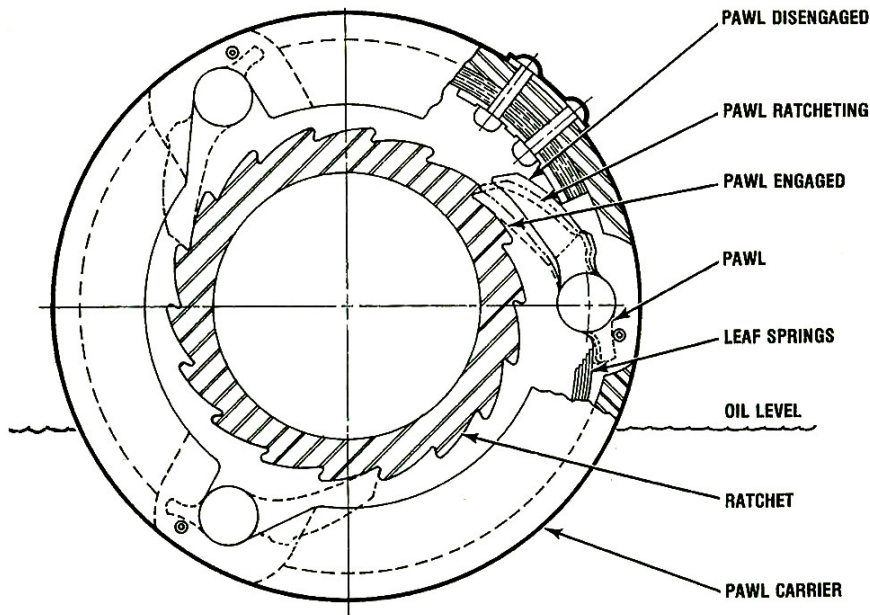
Figure 3: Ratchet and pawl clutch example

Engagement of the air turbine starter with the engine is controlled via a ratchet and pawl clutch assembly (Figure 3). At zero or low speeds the three pawls are engaged with the ratchet, which is driven by the starter turbine. The pawl carrier is integral with the starter output shaft, which is constantly engaged with the engine. On a normal start, after ignition, the engine will accelerate to a speed whereby the pawls, acting like flyweights, will disengage from the ratchet to prevent the engine from back-driving the starter. The output shaft continues to rotate with the engine.
