Loading event involving an Airbus A330, VH-QPJ

Bangkok, Thailand, on 23 July 2015

ATSB Transport Safety Report
Aviation Occurrence Investigation
AO-2015-088
Final – 22 December 2015

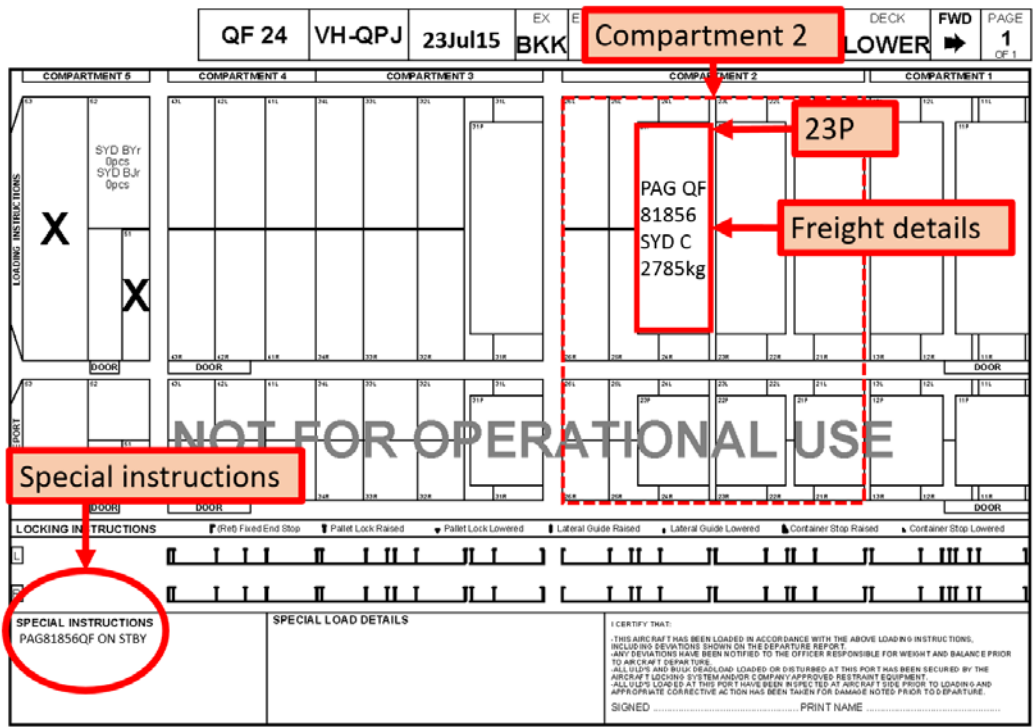
Figure 1: Load instruction report showing freight positions and special instructions

The weight of the standby pallet for 23P indicated on the LIR was 2,785 kg. The final loadsheet indicated 1,225 kg of freight in compartment 2. Compartment 2, depicted in Figure 1, included a number of freight positions including 23P. The calculation for total freight weight in Compartment 2 was based on freight loaded in positions 26L (615 kg), 26R (610 kg) and zero in 23P.

The load controller represented the standby freight as listed on the LIR, with the freight depicted in the loaded position, and a standby notation included in the Special Instructions box. The Qantas

investigation found that was not a documented procedure for handling standby freight, but it was an accepted practice. The training of loading supervisors did not include how standby freight was to be documented on the LIR.

For all flights out of Bangkok, the loading supervisor must receive a scanned copy of the final LIR before transmitting the final loadsheet to the flight crew (by ACARS).

- procedures for listing standby freight in the LIR Special Instructions
- use of LIR Special Instructions
- sample communications for instructions to offload and the required response from loading supervisors.
