# In-flight break-up involving a DJI S900 remotely piloted aircraft

Toowoomba, Queensland, on 19 September 2015

**ATSB Transport Safety Report**  
Aviation Occurrence Investigation  
AO-2015-112  
Final – 22 December 2015

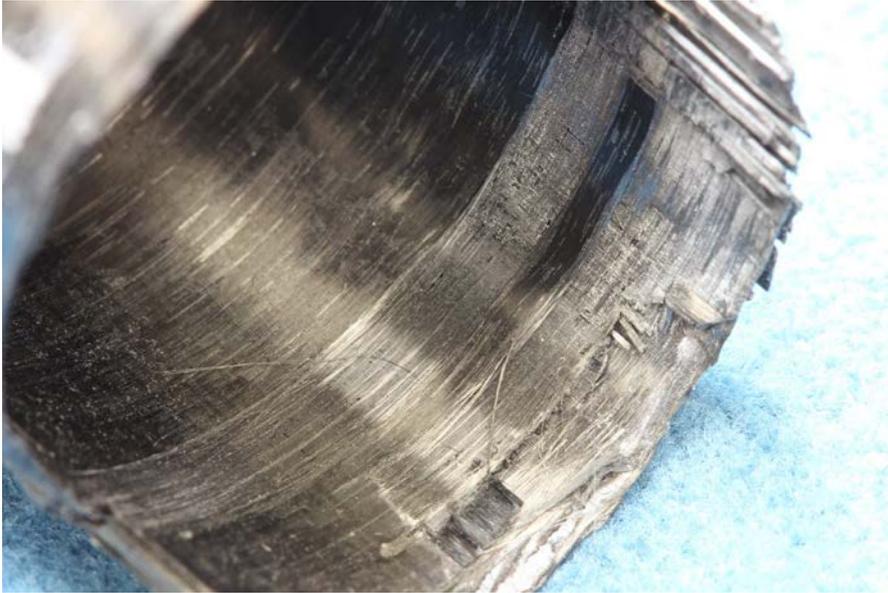
**Figure 1: Innermost layer showing loose filaments**

The RPA had a total time in service of 10.1 hours prior to the incident flight. Six arm tubes connect the motors to the main frame. The No. 5 arm, constructed of carbon fibre, was fractured, but remained attached to the main frame by the motor cable running through it.

Within the unidirectional plies around the fracture site, there were regions where the carbon fibres were not well consolidated or bonded with the resin matrix. Figure 1 shows some of the loose filaments observed on the innermost layer of the tube.

The ATSB was unable to determine whether or not pre-existing damage was present from prior operation or transit. However, the ATSB identified regions close to the fracture surface where fibres were not well consolidated within the resin. This may have affected the strength of this arm, possibly resulting in the in-flight failure.

The observed lack of bonding between fibre and resin is a result of manufacturing processes and would not have been caused by damage during transport or operation.

Even under maximum loads, the flight tests performed by the distributor may not necessarily identify defects (such as poor bonding between fibre and resin) within the manufactured carbon fibre tube, regardless of whether or not these defects ultimately result in failure. This is because subsurface cracks can propagate unpredictably in fibre composites. Failure can occur at a later time and even when the arm is experiencing loads below its designed maximum.
