Man overboard fatality from *Hyundai Dangjin*

Port Walcott, Western Australia | 10 July 2015

ATSB Transport Safety Report
Marine Occurrence Investigation
321-MO-2015-004
Final – 19 January 2016

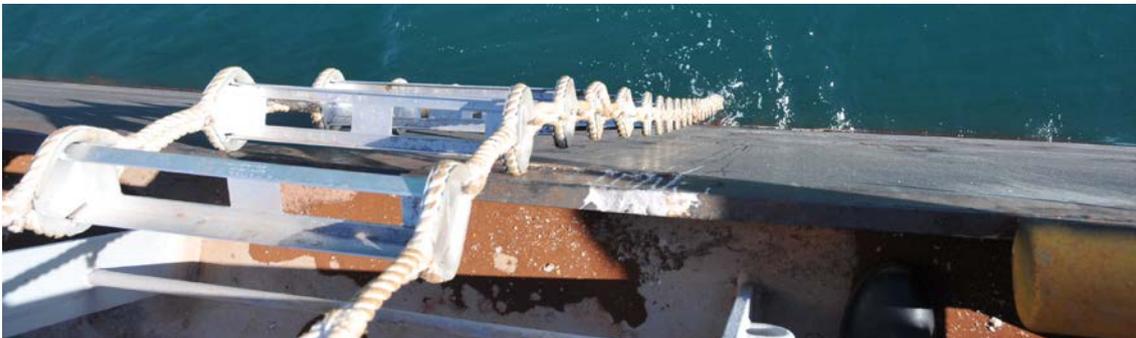
At 0450,¹ the chief mate asked the second mate, via UHF radio, to read the midships draught on the ship's port (outboard) side. The ship's crew had already rigged a rope ladder (Figure 1) adjacent to the draught marks there.

Figure 1: Rope ladder, as rigged at the time of the accident

The rope ladder had been rigged upside down (Figure 1). With their wrong side up, the ladder steps (folded aluminium) did not provide a flat surface to stand on comfortably. Further, the steps were not good handholds.

Toyo Sangyo's review of its shipboard safety management system (SMS) resulted in a 'Safe Draft Check Instruction' being included in the procedures related to cargo operations for bulk carriers. The instruction details the procedures (including permits to work) when checking the ship's draught from a rope ladder.

Rio Tinto Iron Ore, the Port Walcott terminal managers, reviewed the draught survey methods at its terminals. As a result of the review, the reading draught marks from rope ladders was prohibited. An alternate method, using a manometer, was put in place.
