Flap system failure leading to loss of control involving Cessna 208, VH-WZJ

Townsville Airport, Queensland, 10 November 2015

ATSB Transport Safety Report
Aviation Occurrence Investigation
AO-2015-133
Final – 27 May 2016

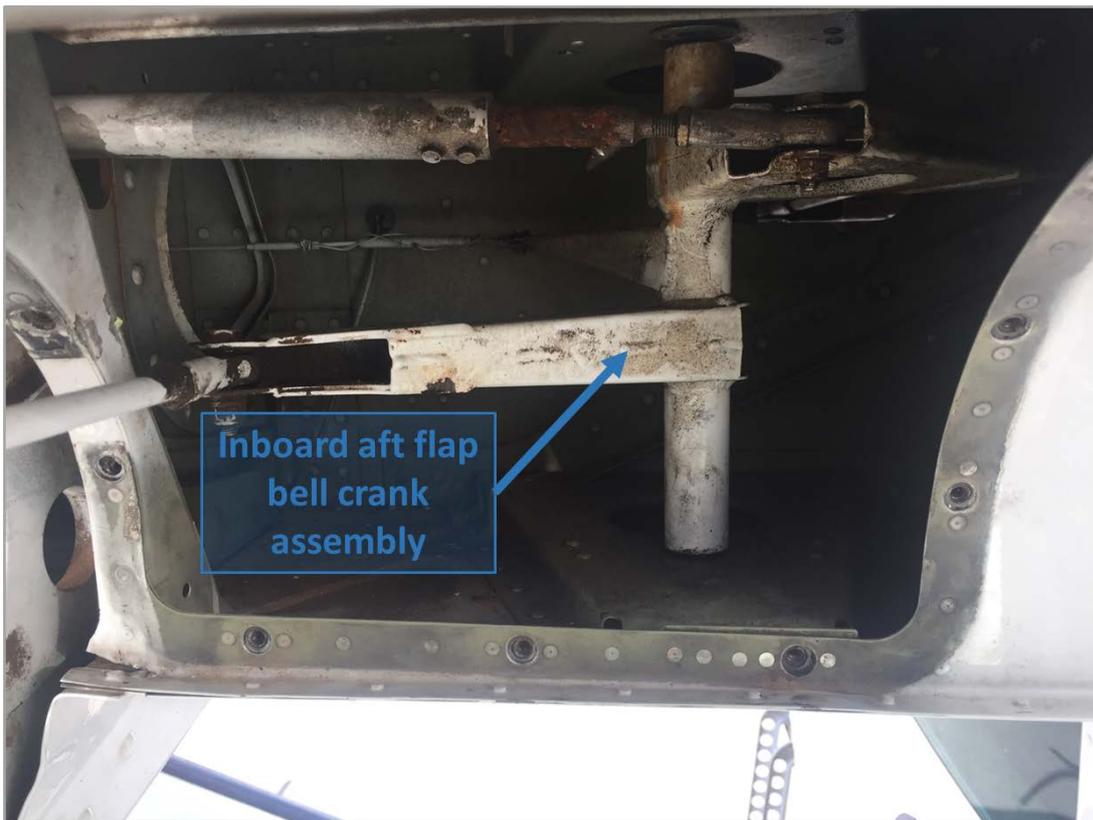
Figure 1: VH-WZJ inboard aft flap bell crank assembly

During the taxi to parking, the pilot fully retracted the flaps. With the flaps flush against the trailing edge of the wing, initially, neither the pilot nor the aircraft maintenance engineer could pinpoint the reason for the control issue. However, when the engineer gave the left flap a shake, it fell freely down, unattached on the inboard side. After removing some wing access panels, the engineering inspection discovered a loose flap bell crank retaining bolt.

The operator advised that a flap bolt had come loose allowing the lower part of the rear aft bell crank to move free. An inspection indicated that the pivot bolt may not have been lubricated for a long period of time.

The reason for the pivot bolt working loose could not be established. However, as a preventative measure the operators approved Maintenance Program has been amended. This amendment included new maintenance actions and new replacement intervals for the affected bell crank, that are additional to the maintenance requirements in the Cessna maintenance schedule tasks.

This included life limits similar to those mandated by Cessna for the primary flap bell crank assembly and replacement at 10,000 landings for:

- bearings fitted to all four aft flap bell cranks
- bearings fitted to the left inboard forward flap bell crank
- all four aft flap bell crank attaching parts and bolts
- left inboard forward flap bell crank attaching parts and bolt.

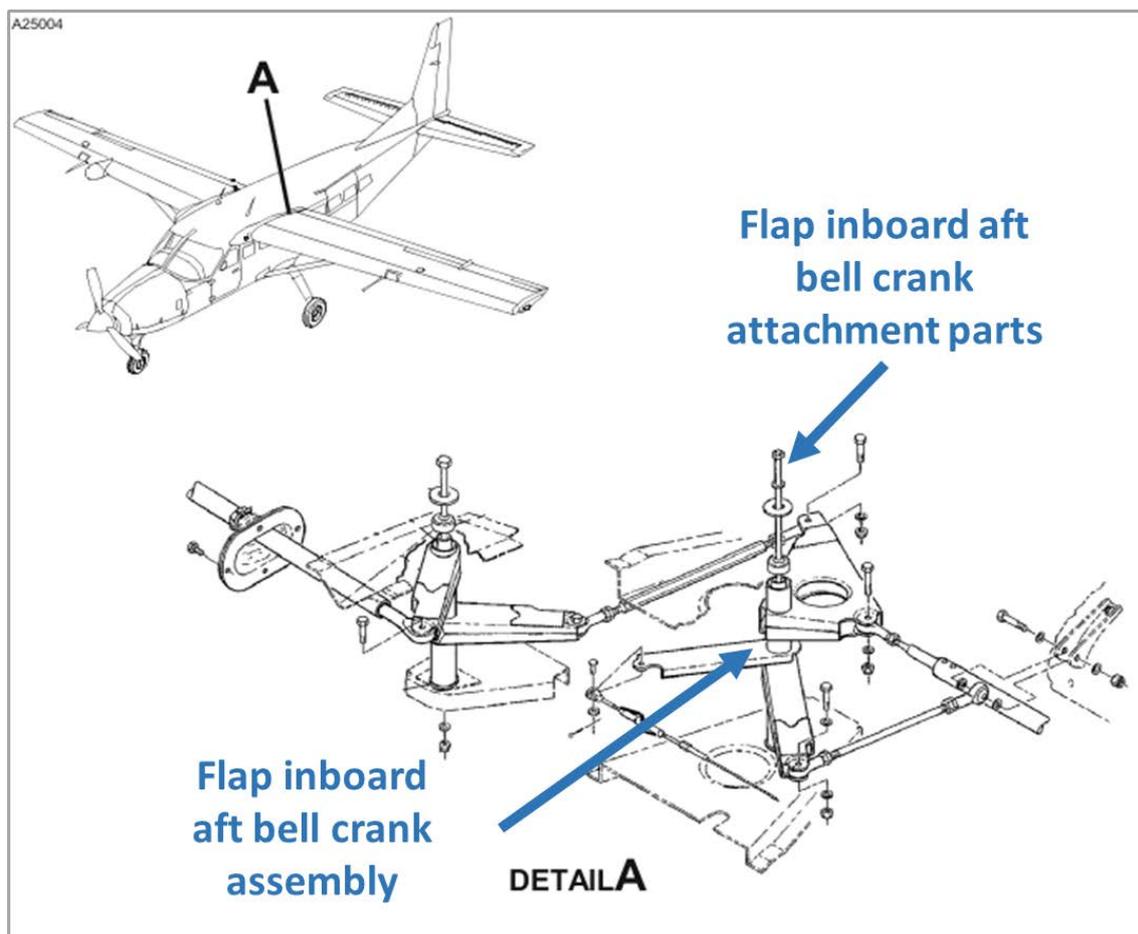
Figure 2: Diagram showing the location of the left wing flap inboard aft bell crank assembly

The aft bell crank as referenced in (Figure 2) showed that the assembly is secured into location with a single bolt securing into an anchor nut assembly on the bottom. According to the operator, there was no secondary locking system.

Reference was made to the Cessna 208 maintenance manual (maintenance manual), chapter 27-50-01 'removal and installation procedures' for this component. However, the instructions did not include a recommended torque setting for any hardware in the flap system. Engineers were required to reference a torque setting in chapter 20 of the maintenance manual – the 'standard practices' section. The procedures also advised on the requirement for Loctite 242 to be applied to the component.
