Collision with terrain involving a Robinson R22, VH-HWJ

90 km S of McArthur River Mine, Northern Territory, on 12 November 2015

ATSB Transport Safety Report
Aviation Occurrence Investigation
AO-2015-134
Final – 27 May 2016

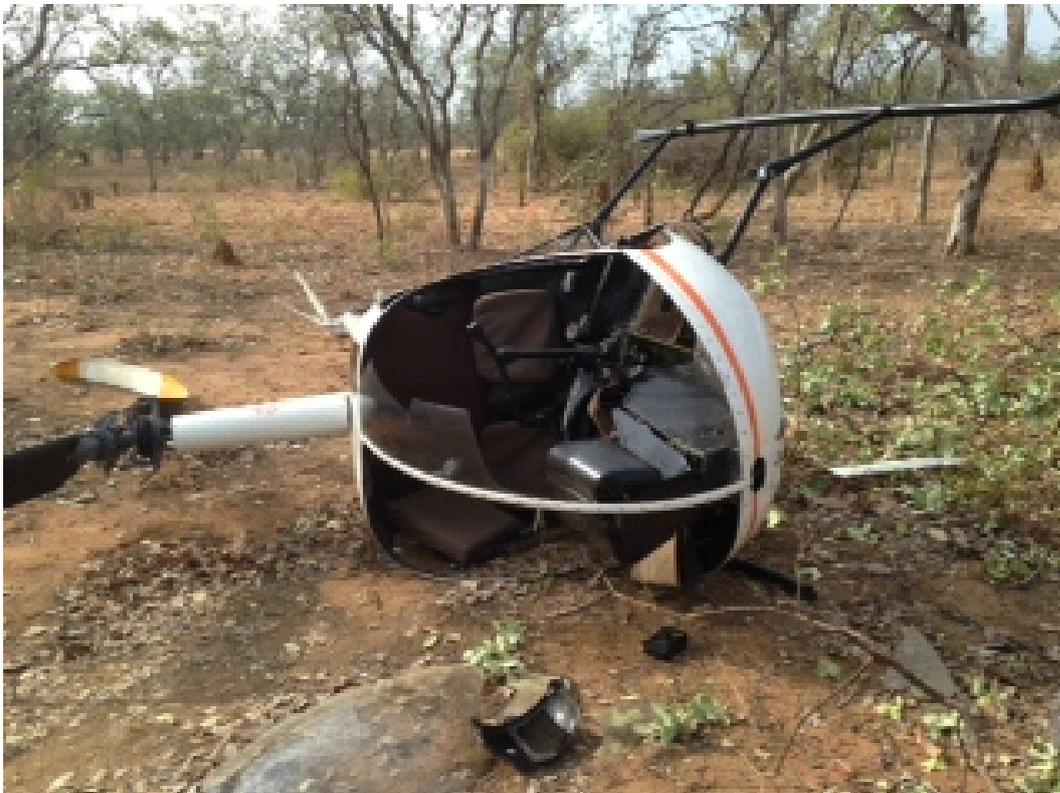
Figure 1: Accident site showing damage to VH-HWJ

At about 1400 Central Standard Time (CST), as the helicopter approached the cattle yards, it descended rapidly and collided with a tree and terrain. The helicopter landed on its side and sustained substantial damage (Figure 1). The accident occurred about 200 m prior to the cattle yards. The pilot sustained serious injuries and was unable to recall the sequence of events.

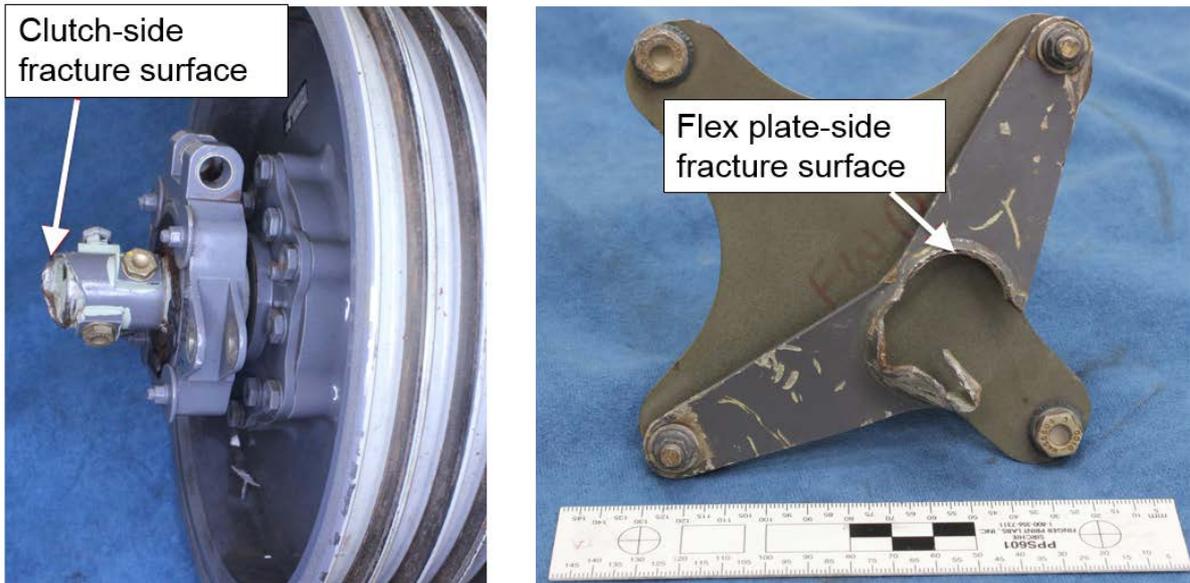
Figure 2: Fracture surfaces

The yoke connecting the clutch shaft to the rearward flex plate was found to have fractured at the connection to the shaft (Figure 2). The ATSB conducted analysis to determine whether the yoke failure may have contributed to the accident, or occurred as a result. The analysis found no evidence of fatigue damage in the yoke, and no other signs of pre-existing damage. The helical fracture was consistent with torsional overstress inducing failure in the yoke.
