# Personal electronic device fire in-flight involving Boeing 747, VH-OJS

500 km WNW of John F. Kennedy International Airport, United States, 21 June  
2016

**ATSB Transport Safety Report**  
Aviation Occurrence Investigation  
AO-2016-066  
Final – 28 September 2016

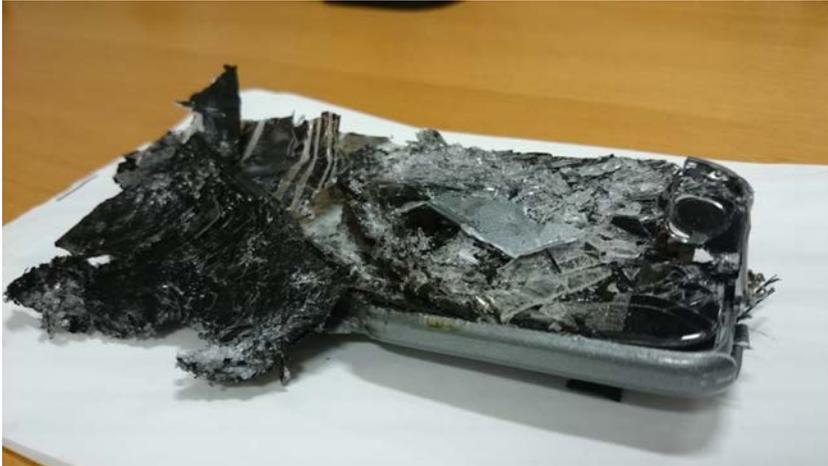
After confirming the PED fire had been extinguished, the cabin crew attempted to remove the PED in order to place the device in water, in accordance with lithium type battery fire procedures. The PED could not be removed without further damage and risk of fire. Therefore, the cabin crew elected to leave the device in place and position a crewmember with a fire extinguisher near seat 3A for the remainder of the flight. About 10–15 minutes after the incident, this crewmember identified further heat coming from the crushed PED. They again discharged the fire extinguisher onto the PED, eliminating the heat.

**Figure 1: Crushed PED after removal from seat**

- A review of reported events revealed 22 similar occurrences of trapped or crushed PEDs. Seven of these occurrences resulted in smoke and/or heat being produced. This incident was the first event to result in fire.
- The investigation determined that the likely area for the PED to intrude into the seat mechanism was adjacent to the seat belt anchor point. This area becomes more exposed as the seat reclines towards the flat position.
- Mesh netting within the seat structure is designed to capture objects that fall behind the seat. Damage to seat 3A consisted of an approximate 5 cm melt area to this mesh netting. There was no other damage noted to the seat structure.

As a result of this occurrence, the aircraft operator has advised the ATSB that the seat manufacturer is developing design solutions to prevent ingress of PEDs into the seat structure.
