Runway incursion involving Fairchild SA227, VH-HPE

Richmond Airport, Queensland, 7 June 2016

ATSB Transport Safety Report
Aviation Occurrence Investigation
AO-2016-056
Final – 14 October 2016

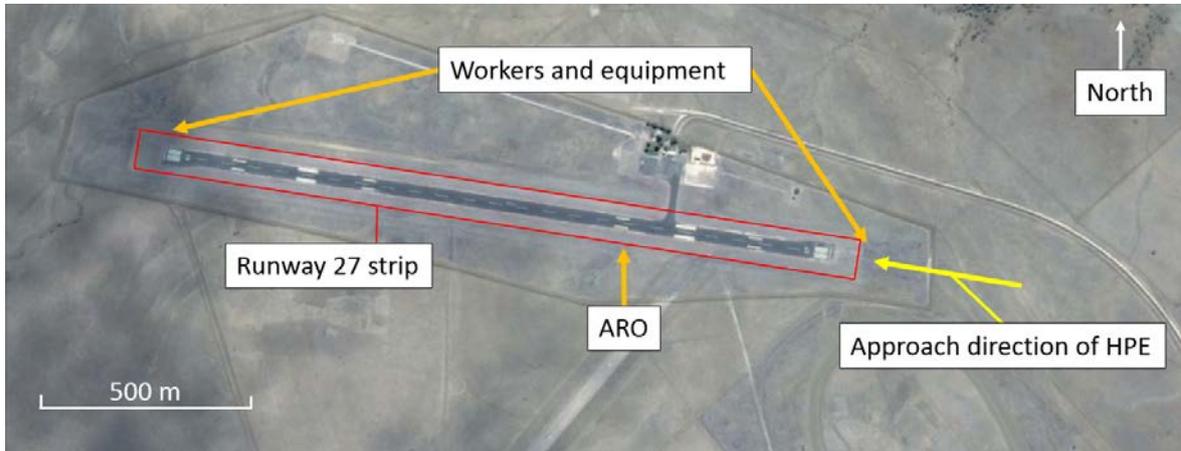
Figure 1: Richmond Airport

After the brief, the workers undertook the required task in three groups. One group positioned at the eastern end of the runway and a second group at the western end of the runway while the ARO remained at a mid-point along the runway (Figure 1). While the work groups conducted the plant removal, the pilot of HPE activated the pilot activated lighting.³ The workers in the groups at each end of the runway observed the lights illuminating and immediately began to vacate the runway strip.⁴ The pilot made a further broadcast when 20 NM east of Richmond, and received only a short response from the AFRU.
