Flap cable failure and ground strike involving Airparts (NZ) FU-24, VH-TTD

50 km ESE of Tamworth Airport, New South Wales, 26 June 2016

ATSB Transport Safety Report
Aviation Occurrence Investigation
AO-2016-067
Final – 14 October 2016

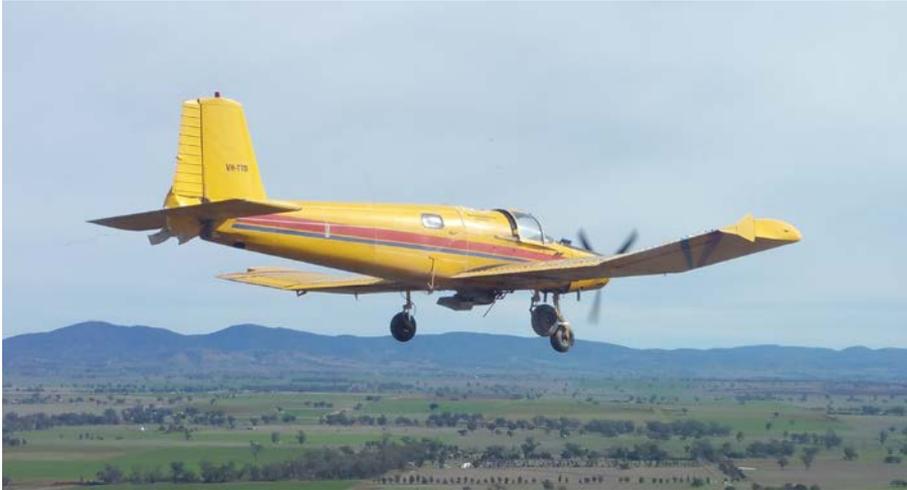
Figure 1: VH-TTD flying towards Tamworth Airport on the incident flight

The pilot contacted Tamworth air traffic control (ATC) and informed them that they had a 'bit of an issue'. They also advised that they had no elevator control, but still had the aircraft under control (Figure 1). ATC cleared the pilot to manoeuvre as required to approach and land on the main runway at Tamworth.

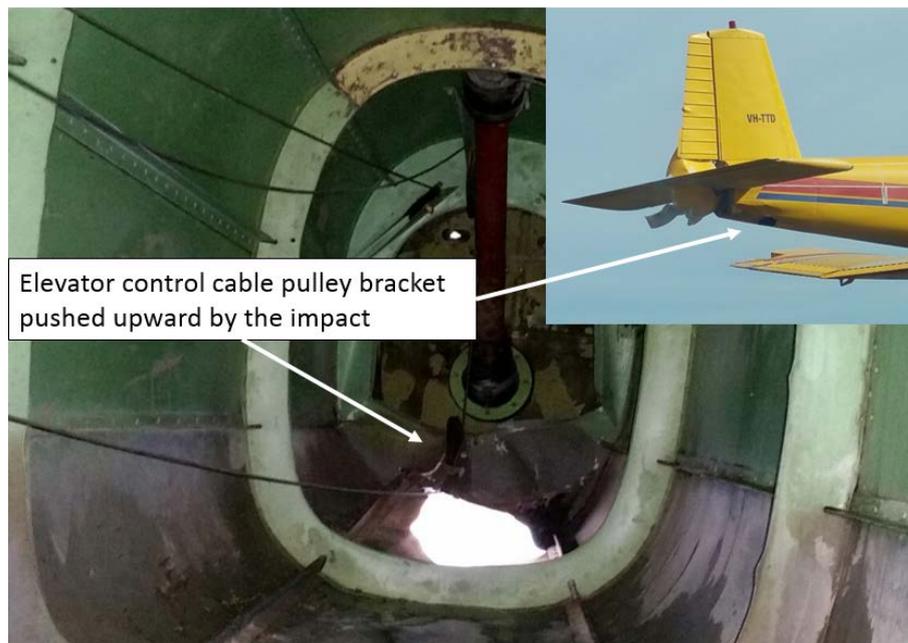
Figure 2: VH-TTD elevator control cable pulley

- The structural frame supporting the lower elevator control cable pulley was pushed up about 10 cm (Figure 2).
- The centre section just aft of the hopper (Figure 3) had about 12 mm of water in it and the drain hole for the centre section was blocked by fertiliser. The repair organisation assessed that the size of the drain hole was inadequate and that a larger hole with a removable bung would be preferable.
- The flap control cable had failed at the rear flap pulley and the failure appeared to be due to corrosion (Figure 4).

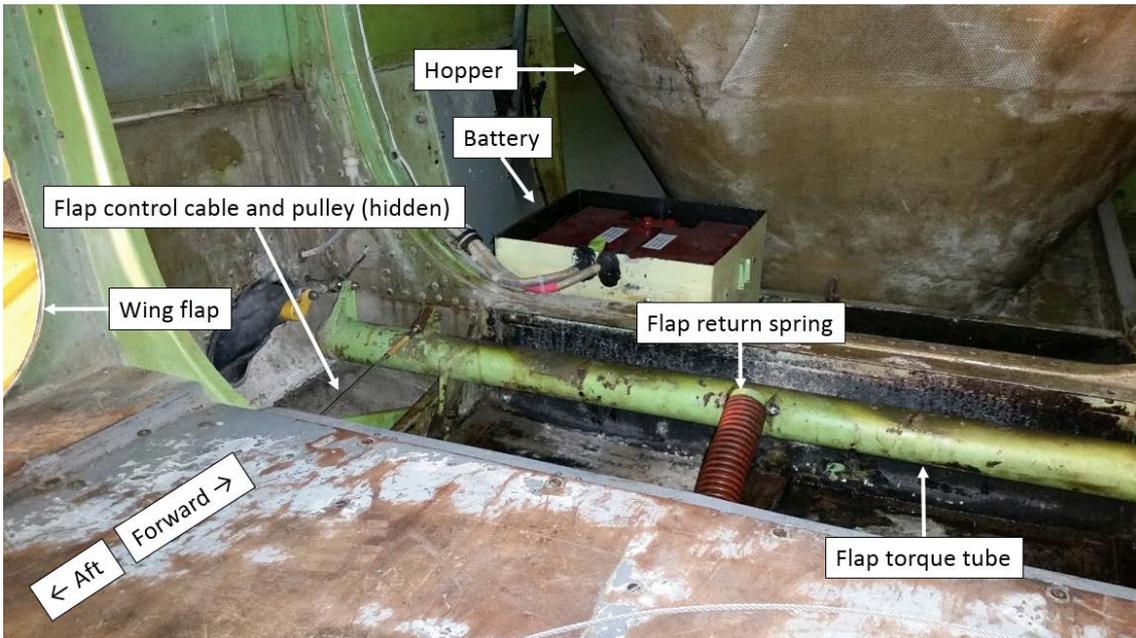
Figure 3: VH-TTD centre section

Entrapped water, fertiliser and potentially, the previous use of an unsealed lead-acid battery,⁷ all contributed to a corrosive environment within the centre section of the aircraft, and corrosion of the flap cable.

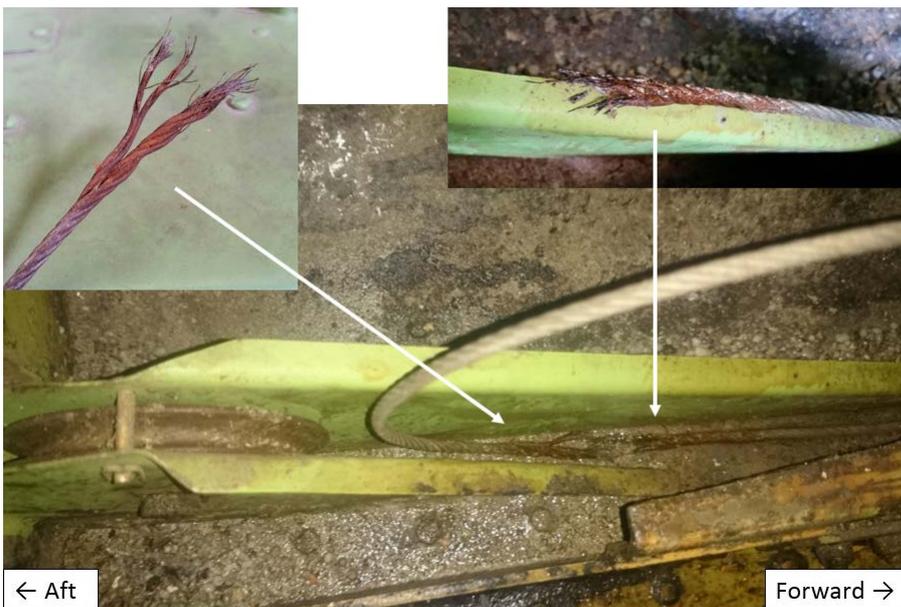
Figure 4: VH-TTD broken flap cable

The ATSB notes that the corrosion present on the flap control cable at the location of the failure takes a considerable amount of time to develop. The corrosion was confined to the working length of the cable that was in contact with the flap control system rear pulley, which is considered to be a critical fatigue area. The failed cable was comprised of woven steel wires plated with zinc or tin. The cable was confirmed to be the correct type for the application.

Over time, in the absence of a suitable lubricant, the plating can wear due to frictional contact with the pulley. This will render the cable susceptible to corrosive attack and elevate the likelihood of a fatigue failure. The flap control cable was not removed during the last periodic inspection, which could have detected the corrosion damage. Nor was grease applied to the working length of the cable, or the rear flap pulley, during the last few inspections to mitigate against the development of corrosion.

The FU-24 rear flap control system pulley will be removed during CASA Schedule 5 periodic inspections to facilitate inspection of the flap control cable.

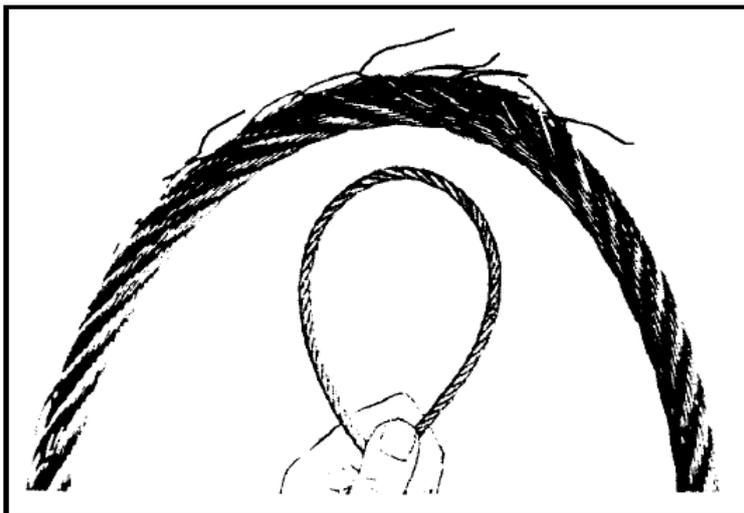
Figure 5: Cable inspection technique

United States Federal Aviation Administration [Advisory Circular 43-13-1B chapter 7](#), section 8, paragraph 7.149 states that: 'deterioration, such as corrosion, is not easily seen, therefore, control cables should be removed periodically for a more detailed inspection and any cable with a broken strand in a critical fatigue area⁶ must be replaced.' See Figure 5 below.
