Separation issue due to runway incursion involving Gippsland Aeronautics GA-8, VH-BFL, and Cessna 210, VH-NLV

Mitchell Plateau ALA, Western Australia, 9 August 2016

ATSB Transport Safety Report
Aviation Occurrence Investigation
AO-2016-097
Final – 14 October 2016

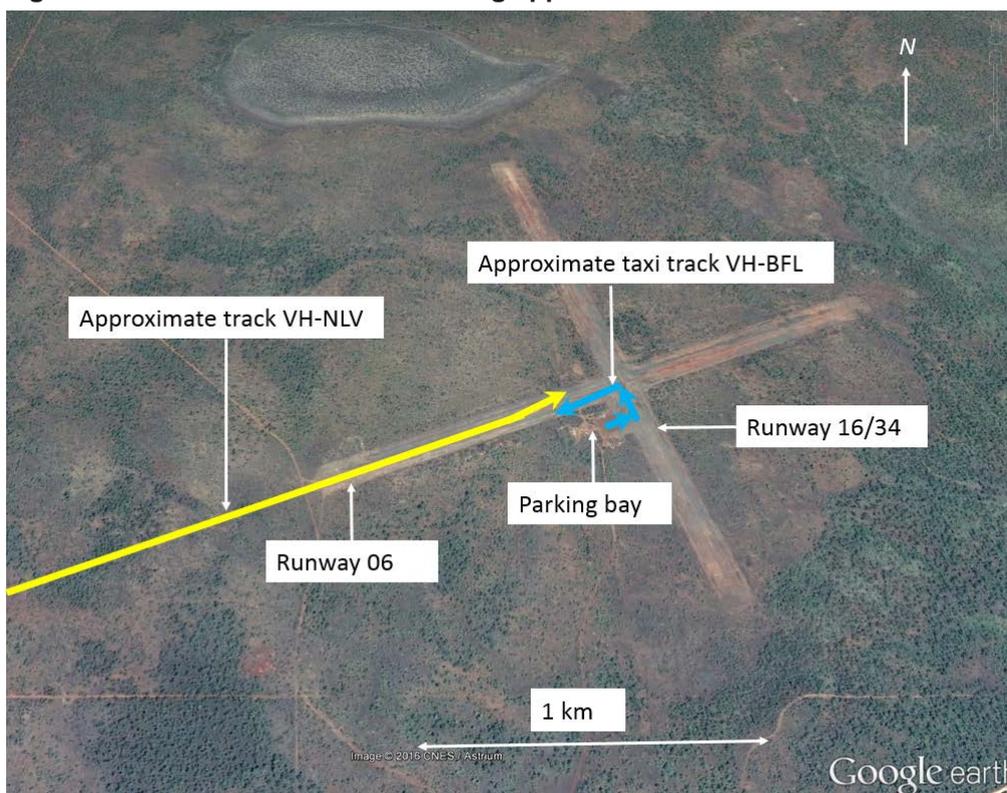
Figure 1: Mitchell Plateau ALA showing approximate aircraft tracks

Shortly before 1100, after completing orbits overhead Mitchell Falls, about 9 NM south-west of Mitchell Plateau ALA, the pilot of NLV positioned the aircraft to track for a straight-in approach to runway 06 at Mitchell Plateau ALA (Figure 1).

When at about 1 NM on final approach to runway 06, the pilot of NLV broadcast again on the CTAF and did not receive a response. From the aircraft's position, the parking bay and adjacent taxiway were obscured by a line of trees, and the pilot was unable to see BFL.

As the pilot of NLV flared the aircraft for landing, they sighted BFL turn left and taxi onto runway 06. The pilot of NLV assessed that if they conducted a go-around the aircraft may be unable to climb fast enough to avoid the aircraft on the runway and could not diverge from the runway direction due to the trees beside the runway, therefore the pilot elected to land. After landing, the pilot of NLV braked more heavily than normal and moved to the left of the runway to increase the separation between the two aircraft.
