# Loss of separation due to runway incursion involving Airbus A320, VH-VGI, and Fokker F50, VH-FKV

Adelaide Airport, South Australia, 17 August 2016

**ATSB Transport Safety Report**  
Aviation Occurrence Investigation  
AO-2016-102  
Final – 22 November 2016

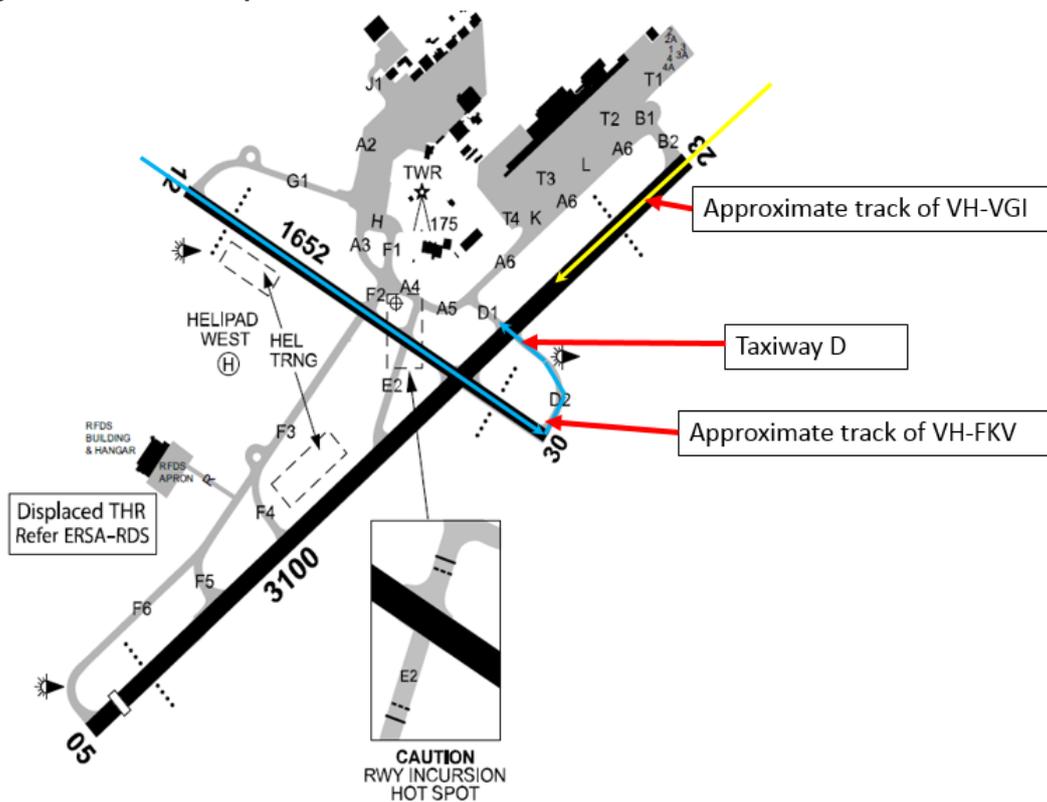
Figure 1: Adelaide Airport

Air traffic control (ATC) audio recordings showed that at 0926:53, after FKV had rolled through the intersection with runway 23, the aerodrome controller (ADC) cleared an aircraft for take-off on runway 23 (Figure 1).
