Loading event involving Airbus A320, VH-VFN

Sydney Airport, New South Wales, 8 September 2016

ATSB Transport Safety Report
Aviation Occurrence Investigation
AO-2016-119
Final – 14 December 2016

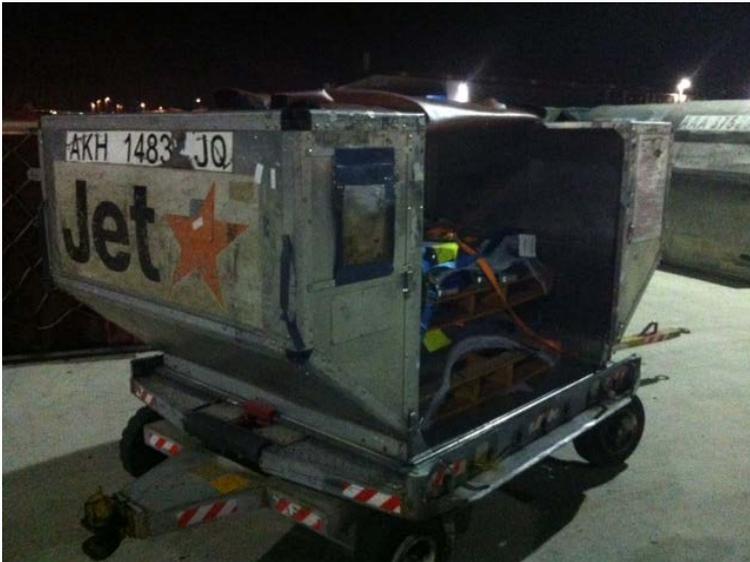
Figure 1: Container AKH 1483 JQ

The leading hand assigned to loading the aircraft had received the deadload weight statement¹ (DWS) for the cargo from the cargo terminal operator (CTO), and printed out a copy to refer to while loading the aircraft. The DWS listed three containers of freight, which the leading hand reported was usually loaded onto the aircraft before the passenger bags. The CTO had previously delivered the three containers to the loading bay from their facility. The leading hand checked the containers with those listed on the DWS – crosschecking the container numbers and the flight details, and confirming that the sum of the weight of the three containers corresponded to the total gross weight on the DWS. Two of the three listed containers were correct, however, the third was listed on the DWS with number 4183 and a gross weight of 240 kg, while the container on the bay was number 1483 (Figure 1), which was subsequently found to have had a gross weight of 900 kg.

Subsequent investigation revealed that the incorrect container was delivered for loading; the CTO had delivered container 1483 (which weighed 900 kg) instead of 4183 (which weighed 240 kg).

The aircraft operator advised that a member of the freight company misread the digits on the container (confusing 1483 for 4183) and transported it to the incorrect bay while delivering the correct DWS and container card.

Ground crew have been reminded to offload any freight where there is a discrepancy in the paperwork.

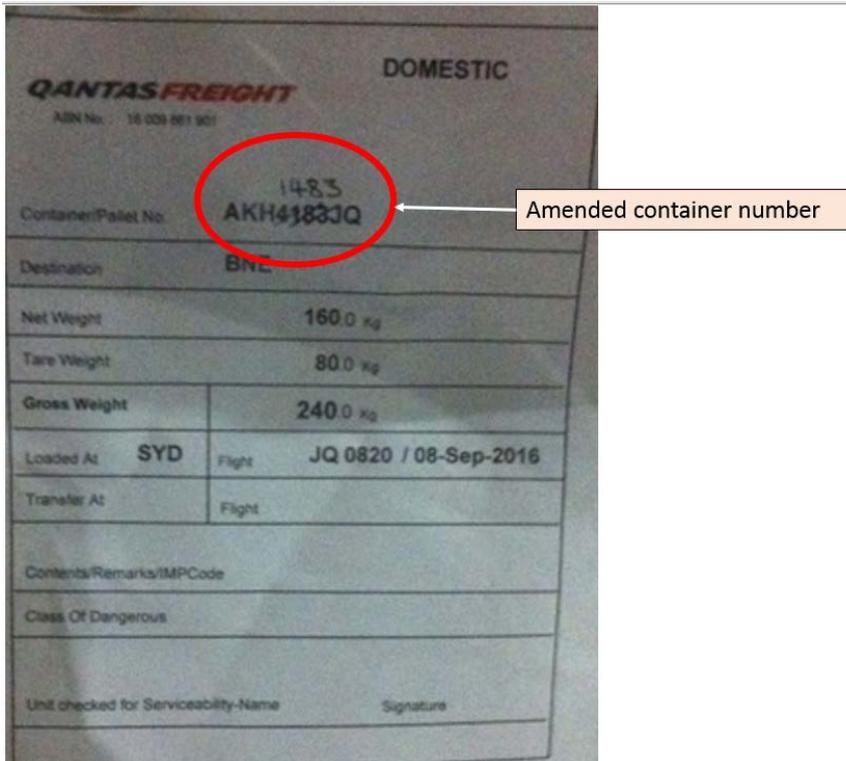
Figure 2: Container card

The container card associated with, and attached to the container also had number 4183 on it (Figure 2). The leading hand assumed that the freight handler had inadvertently transposed the first two digits of the container number from 14 to 41, entered that onto the card and transferred the error onto the DWS. The leading hand therefore amended the card and the DWS with the actual number of the container (1483), and entered that container number onto the underfloor load advice (ULA) as it was loaded onto the aircraft (Figure 3).

The leading hand (incorrectly) assumed the freight container (1483) was the correct container to be loaded, but that the container number on the container card and DWS (4183) had been entered incorrectly (due to a transcription error). Although the leading hand could have requested a new printed DWS and container card, due to the combination of the limited turnaround time available and the concern to ensure the freight made it to the destination that night, the leading hand instead 'corrected' the numbers with a pen so they matched the number on the container. This resulted in a lost opportunity for the leading hand's incorrect assumption to be identified. Similarly, although the captain could see there was a discrepancy, they accepted the hand-written amendment to the DWS based on the leading hand's assurance that the correct container been loaded onto the aircraft.
