Wirestrike involving Cessna 441, VH-NAX

Coorabie ALA, South Australia, 5 September 2016

ATSB Transport Safety Report
Aviation Occurrence Investigation
AO-2016-110
Final – 14 December 2016

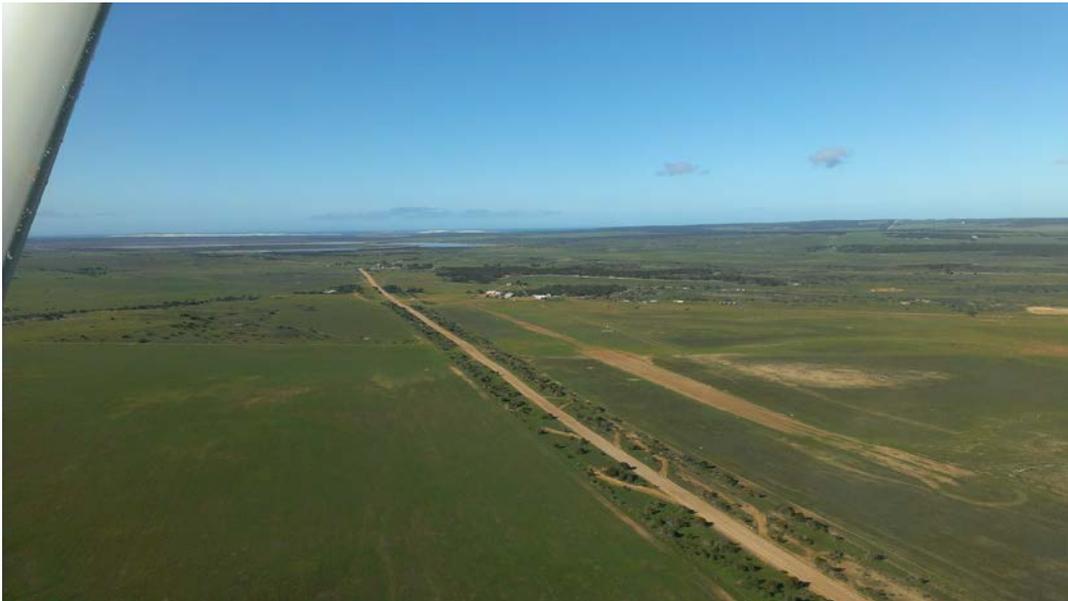
Figure 1: Coorabie ALA facing south

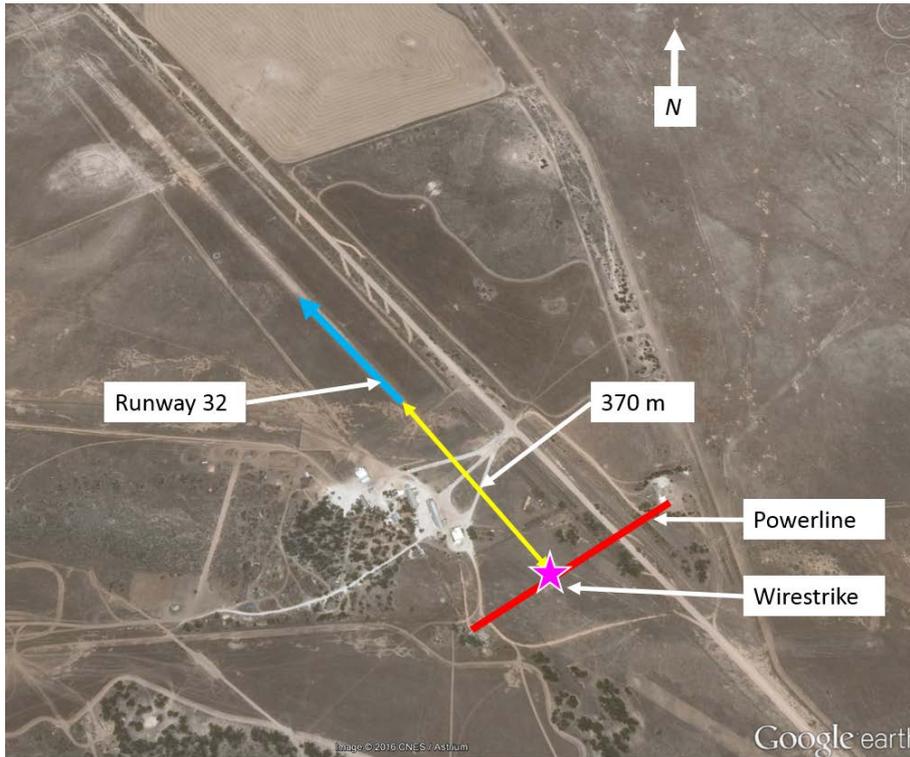
The pilot then conducted a go-around and a left circuit at about 1,100 ft above ground level. The aircraft subsequently landed on runway 32. While back-tracking, the pilot sighted a power pole on a hill beyond the runway 32 threshold (in the direction from which the aircraft had just approached). After shutting the aircraft down, the pilot noticed damage to the right propeller blades and suspected that the aircraft had struck a powerline (Figure 2). Witnesses on the ground confirmed that they had seen and heard the aircraft strike the powerline.

Figure 2: Coorabie ALA showing the powerline 370 m from the threshold

The powerline was located about 370 m from the runway threshold and about 7.5 m above ground level. The powerline was below the recommended slope gradient of 5 per cent (Figure 3).

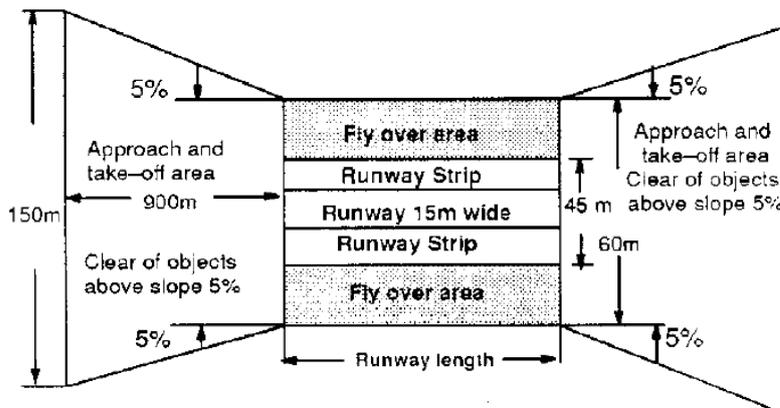
The Civil Aviation Advisory Publication (CAAP) 92-1(1) [Guidelines for aeroplane landing areas](#), provided guidance on how pilots may determine the suitability of an aeroplane landing area (ALA) such as the recommended obstacle clearance standards and suggested landing area markings. The CAAP defined an obstacle free area to mean ‘there should be no wires or any other form of obstacles above the approach and take-off areas, runway, runway strips, fly-over areas or water channels’. The minimum landing area physical characteristics recommended in the CAAP for aircraft (other than single-engine and centre-line thrust aeroplanes not exceeding 2,000 kg maximum take-off weight) for day operations is depicted in Figure 3. This shows the approach and take-off area should be clear of wires within 900 m of the runway ends above a 5 per cent (3°) slope.

Figure 3: Recommended landing area characteristics

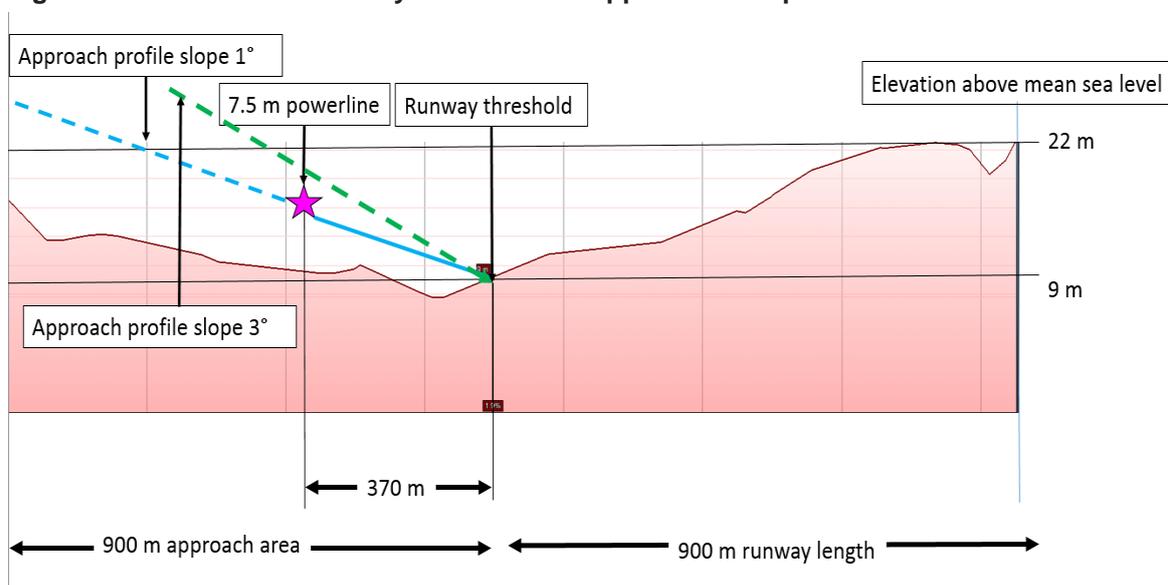
The profile of Coorabie ALA runway 32 and the approach area of 900 m (based on the recommended dimensions specified in Figure 3), obtained from Google earth, is depicted in Figure 4. The cleared area commencing from the runway threshold was about 1,170 m in length. Along that length, the profile rose from 9 m (30 ft) to 22 m (72 ft) elevation at the nominated runway length of 900 m, with higher ground rising to about 29 m (90 ft) beyond 900 m. The information provided to the operator by the ALA operator was that the runway length was 900 m, suggesting that the rising terrain beyond that point was not part of the runway. The stated runway elevation was 75 ft (23 m).

As can be seen in Figure 4, the terrain at the powerline was about the same height as the runway 32 threshold, with a dip in between. The glide path from a powerline 7.5 m above the terrain to the runway threshold was about 1°. A normal approach path is about 3°.

Runway slope is one environmental condition that can affect a pilot's perception of the aircraft's position relative to a normal approach profile. Flight Safety Foundation *Approach and landing accident reduction tool kit briefing note 5.3 – Visual illusions* stated that an uphill slope creates the illusion of being too high. That illusion may induce the pilot to 'correct' the approach resulting in a lower flight path, or may prevent the pilot from detecting when the aircraft is too low during the approach.

Figure 4: Coorabie ALA runway 32 and 900 m approach area profile

It is essential for pilots to be aware of hazards prior to operating into an aerodrome. The location of known hazards and obstacles such as powerlines should be included in aerodrome information that is provided to pilots and aircraft operators who are permitted to operate at the airfield. As runway slope can result in visual illusions that may affect a pilot's judgement of the approach profile, runway slope information should also be included in operational information.

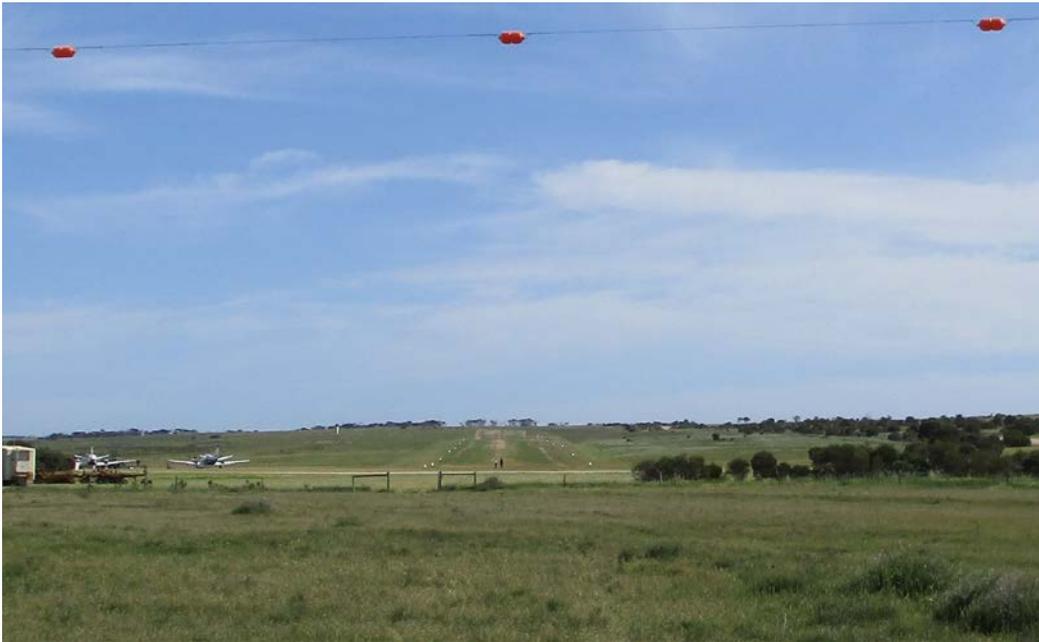
Figure 5: Powerline with orange markers

Following the incident (at the time of repairing the wire), the infrastructure provider marked the wire with three round orange markers (Figure 5).
