Engine failure and forced landing involving Jabiru SP500, 19-5503

14 km N of Boonah (ALA), Queensland, 11 September 2016

ATSB Transport Safety Report
Aviation Occurrence Investigation
AO-2016-116
Final – 14 December 2016

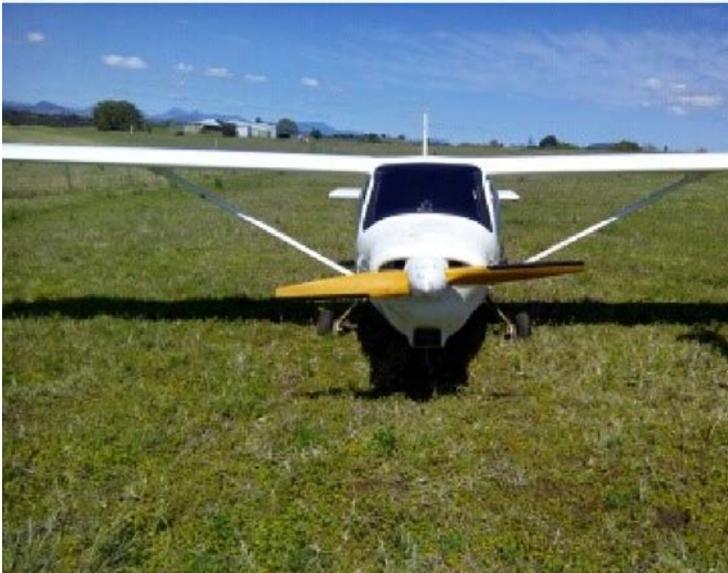
Figure 1: 19-5503 after the forced landing

The pilot identified a paddock to the north of their position as suitable for a forced landing. They manoeuvred the aircraft to conduct a forced landing into the paddock (Figure 1). The pilot ensured that turns made during the forced landing were not tight and of low bank angle to avoid an aerodynamic stall. Late in the ground roll, the nose wheel dug into the soft surface (Figure 2), the aircraft tipped onto its nose and the right wingtip struck the ground. The aircraft then stopped and settled onto its wheels. The pilot was not injured and the aircraft sustained minor damage.

- The oil pump drive failed leading to engine failure and forced landing.
- The soft surface of the paddock used for the forced landing resulted in damage to the landing gear.

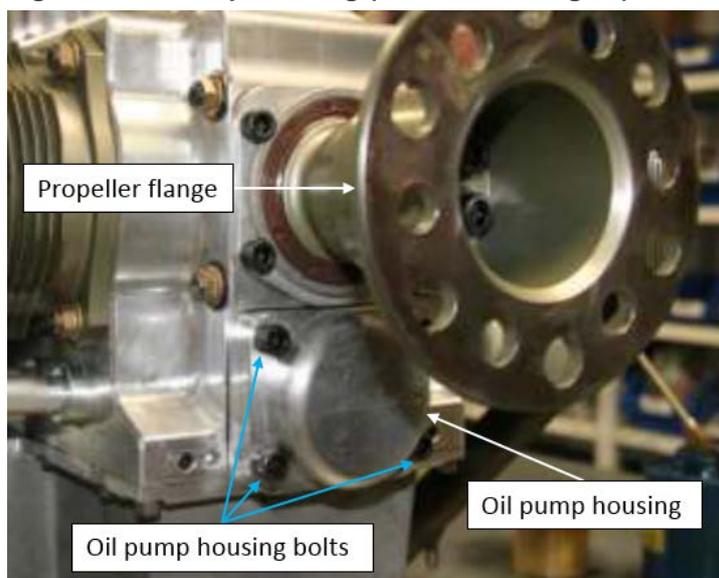
Figure 3: Oil Pump Housing (not incident engine)

A post incident examination of the engine found the engine oil pump drive had failed.

Jabiru advised that they are aware of one previous oil pump drive failure. In the previous occurrence the manufacturer found the engine maintainer had tightened the oil pump housing bolts (Figure 3) unevenly.

Fit the outer pump housing over the gears and insert & hand tighten the retaining cap screws. Use Loctite 243 on the threads and ensure the Jabiru bird is oriented correctly.

While the housing is still loosely held to the engine, rotate the crankshaft through at least 2 full revolutions. This turns the cam and allows the oil pump to find its preferred position. The housing can now be tightened to the value given in Table 9.² Failure to turn the engine can result in the oil pump being offset from the cam axis – this applies side loads to the cam and can eventually crack it or break the tip off altogether.
