# Fuel exhaustion event involving a Cessna 182, VH-DNZ

Adelaide, South Australia, on 2 October 2015

**ATSB Transport Safety Report**  
Aviation Occurrence Investigation  
AO-2015-115  
Final 28 January 2016

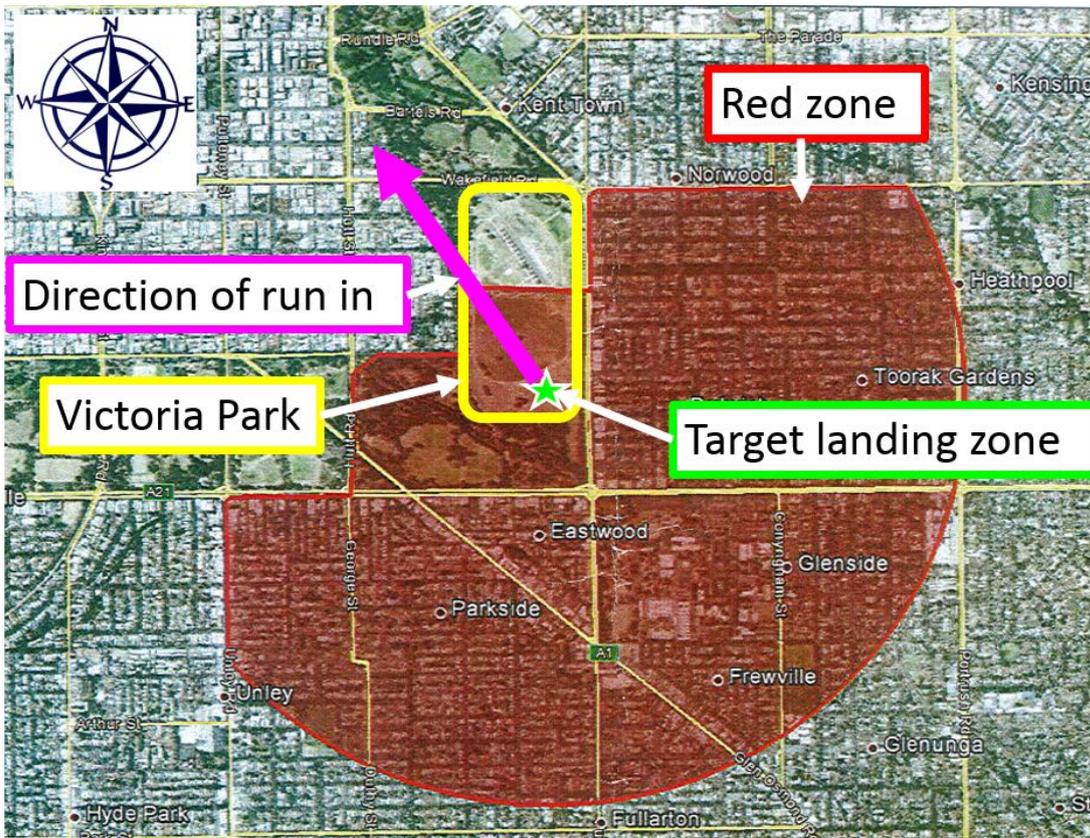
**Figure 1: Drop area agreed between Australian Parachute Federation and Airservices Australia**

The target landing zone for the parachutists was Victoria Park, which would require the pilots to obtain a clearance from Adelaide air traffic control (ATC) to enter Adelaide control zone. Parachute operations normally included a drop area of a 1 NM radius around the target landing zone. However, the north-western corner of that 1 NM radius circle from Victoria Park infringed on the separation required for aircraft arriving and departing on runway 05/23 at Adelaide Airport. Therefore, the drop area agreed between Airservices Australia and the Australian Parachute Federation (APF) for the operation was as depicted by the red zone in Figure 1.

About 2 minutes later, the approach controller revised the estimated drop time to 1433. At about 1411, the pilot of DNZ asked the approach controller whether an earlier clearance would be available if they amended the run in to the original red zone (Figure 1). Remaining within the red zone would increase the distance of DNZ from aircraft on final approach to runway 23 at Adelaide, and potentially expedite a clearance. The controller replied that if they could remain in the original area, they could expect a drop time of 1426. The controller confirmed again at 1417 that they had reports the wind was suitable (to operate within the red zone), so the pilot of DNZ could expect a clearance only into the original red zone.

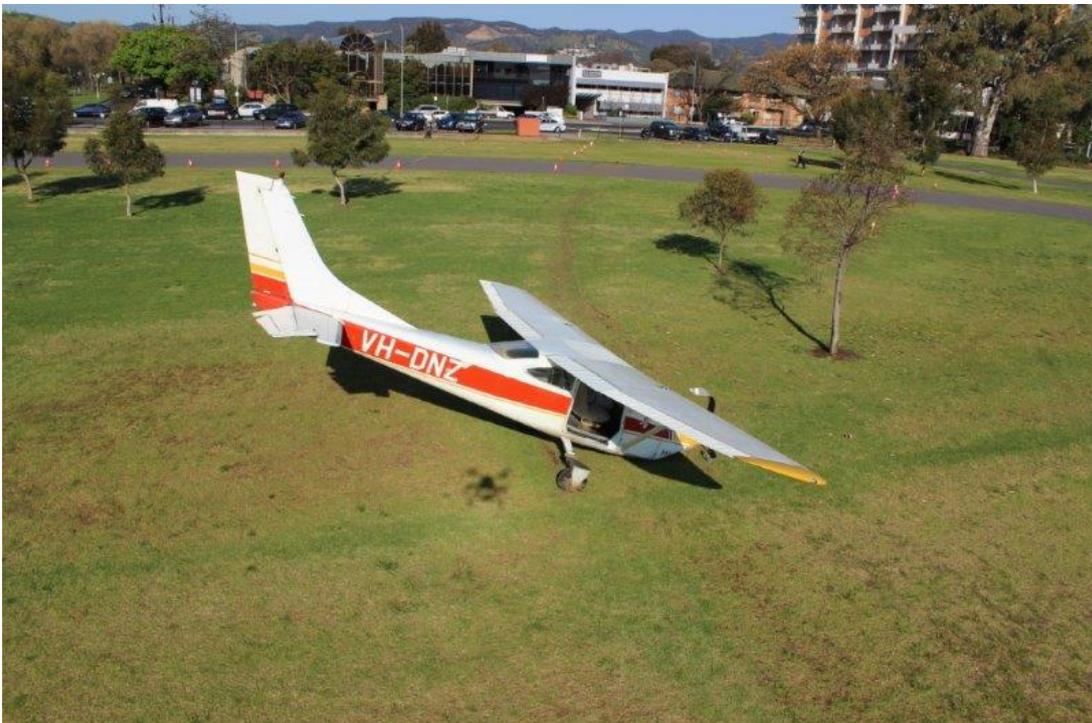
**Figure 3: Accident site showing damage to VH-DNZ**

The pilot aimed to land the aircraft in ‘pit straight’ on the racecourse, which was directly into the north-westerly wind, but as the aircraft lined up with the straight, the pilot saw a car on the bitumen. The pilot conducted a turn to the right then to the left and landed the aircraft on grass. The pilot reported that it was a very heavy landing, and that the aircraft landed either flat or nose wheel first. The nose wheel broke off, the propeller struck the ground, and the aircraft slewed to the left. Two of the parachutists were ejected from the aircraft during the impact. Two of the parachutists sustained serious injuries, and two were uninjured. The pilot sustained minor injuries and the aircraft was substantially damaged (Figure 3).

A representative of the Australian Parachute Federation aircraft committee inspected the aircraft following the accident. The representative found that the aircraft impacted the ground very heavily in a nose-down attitude. About half a litre of fuel was drained from the system after the aircraft was removed from the site.

The ATSB obtained video footage of the incident taken from inside the aircraft. During the approach, the aircraft banked steeply to the right towards a built-up area, then to the left towards the landing site. As the aircraft wings levelled, the nose pitched up and the left wing appeared to come into close proximity with a building. At that time, the pilot retracted the flaps. The aircraft then descended rapidly and collided with the ground in a nose-down attitude.
