Synthetic vision display error involving Pilatus PC-12 VH-OWA

Meekatharra Airport, Western Australia, 18 June 2016

ATSB Transport Safety Report
Aviation Occurrence Investigation
AO-2016-064
Final – 17 January 2017

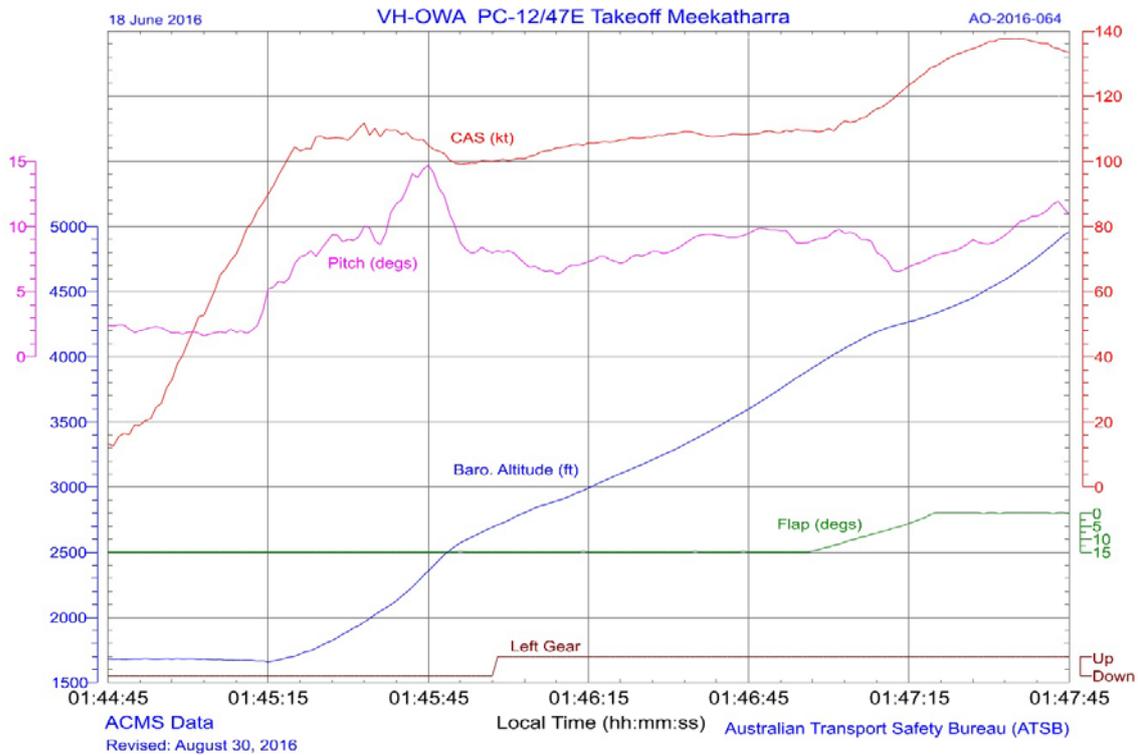
Figure 1: Plot of selected data from the incident flight

The flight data was downloaded from the aircraft condition monitoring system and analysed by the ATSB. Figure 1 depicts the calibrated airspeed and pitch angle from the start of the take-off roll. The change in pitch (pink line) from the pilot pulling back on the control column in reaction to the synthetic vision started at about 0145:30 in Figure 1.

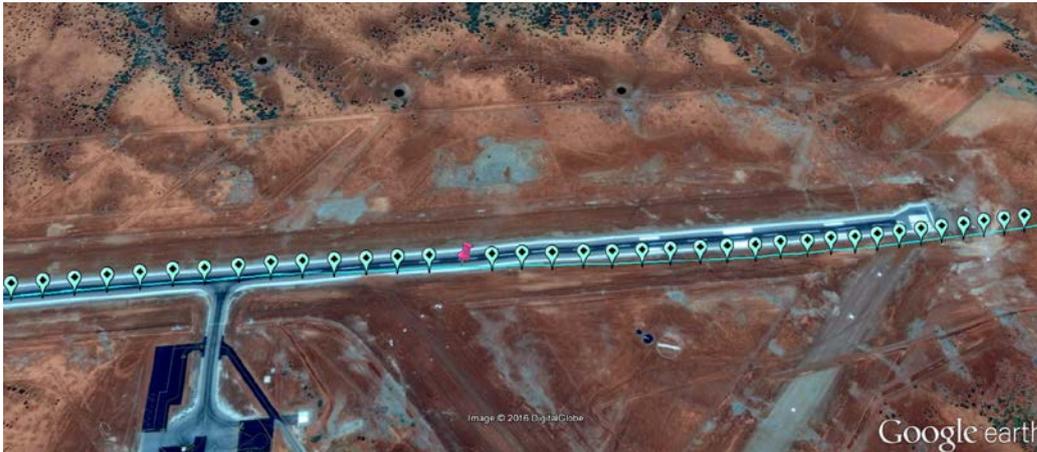
Figure 2: Deviation of OWA (travelling from left to right) from runway centreline showing the estimated point of the radalt failure (in pink)

Figure 2 shows the aircraft recorded GPS track, with the pink marker indicating the first significant increase in pitch attitude, and therefore the approximate point of radalt failure. The aircraft was then at about 250 ft above the runway.

The movement of the runway to the left of the screen was probably associated with a small displacement of the aircraft to the right of the runway centreline. The wind at the time was from 094° at 9–11 kt, therefore largely a headwind component and the lateral displacement of the aircraft was unlikely to be a result of the wind.
