# Taxiing incident involving Airbus A330, 9M-XXK

Melbourne Airport, Victoria, 9 September 2016

**ATSB Transport Safety Report**  
Aviation Occurrence Investigation  
AO-2016-117  
Final – 9 February 2017

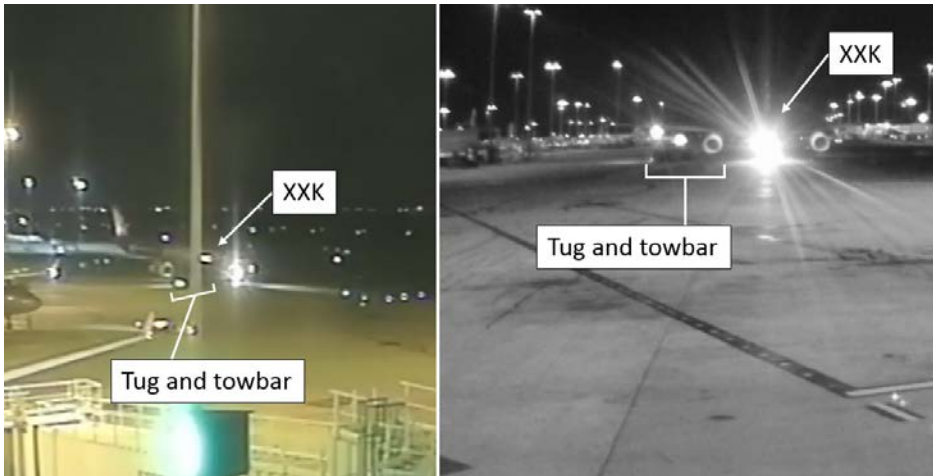
**Figure 2: Positions at commencement of aircraft taxi**

At 0009, the first officer confirmed to the captain that the AME and tug were clear, the captain then began to taxi. At this time, the AME was walking towards the left side of the tug, which remained parked forward of the aircraft's right engine and wing. As the AME walked, they detected the aircraft's taxi light illuminate and the aircraft begin to move. The AME then ran toward the tug door and alerted the tug driver to the aircraft movement.

The flight crew procedures required the flight crew to visually confirm that all ground equipment was clear of the aircraft prior to taxi. The first officer assessed that the tug and tow bar were clear of the right engine when they were not, although their perception may have been influenced by an expectation of them being clear given the communications with the AME and ATC providing taxi clearance.

- The flight crew and ground crew had differing understandings of procedures. These differing understandings led to different expectations of when the aircraft would commence taxi which resulted in the near collision.
- The first officer incorrectly assessed the distance of the tug from the aircraft.
