# Loss of separation involving Bombardier DHC-8, VH-LQG, and Boeing 777, ZK-OKF

11 km east of Sydney Airport, New South Wales, 9 December 2016

**ATSB Transport Safety Report**  
Aviation Occurrence Investigation  
AO-2016-169  
Final – 24 March 2017

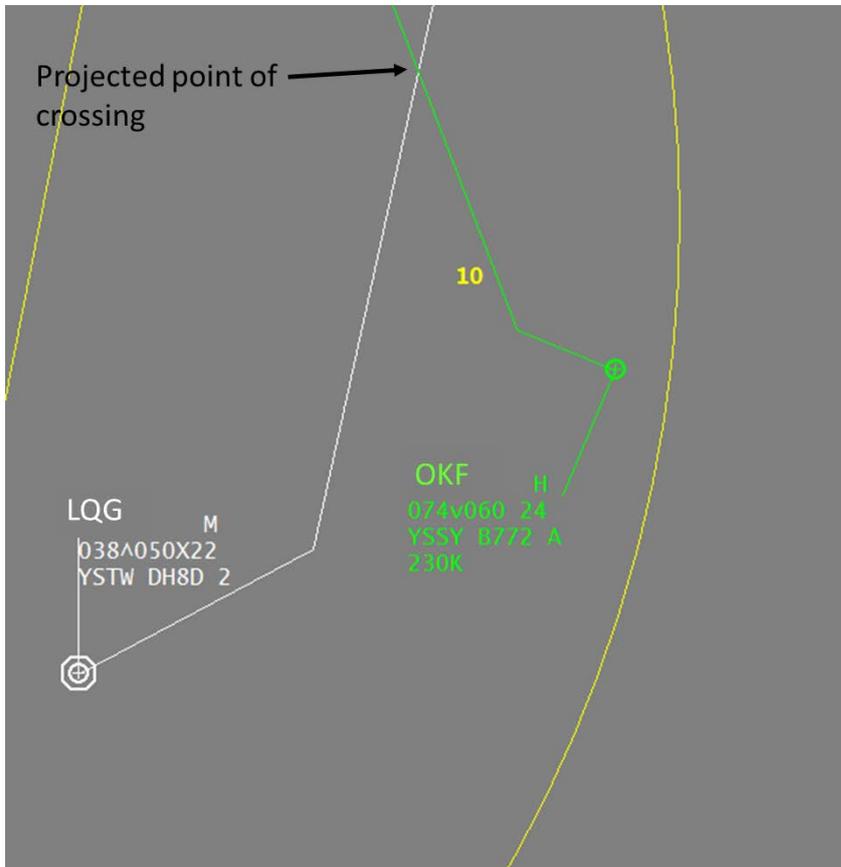
At 1408:38, as the aircraft climbed through 3,800 ft (Figure 1), Sydney Departures advised LQG there would be a short delay at 5,000 ft due to traffic above them. This was acknowledged by the PM.

**Figure 1: Disposition of aircraft when LQG was passing 3,800 ft direct KAMBA and showing the projected point of crossing.**
