Call sign confusion involving Airbus A330, VH-EBA, and Boeing 737, VH-VXF

near Brisbane Airport, Queensland, 15 December 2016

ATSB Transport Safety Report
Aviation Occurrence Investigation
AO-2016-173
Final – 27 April 2017

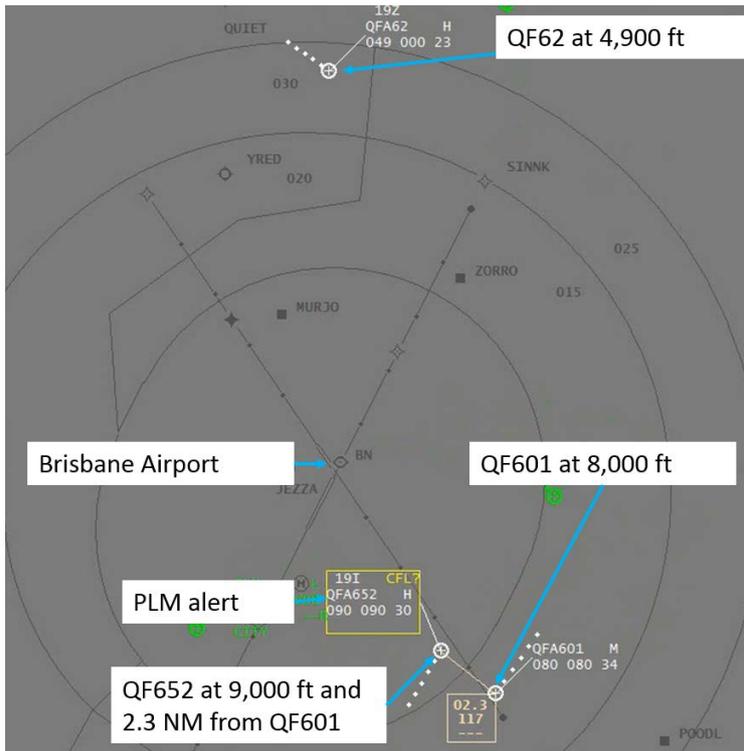
Figure 1: Traffic disposition and PLM alert

About 30 seconds later, the air traffic system identified a discrepancy between the controller-cleared flight level of 9,000 ft and the flight crew-entered altitude of 2,500 ft. The controller received a predicted level mismatch (PLM) alert, which displays as 'cleared flight level (CFL?)'.¹ The controller asked the crew of QF652 to confirm they were maintaining 9,000 ft, and the crew responded that they were on descent to 2,500 ft as cleared. The aircraft was passing 9,200 ft at this stage. The controller immediately responded 'no, that was for Qantas 62, Qantas 652 maintain 9,000'. By that time, radar data indicated that QF62 was at 4,900 ft. No read back was heard from the crew of QF62 to the clearance inadvertently issued to QF652.

As the two aircraft passed each other, radar data showed QF652 at an altitude of 9,000 ft and QF601 at 8,000 ft, with 2.3 NM lateral separation (Figure 1). Figure 2 shows QF652 at 8,700 ft and lateral separation with QF601 of 2.6 NM (Figure 2). The incorrect descent clearance resulted in a loss of separation with QF601, where the separation required was 3 NM or 1,000 ft and the minimum separation recorded was 2.5 NM and 700 ft.

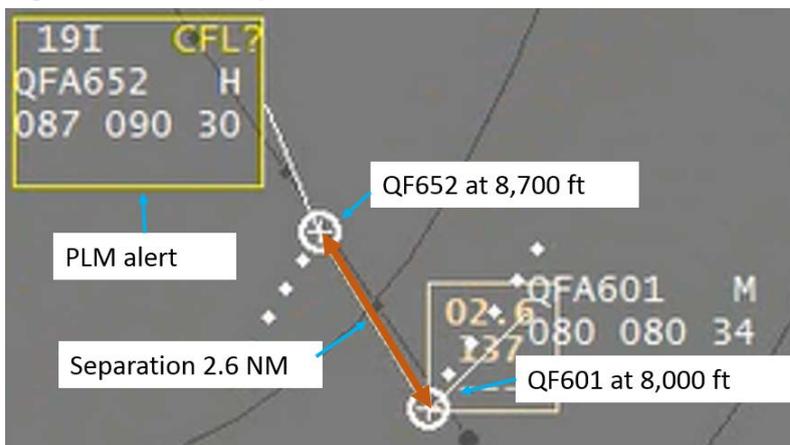
Figure 2: Loss of separation

- The controller inadvertently assigned descent to QF652 instead of QF62 due to call sign confusion, resulting in a loss of separation with QF601.
- The two inbound aircraft were operating on the same frequency with similar call signs and call sign confusion mitigation strategies were not used by air traffic control.
