Landing on an occupied runway involving Beech Aircraft Corporation B200, VH-ZOK

Horsham Airport, Victoria, 18 December 2016

ATSB Transport Safety Report
Aviation Occurrence Investigation
AO-2016-175
Final – 24 May 2017

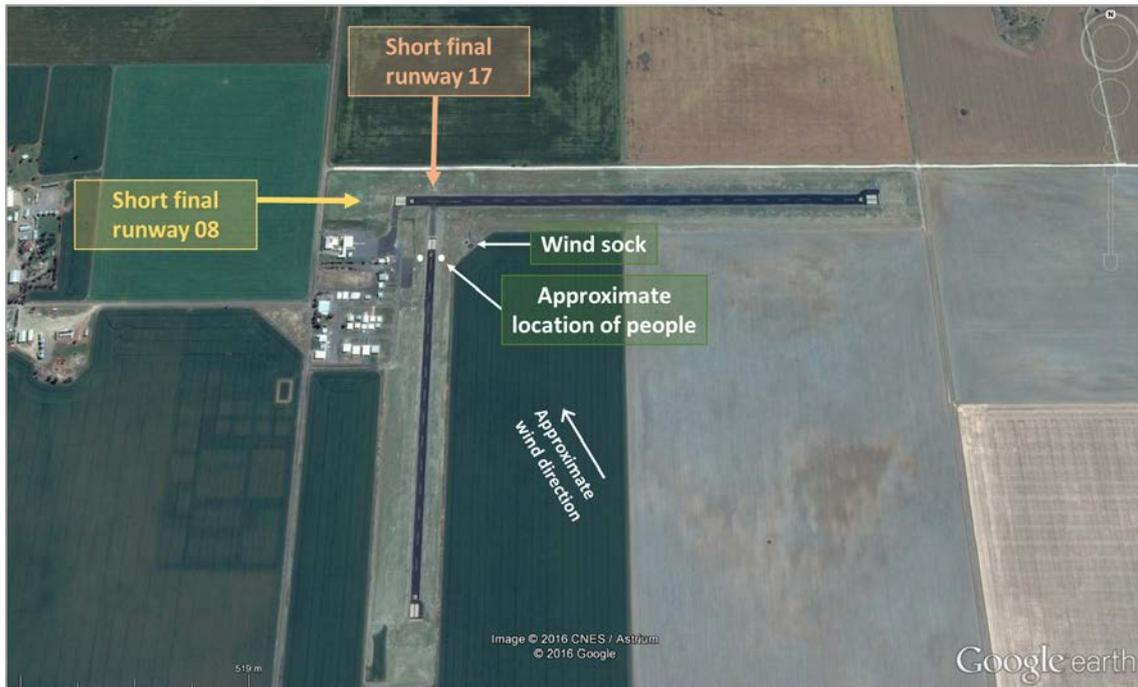
At the time when the event ground personnel were laying out the ropes, a powered aircraft was conducting circuits on runway 08 (Figure 1).

Figure 1: Map of airport showing runways 08 and 17 and the approximate location of the ground personnel

The ground personnel noticed the sound of another powered aircraft and looked up to see the landing lights of an aircraft on final approach for runway 17. The ground personnel were located on the grass on both sides of the runway and each moved back about 10 to 15 m within the runway white gable markers.⁵
