Landing on the left side of the runway strip involving British Aerospace AVRO 146, VH-NJW

Darlot Airport, Western Australia, 20 January 2017

ATSB Transport Safety Report
Aviation Occurrence Investigation
AO-2017-014
Final – 24 May 2017

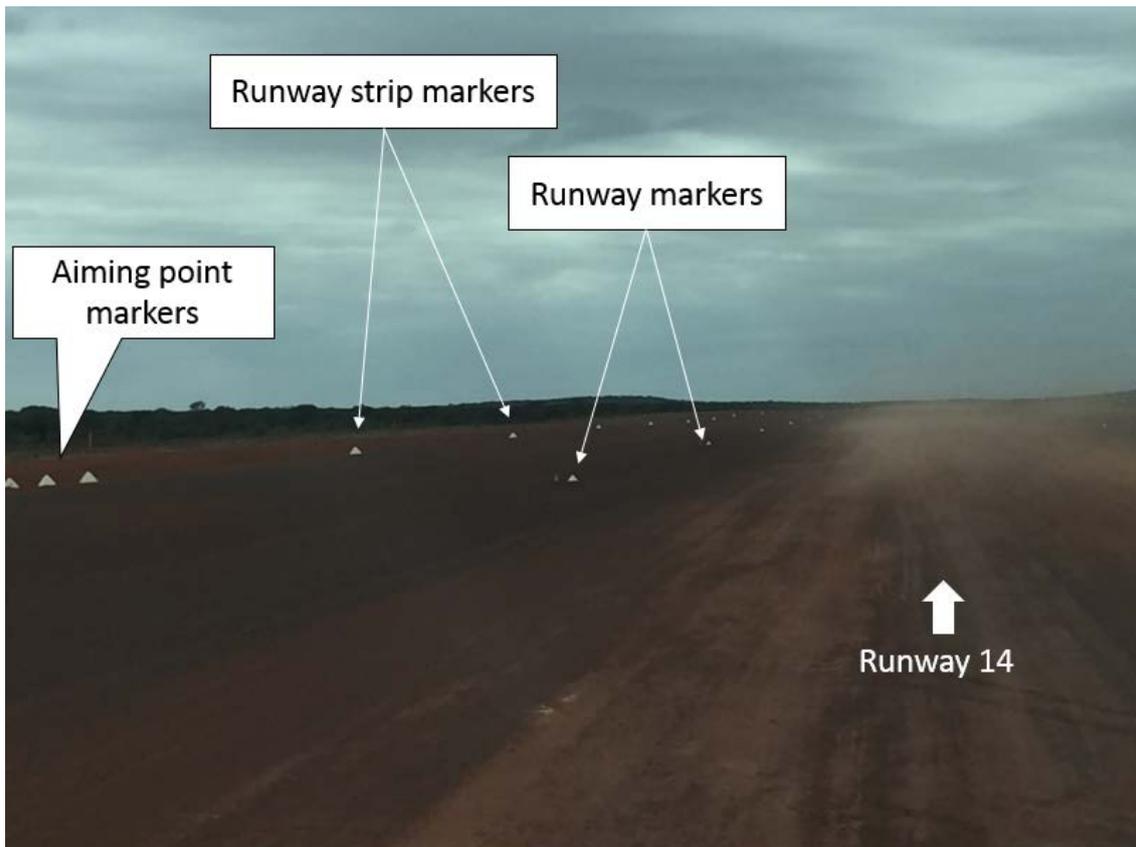
Figure 1: Darlot Airport runway 14

Source: Pilot, annotated by ATSB. Image depicts Darlot Airport runway 14 and left side of runway strip as viewed from the right seat of the aircraft with white frangible cones used as markers. Raised dust extends from the centre of the runway across the southern side of the runway strip.

Where aiming point markers are not required, such as on unsealed runways, the airport operator can elect to ‘implement an aiming point marking by providing an appropriate marking.’ Darlot Airport used three frangible white cones, either side of the runway on the edge of the runway strip, as aiming point markers (Figure 1).

runway strip markers as the left runway markers because the right runway and runway strip markers were obscured by the raised dust. This was confirmed in their mind by the presence of the aiming point markers on the left side of the runway strip. The PF was seated in the left seat and therefore used the aiming point markers on the left side as their visual guidance cue for the aircraft landing.

- The PF landed the aircraft in the runway strip to the left of the runway due to raised dust obscuring the markers on the right side of the runway and runway strip.
- Aiming point markers were employed in a non-standard manner at the unsealed runways used by the operator, which may have contributed to the PF landing the aircraft left of the runway.

The operator submitted a discussion paper to the Civil Aviation Safety Authority on the provision of aiming point markers for unsealed runways. The paper proposes the standardisation of aiming

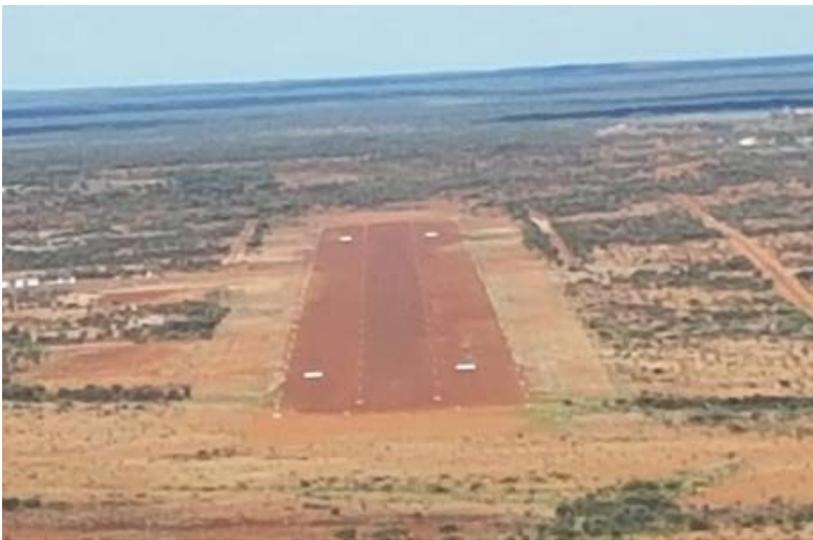
Figure 2: Gable aiming point markers within the runway strip (different airport used by the operator)

The aircraft operator provided services to three other airports with unsealed runways. Following this incident, the operator reviewed the other airports and found that at two airports the aiming point markers were located inside the runway strip (one used gable markers and the other cones), either side of the runway (Figure 2), and at the third airport the aiming point markers had been removed. Therefore, the aiming point markings were inconsistent between all four airports.

The siting of aiming point markers at airports with unsealed runways used by the aircraft operator was not standardised with respect to the type of markers used or the position of the markers relative to the runway. The pilot had experience, from operating into other unsealed runways, of aiming point markers positioned in the runway strip next to the runway. Therefore, the position of the aiming point markers on the left side of the runway strip markers was not recognised by the PF as an indicator that the aircraft was landing to the left of the runway.
