Collision with terrain involving Robinson R44, VH-MNU

Moreton Island, Queensland, 17 May 2017

ATSB Transport Safety Report
Aviation Occurrence Investigation
AO-2017-054
Final – 5 September 2017

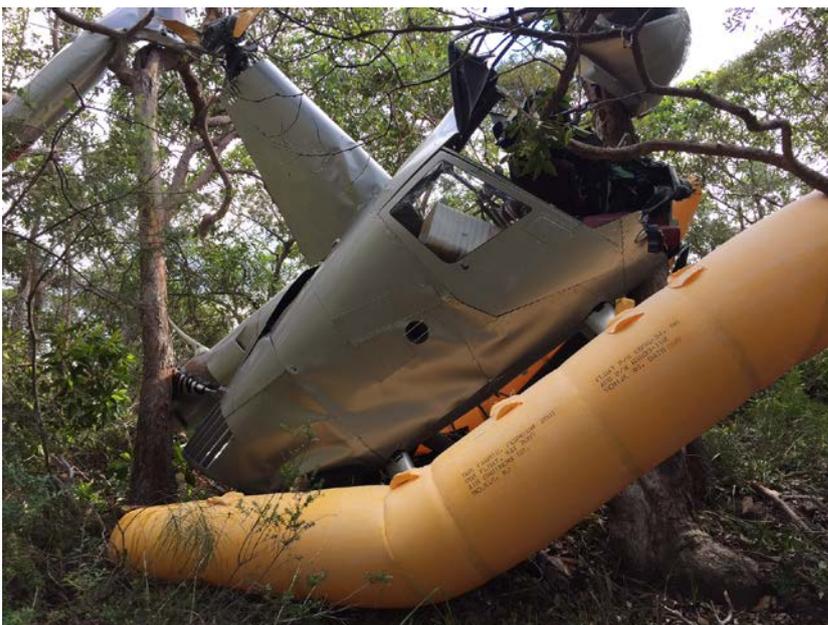
Figure 1: Accident site showing damage to VH-MNU

As the helicopter neared treetop height, the pilot deployed the emergency floats. As the floats contacted the trees, the pilot raised the collective to cushion the impact. The pilot and passenger sustained minor injuries and the helicopter was substantially damaged (Figure 1).

- The combination of low airspeed and turning right with a tailwind contributed to a loss of tail rotor effectiveness. The pilot’s response was ineffective at recovering control of the helicopter, particularly given the operation at low height above the trees.

- Company pilots are to be briefed and trained on task specific operations.
- A presentation on LTE has been given to all company helicopter pilots.
- The operations manual has been amended to highlight and add more detail to specific task training and pilot limitations.
- Training items have been updated to incorporate scenario/task training flights.
- Company pilots were required to re-read the operations manual, with a focus on the planning section (Part D).
- Company pilots will complete cockpit resource management (CRM) training.
