# Flight below the minimum permitted altitude involving Boeing 737-376, VH-XMO

Launceston Airport, Tasmania | 17 June 2016

**ATSB Transport Safety Report**  
Aviation Occurrence Investigation  
AO-2016-061  
Final – 28 November 2017

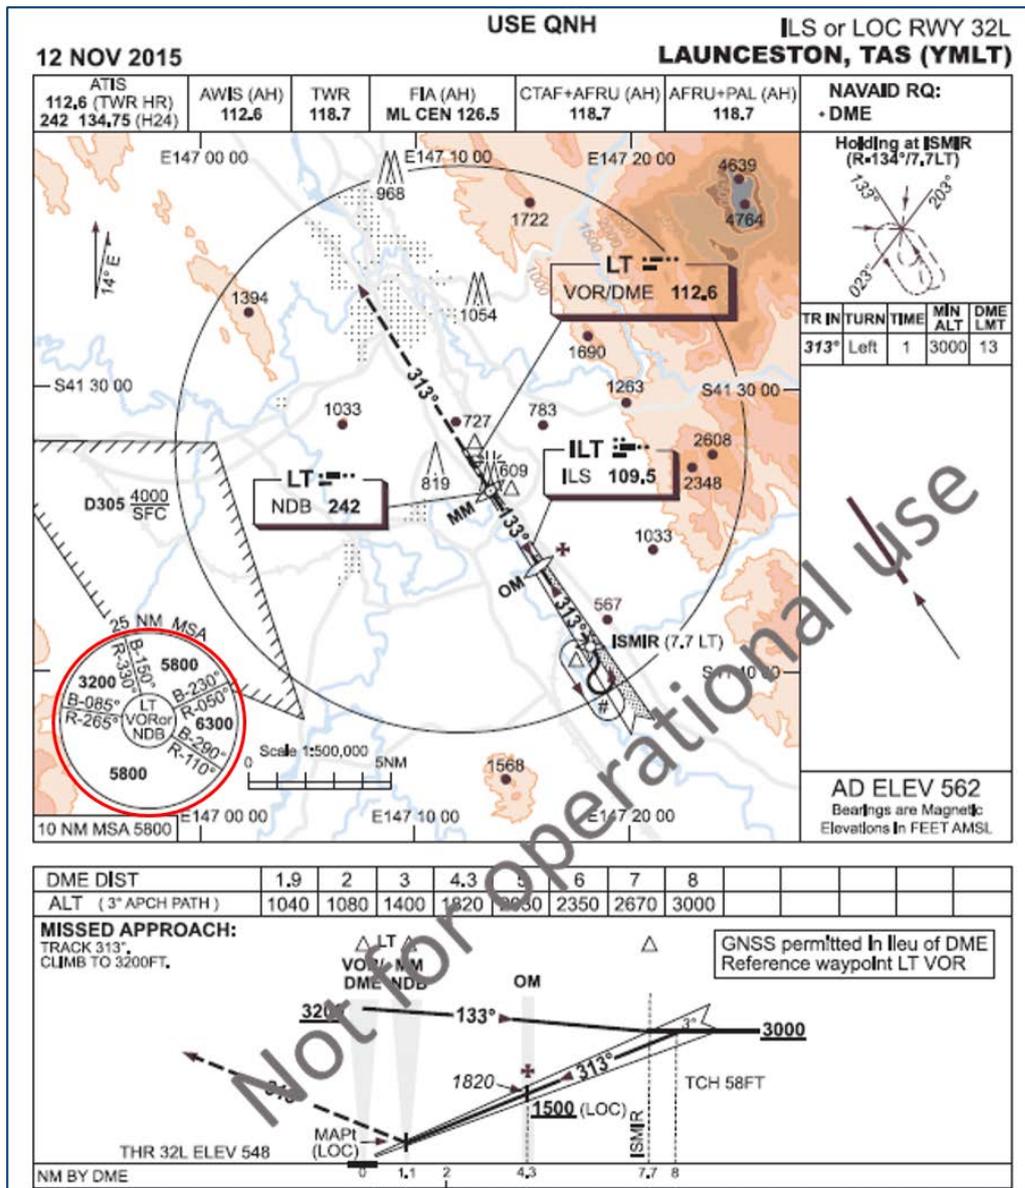
**Figure 1: Launceston instrument landing system approach chart for runway 32L with relevant minimum safe altitudes required for manoeuvring, in instrument meteorological conditions or at night, circled in red.**

By about 0148, the aircraft was turning left through a heading of 140 degrees and climbing through 3,900 ft. The aircraft was also approaching the boundary of the 3,200 ft minimum sector altitude<sup>4</sup> (MSA). At about the same time, ATC asked the crew to confirm that they would be remaining within the 3,200 ft sector and advised that otherwise they needed to be at 5,800 ft. The crew responded by advising they were climbing to 5,800 ft.

The aircraft subsequently entered the 5,800 ft MSA sector at about 4,400 ft, on a steady heading of about 110 degrees, and about 3.5 NM (6.5 km) southwest of the airport. As the aircraft was below the required MSA, ATC issued a safety alert for terrain and instructed the crew to climb immediately to 5,800 ft.

The south-easterly flight path resulted in the aircraft tracking towards a sector with a MSA of 5,800 ft while at an altitude of 3,200 ft. Although the crew had commenced a climb, the aircraft had only achieved an altitude of 4,400 ft when it entered the 5,800 ft sector. As a result, ATC

- A flight standing order was issued that drew flight crew's attention to the runway 32L instrument approach procedure's missed approach and the requirements for subsequent manoeuvring.
- The approach briefing requirements were amended to include intentions for manoeuvring following the completion of a published missed approach.
- A 'Hot Topic' discussion item – post missed approach manoeuvring and management, was added to the recurrent simulator training program.
- The recurrent simulator training program, released in December 2016, included exercises that reinforce the enhanced arrival and approach briefing requirements. Crews were required to demonstrate appropriate inflight management and manipulation subsequent to completion of a published missed approach.
