# Collision between the tug Arafura Sea Delta and general cargo ship Thorco Crystal

Weipa Harbour, Queensland | 24 June 2017

**ATSB Transport Safety Report**  
Marine Occurrence Investigation  
332-MO-2017-005  
Final – 6 December 2017

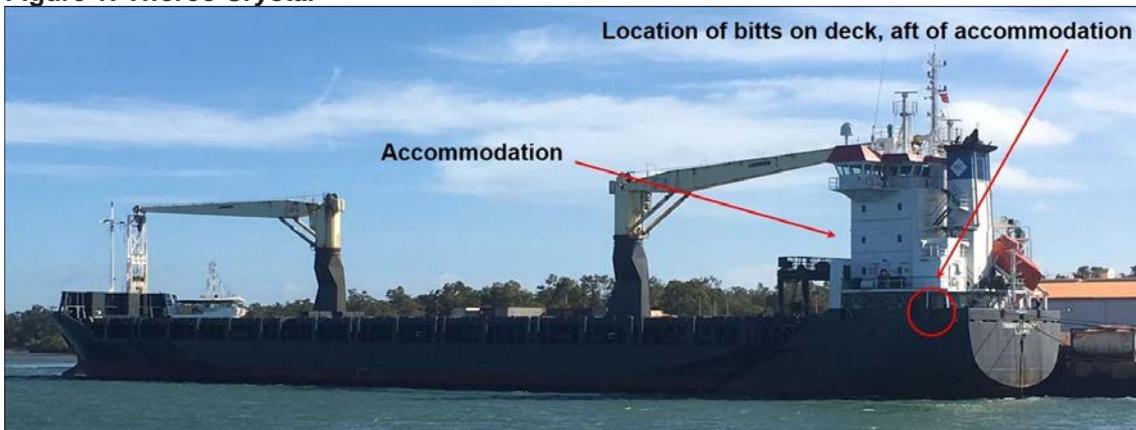
**Figure 1: *Thorco Crystal***

On 24 June 2017 at about 0735,<sup>1</sup> the tug *Arafura Sea Delta* collided with the general cargo ship *Thorco Crystal* (Figure 1) about 2 NM west of Humbug Point Wharf, Weipa, Queensland. *Arafura Sea Delta* was one of two tugs assigned to assist *Thorco Crystal's* berthing. *Thorco Crystal* was a 146 m long general cargo ship bound for Humbug Point Wharf. The collision resulted in a breach about 80 mm long in *Thorco Crystal's* hull and minor damage to *Arafura Sea Delta's* bow fender frame and bitts.<sup>2</sup>

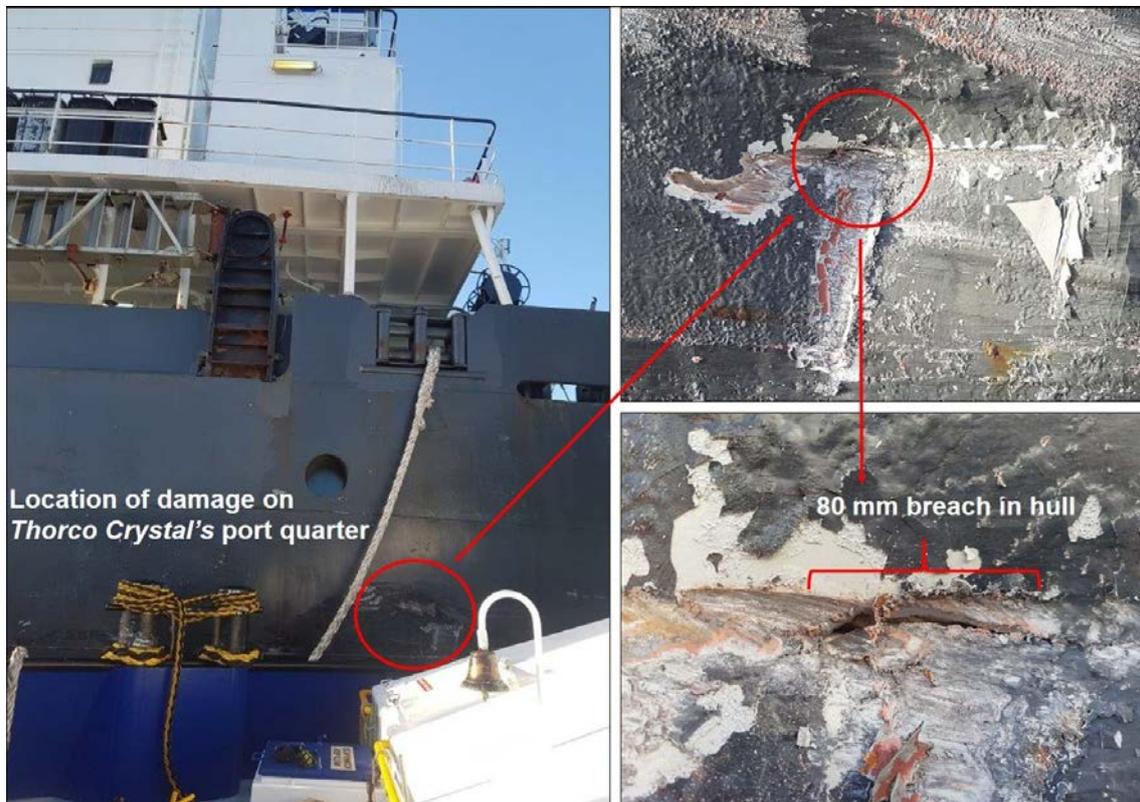
**Figure 3: Damage to *Thorco Crystal's* hull**

*Arafura Sea Delta's* master inspected the damage to the tug and found that the top of the steel frame for the fender on the tug's bow was offset slightly and the starboard bits had some paint damage.

*Thorco Crystal*, when inspected, was found to have a breach about 80 mm long in the hull (Figure 3) and several indentations in the vicinity of the breach. Temporary repairs were performed on board and the ship sailed for its next port without any delays.

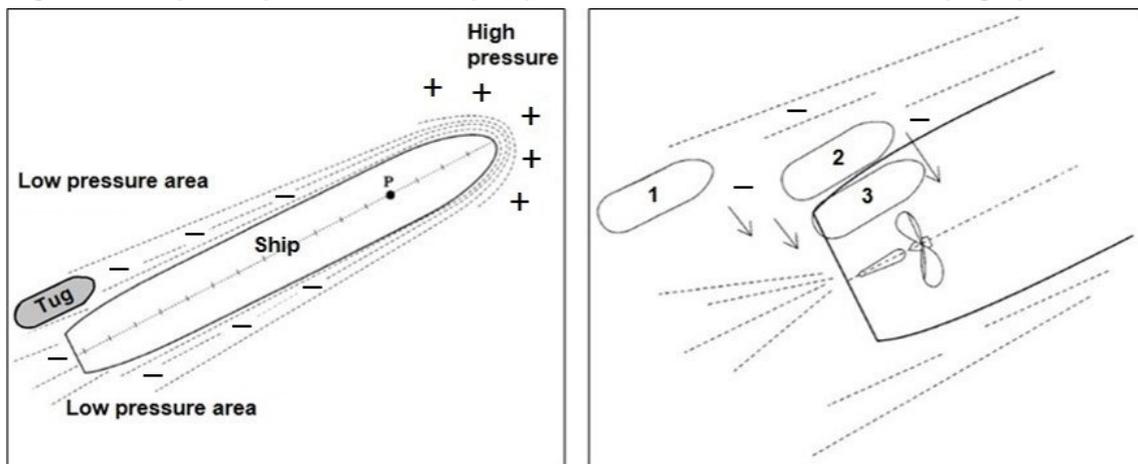
**Figure 4: Simplified pressure zones (Left) and the effect of interaction aft (Right)**

As a tug approaches a ship's quarter (Figure 4-Right, position 1), it may experience a sudden increase in speed as a result of the lower water pressure encountered. As the tug comes abeam of the ship's stern, it may experience a sudden suction force and start to take a sheer towards the ship. Without quick action using counter rudder and appropriate power, the tug will be drawn into the ship's side (Figure 4-Right, position 2). If the ship is in ballast, partly loaded or has an overhanging stern, the tug can be drawn in underneath causing serious damage to the tug's superstructure and/or the ship's side (Figure 4-Right, position 3).

*Arafura Sea Delta*'s position near the ship's port quarter placed it in the low pressure zone surrounding *Thorco Crystal*'s stern. This likely subjected the tug to the hydrodynamic interaction (interaction) forces generated by the flow of water around the ship's hull. The sudden sheer to starboard experienced just before the impact is consistent with the documented effects of interaction forces on a tug operating at a ship's stern. The ship's speed of 4.5 knots and the estimated ebb tidal stream of about 1.8 knots (obtained after the collision) were both factors that had an influence on the strength of the interaction forces generated. Furthermore, tidal streams on the ebb tide are known to reach rates of up to 4 knots in the vicinity of the collision, potentially intensifying the interaction forces generated.

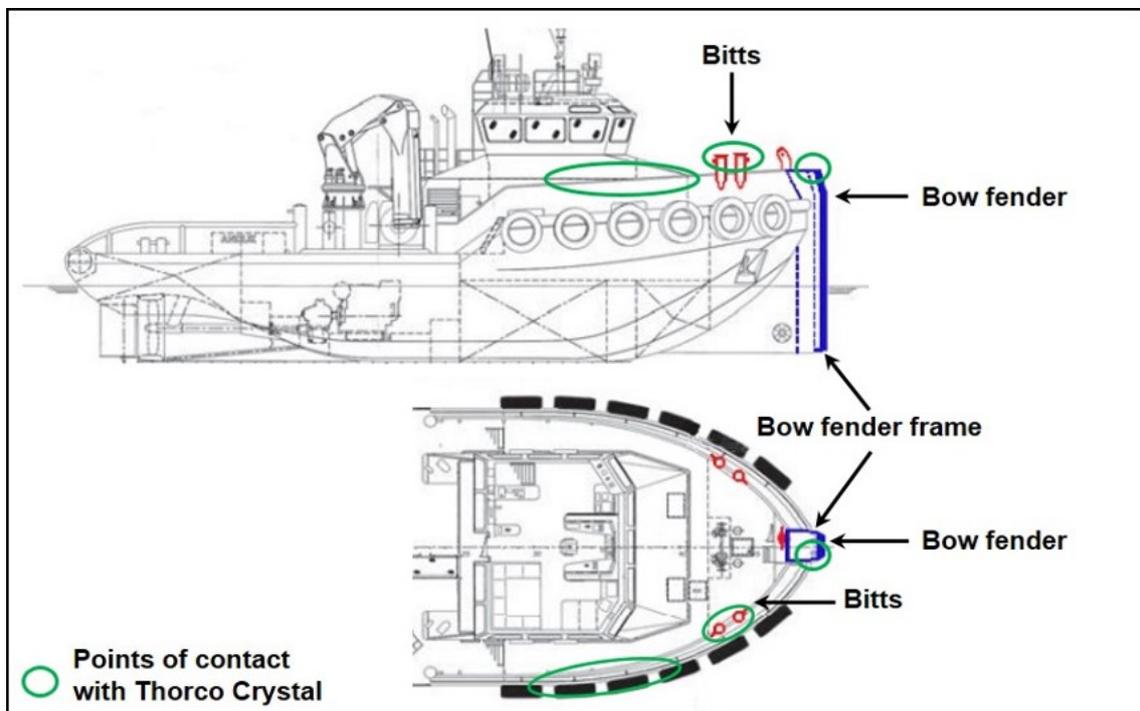
**Figure 5: Layout of bitts and bow fender on *Arafura Sea Delta***

The tug, while suitable for ship operations, had been primarily used for barge work and design features such as the placement of bits forward and the fendering arrangement reflected this (Figure 5). Ship handling operations were not a normal part of the tug's duties. However, the

Tugs now adjust the configuration of their fendering based on the outcome of the pre-planning meeting between the pilots and tug masters.
