Australian Transport Safety Bureau

Collision with terrain involving The Airplane Factory Sling 4, VH-BEG

Caloundra Aerodrome, Queensland, 12 August 2017

ATSB Transport Safety Report
Aviation Occurrence Investigation
AO-2017-081
Final – 20 February 2018

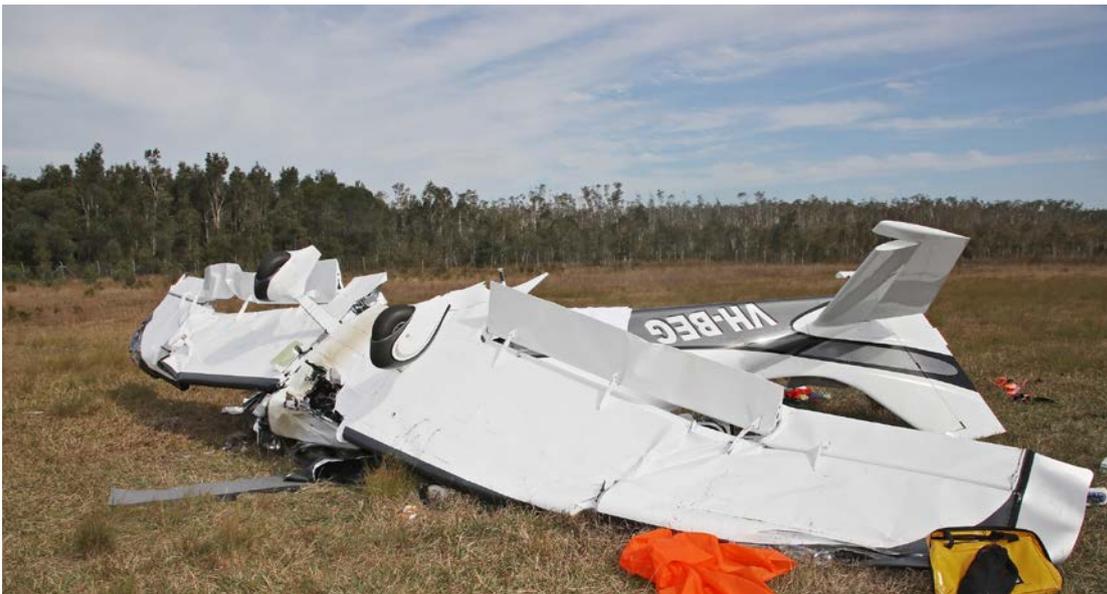
Figure 1: The Airplane Factory Sling 4 amateur-built aircraft, registered VH-BEG

During the left turn, the aircraft aerodynamically stalled and the aircraft rolled to the left. Almost immediately, the left wing tip struck the ground and the aircraft collided with terrain. The fuselage fractured at the engine firewall, the engine was pushed rearward and intruded into the cabin.

The aircraft came to rest inverted and was destroyed (Figure 1). The pilot and all three passengers suffered serious injuries.

The figure shows the wreckage of VH-BEG after emergency services had attended. Source: Queensland Police

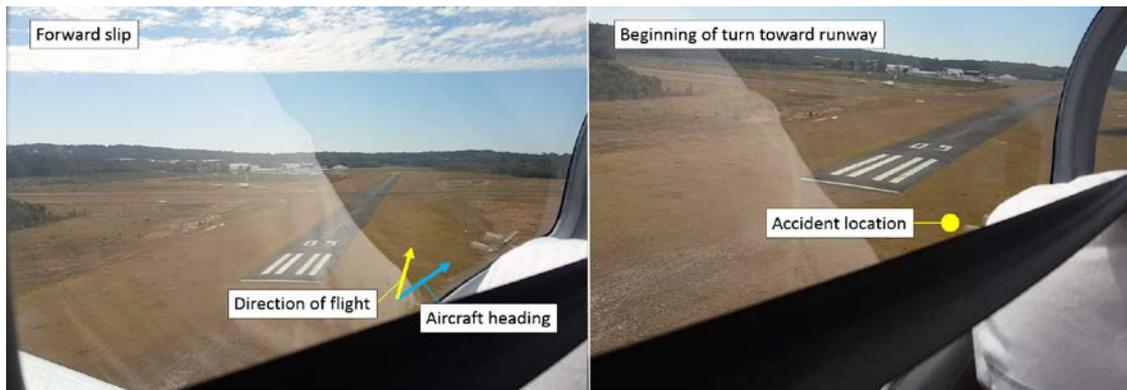
Figure 2: Images from video footage

The footage showed the aircraft in a forward slip with the nose yawed² to the right and tracking parallel to, but right of, the runway extended centreline (Figure 2). The indicated airspeed was 58 kt,³ and the tachometer indicated idle power. The forward slip then stopped and the aircraft turned left toward the runway threshold. At the same time, the descent rate increased.

The figure shows images of the aircraft during the approach prior to the accident. The aircraft is shown in a forward slip (left) and at the beginning of the turn toward the runway 05 threshold (right). Source: Passenger, annotated by ATSB

The aircraft approached the runway threshold on a heading of about 010 degrees magnetic, and appeared to be undershooting the threshold. Pitch angle then increased, an aerodynamic stall occurred, and the aircraft rolled rapidly left. As the aircraft rolled, the slip indicator displayed a full right deflection, indicating that the aircraft had entered an incipient left spin. The footage stopped as the left wing impacted the ground.

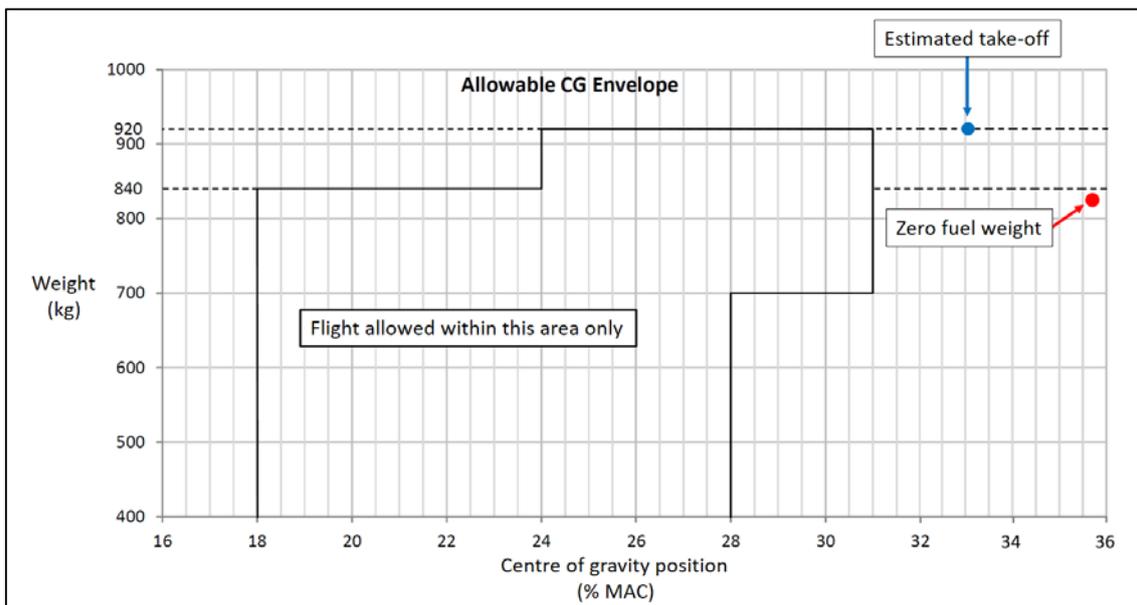
Figure 3: Graphical representation of the aircraft centre of gravity for the accident flight

Based on the above weights, the estimated take-off weight for the accident flight was 919 kg. The take-off centre of gravity position was 33.1 per cent MAC, and the zero fuel weight⁵ centre of gravity position was 35.7 per cent MAC.

The centre of gravity position was outside of the permissible range for the entire flight (Figure 3).

The graph shows the permissible centre of gravity range along with the calculated take-off and zero fuel weight centre of gravity positions. Source: Aircraft manufacturer, modified and annotated by ATSB
